Foyers Tree Felling

Resilience Survey and Woodland Condition Report

Landowner Scottish and Southern Electricity Network

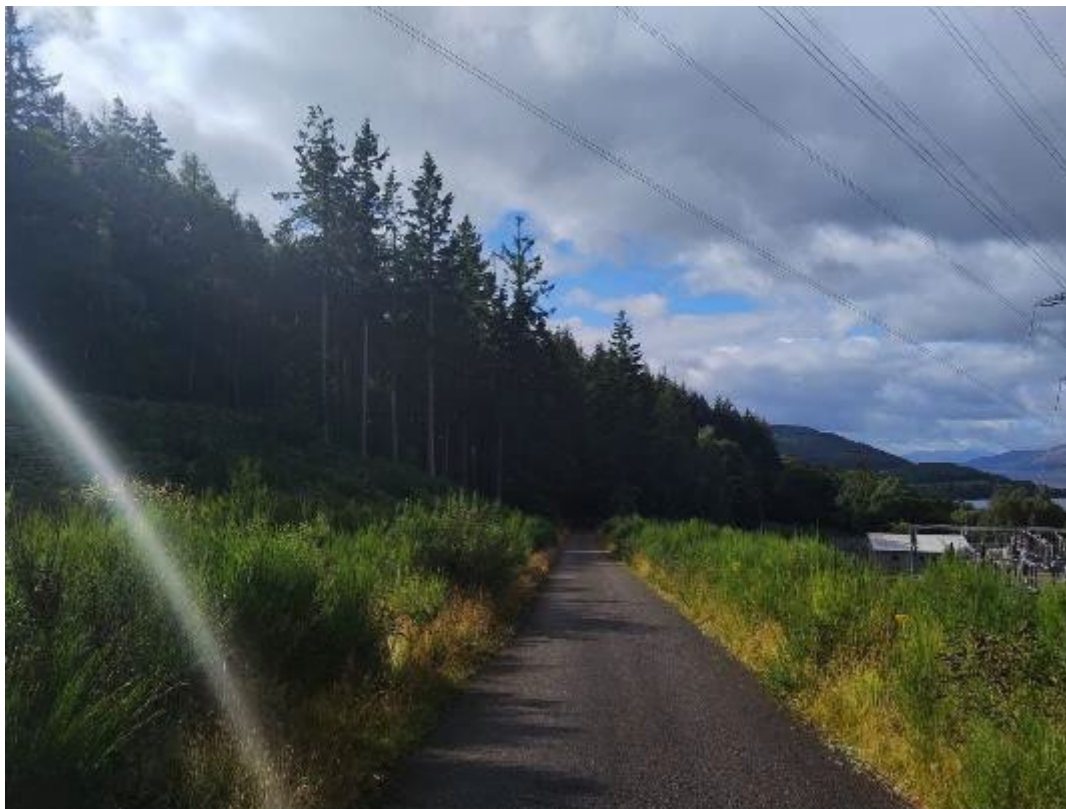
*Plate 1: Study area 1a*

Plate 1 illustrates the woodland type located within compartment 1a (designated for the purpose of this report, see Figure 2). The compartment is predominantly composed of Douglas fir with heights ranging between 34-37m tall. The surveyor noted thinning crowns, but the general condition of the trees appeared healthy. There were signs of root upheaval and weakened anchor points where the root structure was exposed (**Plate 6**). The woodland edge is 46m from the nearest conductor on a 275kv overhead transmission powerline. The understorey largely comprised coppiced oak, rowan and hazel (**Plate 5**). Silver birch was also prevalent. The risk of windthrow was low from the east and south as the block is relatively sheltered. However, the risk of windthrow from the north and northwest is moderate to high due to exposure after the proposed phase 1 felling in Forestry and Land Scotland (FLS) management plans are undertaken (Figure 3).

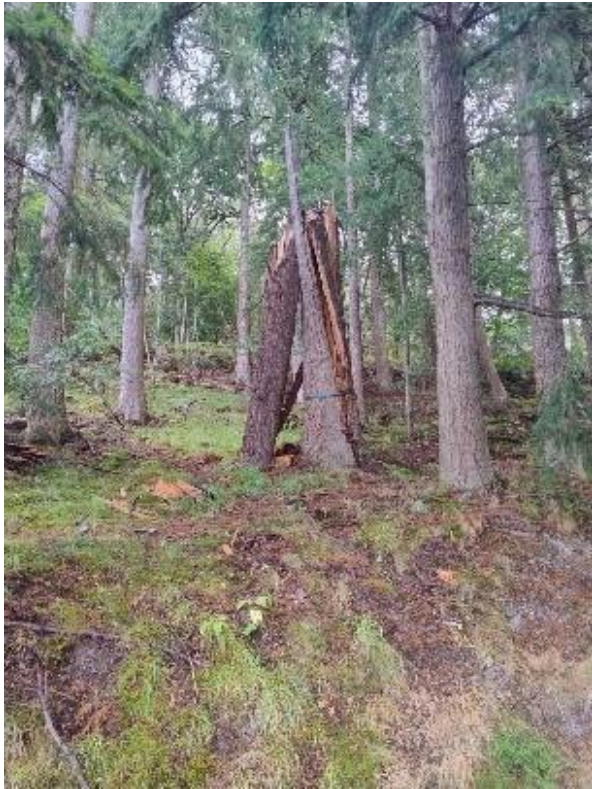
*Plate 2: Windblow in 1a*

Plate 2 illustrates the current wind damage within the compartment. Overall, this coup is healthy despite areas of windblow.

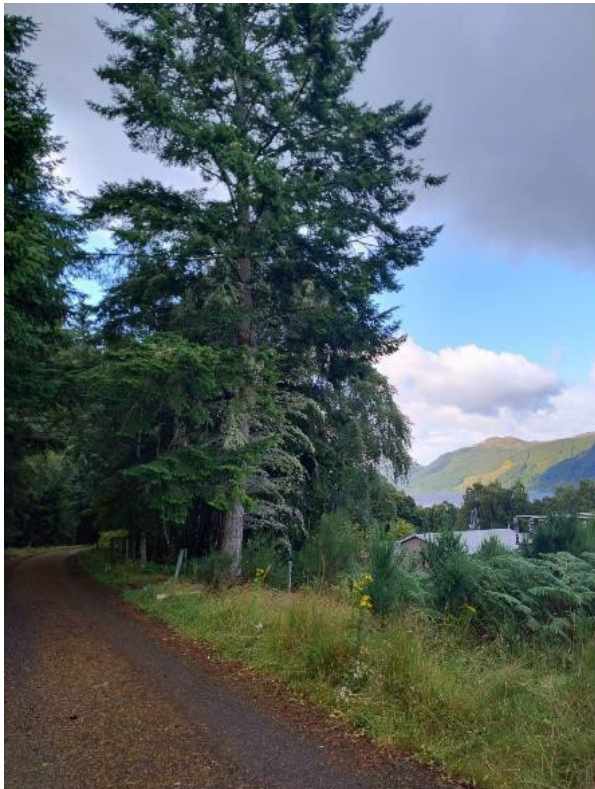
*Plate 3: Study area 1b*

Plate 3 illustrates the woodland type located within compartment 1b (designated for the purpose of this report, see Figure 2). This compartment is predominantly composed of mixed broadleaves (MB). The surveyor noted species such as Norway maple, Silver birch, Small leaved Lime, Douglas fir and European larch. The diameter at breast height (DBH) of the Douglas fir was 44cm. This coup is situated on an embankment weighted or biased towards the substation (**Plate 4**). The woodland edge is 23m to the substation fence and 34m to the closest infrastructure within the substation compound. The height of the MB range between 14 and 20m tall. The Douglas fir was recorded at 29.5m tall and 44m to the nearest conductor. The health of this woodland appeared to be good with no evident signs of root upheaval or decay.

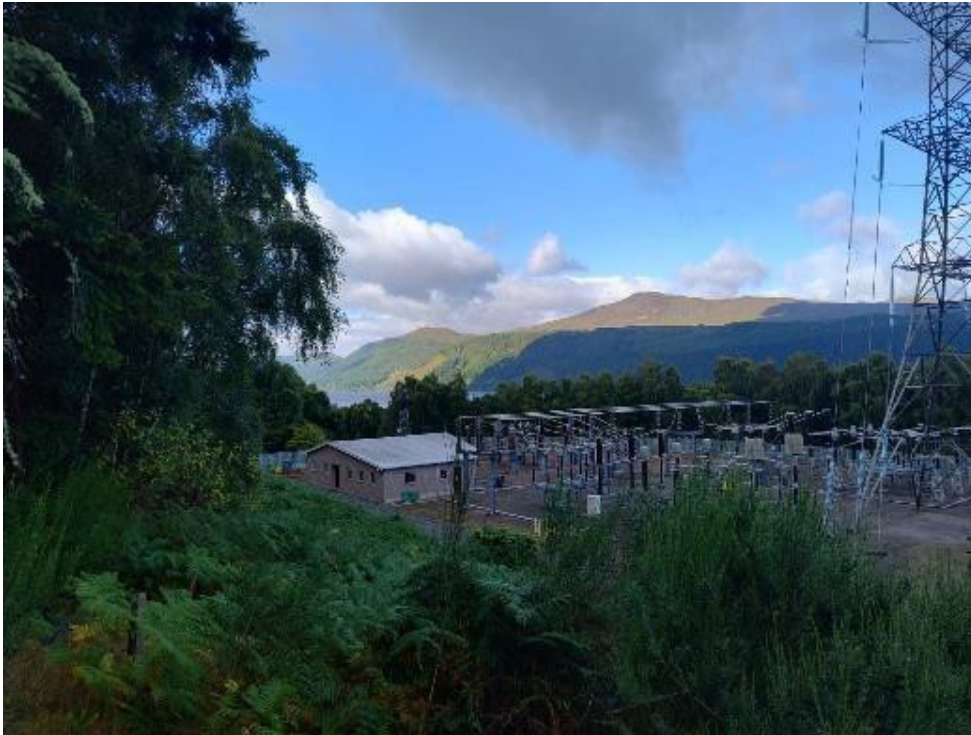
*Plate 4: Foyers Substation*

Plate 4 illustrates the proximity of compartment 1b to the substation.

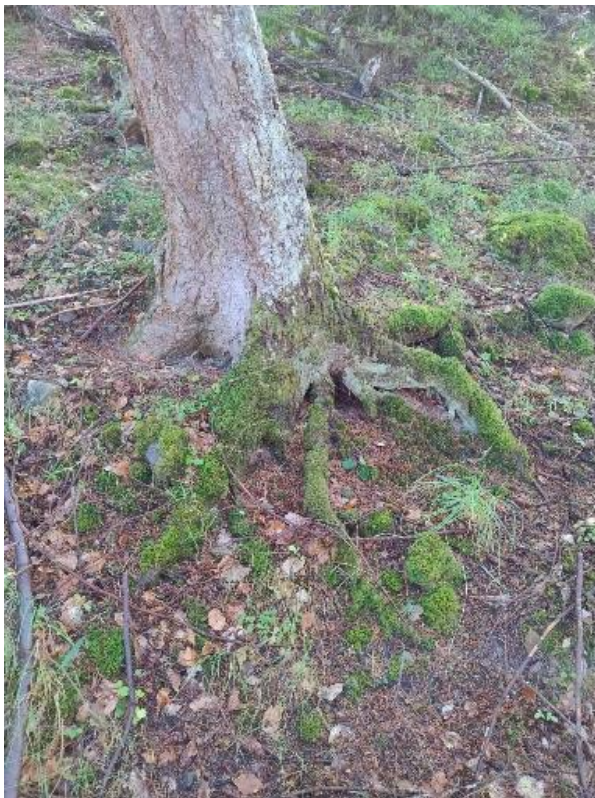
*Plate 6: De-stabilised root base within 1a*

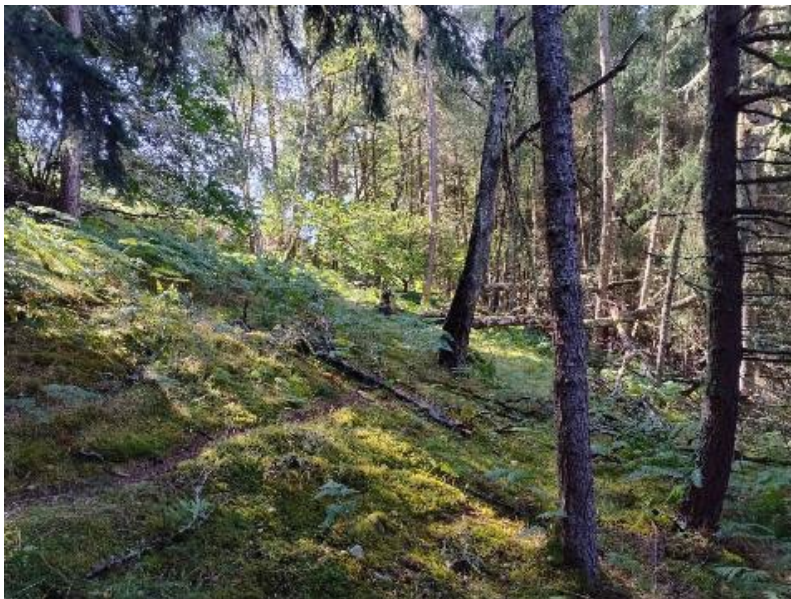
*Plate 7: Glade*

A small glade (**Plate 7**) was noted by the surveyor where the woodland type changed from over mature Douglas fir to mature Douglas fir, Silver birch and European larch. The level of light reaching the forest floor was significant with bracken being dominant. Fungal growth was noted on several trees within this area where decay was evident as illustrated by plate 8.

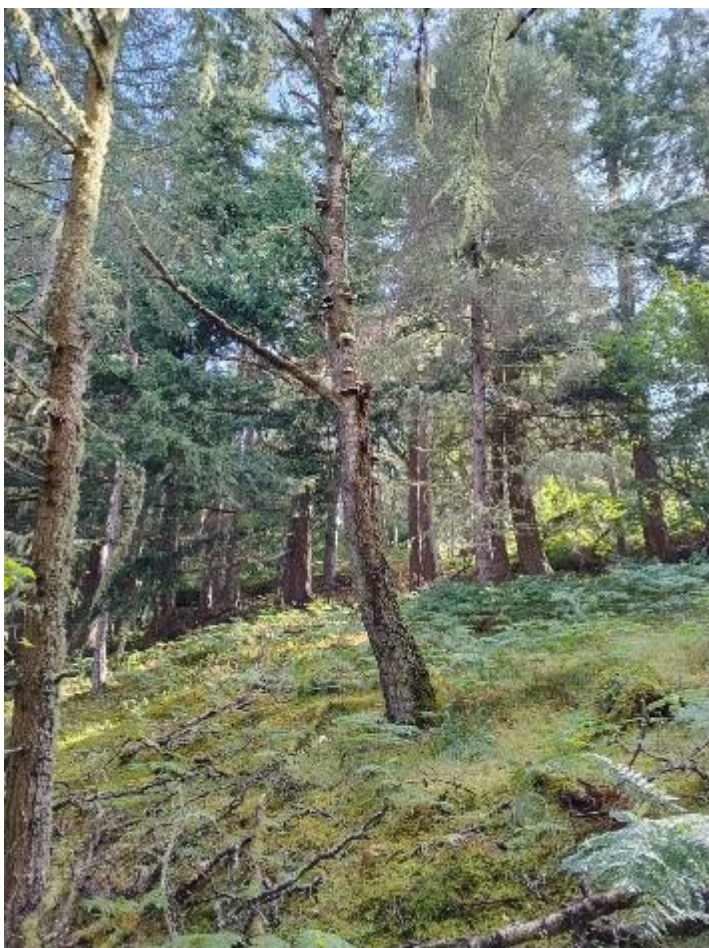
*Plate 8: Fungi growth*

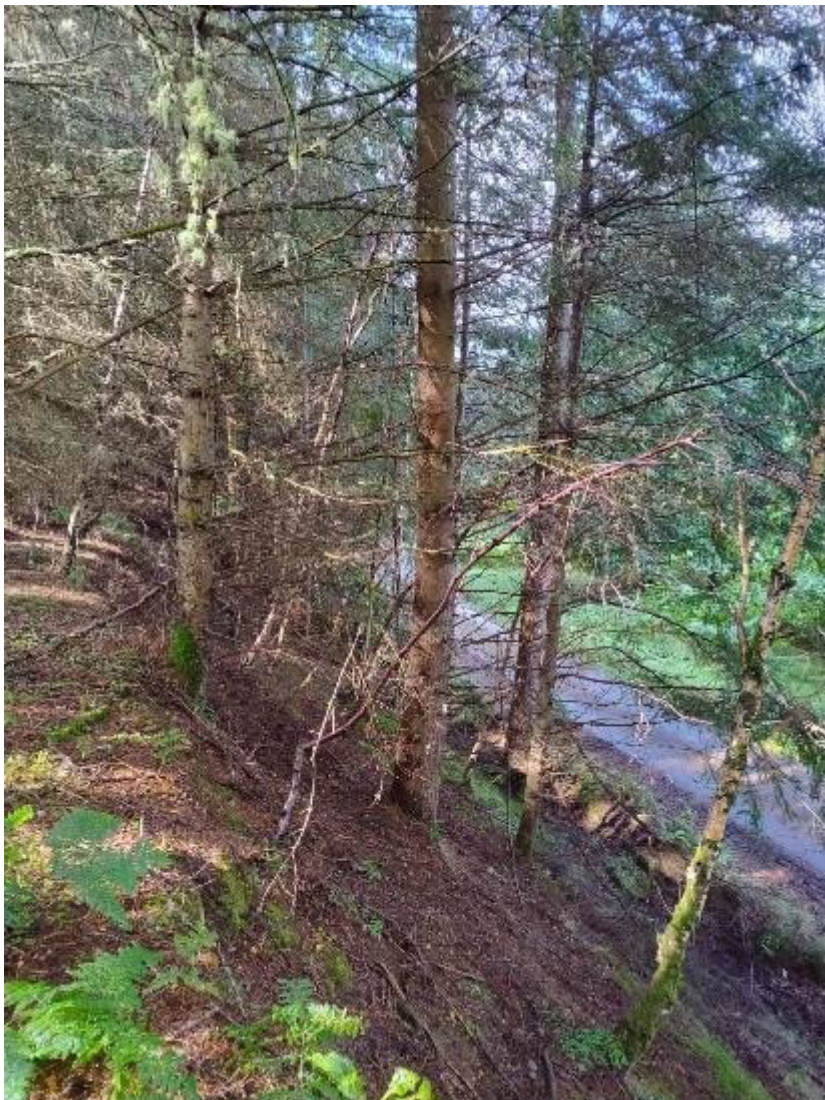
*Plate 9: Conifer crop on embankment*

Plate 9 illustrates Sitka spruce growth on the embankment above the single-track road servicing the substation named 'Loch Ness'. The surveyor was unable to confirm but suspected shallow rooting may be likely due to the ground conditions. The trees growing on the embankment are biased towards the single-track road (Loch Ness) which is also a popular walking route, the name of which is unknown.

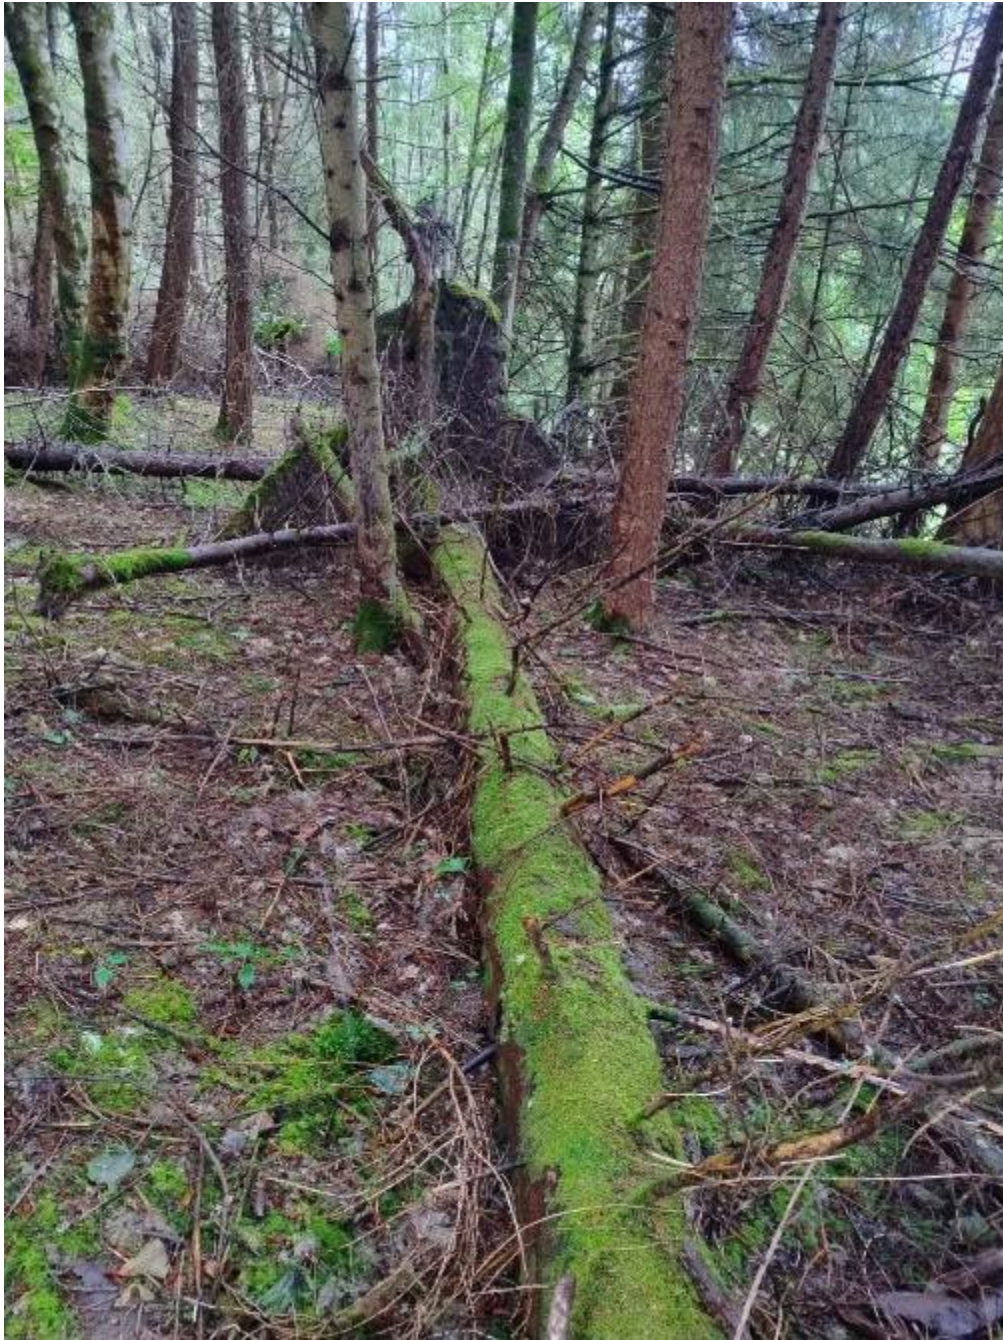
*Plate 10: Windblow*

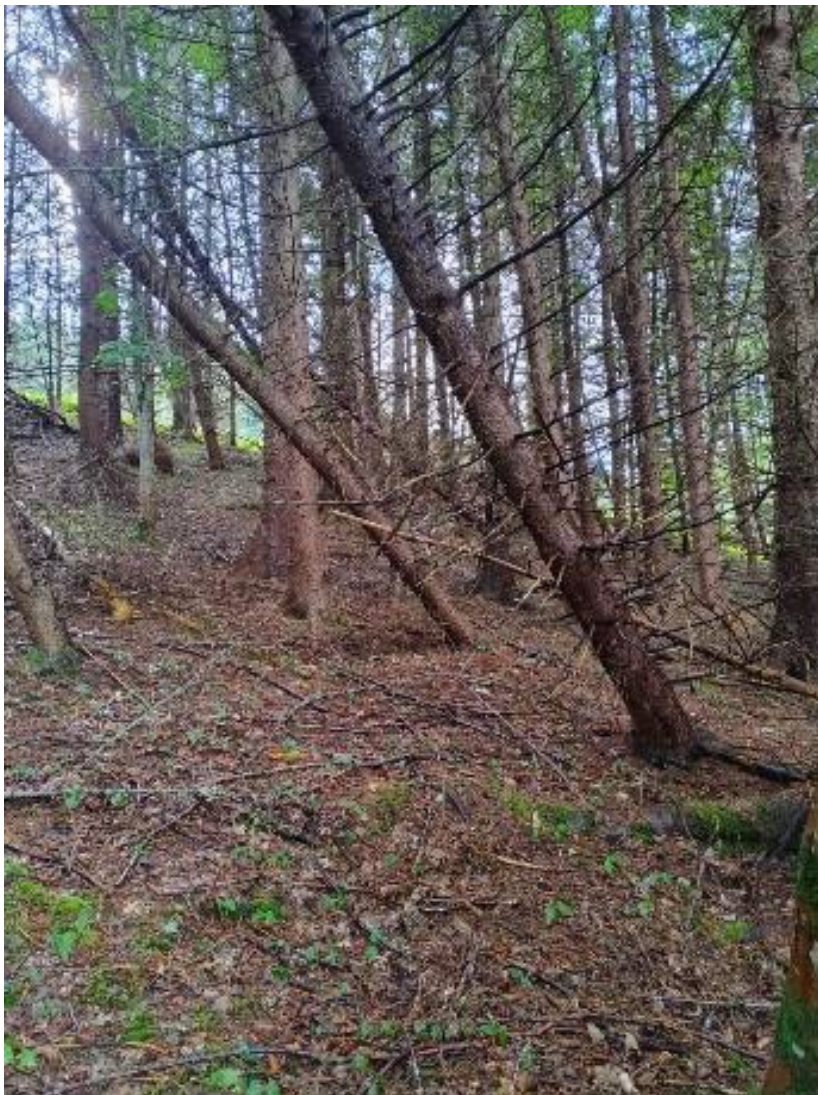
*Plate 11: Suppressed trees blown*

As illustrated by Plate 11 Sitka spruce is dominant within compartment 1c (designated for the purpose of this report, see Figure 2). The woodland does not appear to have been thinned, the understorey comprises 'spindly' suppressed spruce which has blown and died off. The area is largely composed of Sitka spruce and European larch. The majority of the trees within this section have a lean towards the northeast towards the substation.

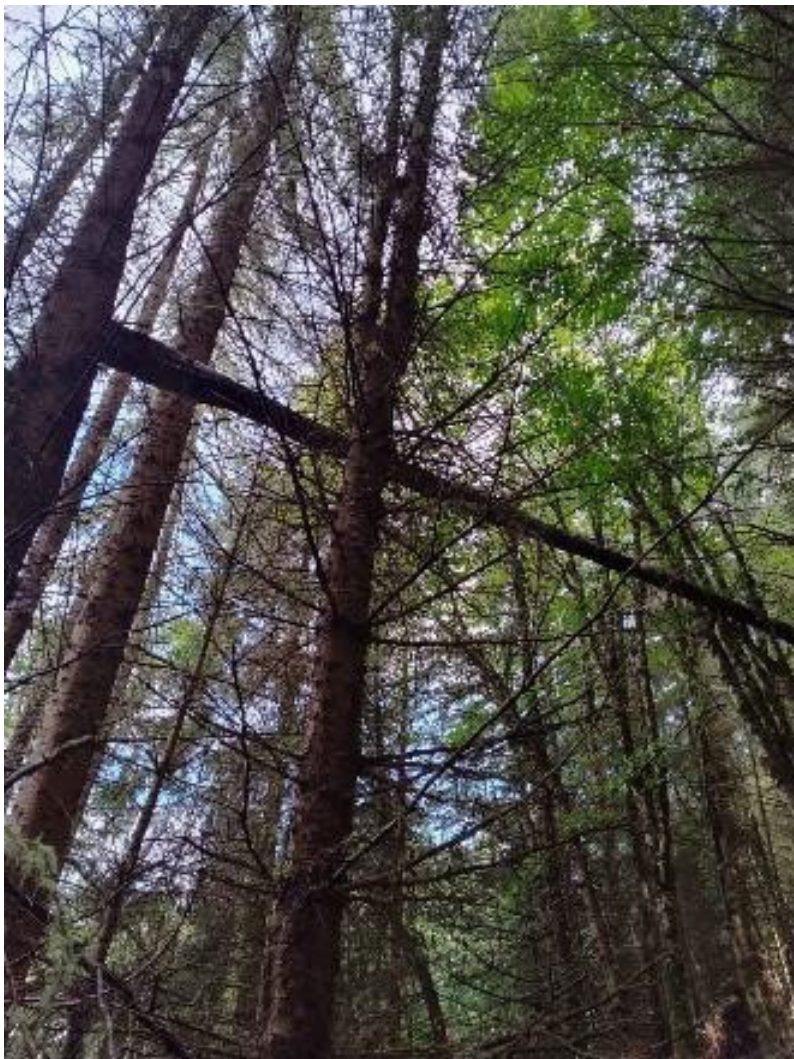
*Plate 12: Split stem - 'widow maker'*

Plate 12 illustrates further existing wind damage that has occurred to the crop. A co-dominant stem has snapped and is hung up. The term 'widow maker' is given in these instances which refers to a detached limb or broken treetop which could cause significant harm/death if it were to fall.

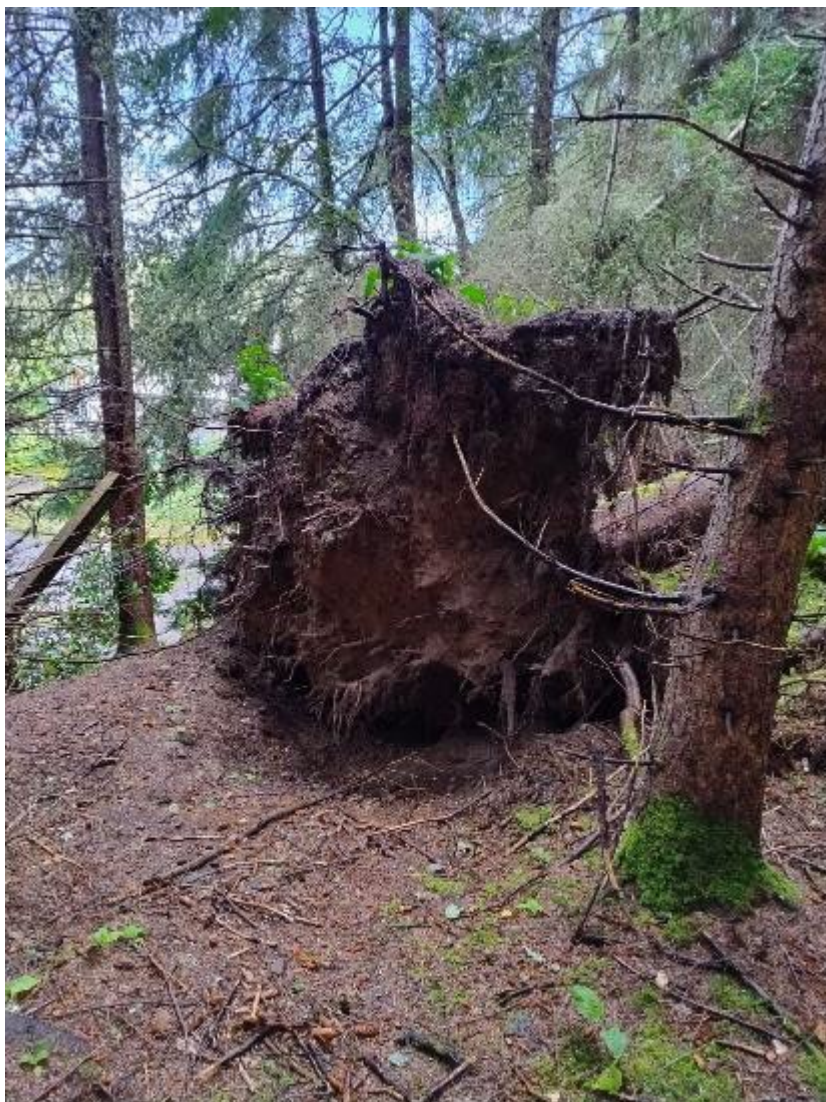
*Plate 13: Root structure on blown tree*

Compartment 1c is largely comprised of over mature Sitka spruce. DBH measurements were taken ranging from 45 up to 75cm. The surveyor struggled to accurately measure tree heights due to the closed canopy; However, top heights were recorded around 34m tall. As illustrated by Plate 13 this area has also suffered from windthrow. Plate 13 gives an indication of the rooting which appears to be quite good. Strong winds potentially from the non-prevailing direction and an over mature crop have likely been the cause for the windblow. Sporadic Norway maple and European larch were also noted within this section.

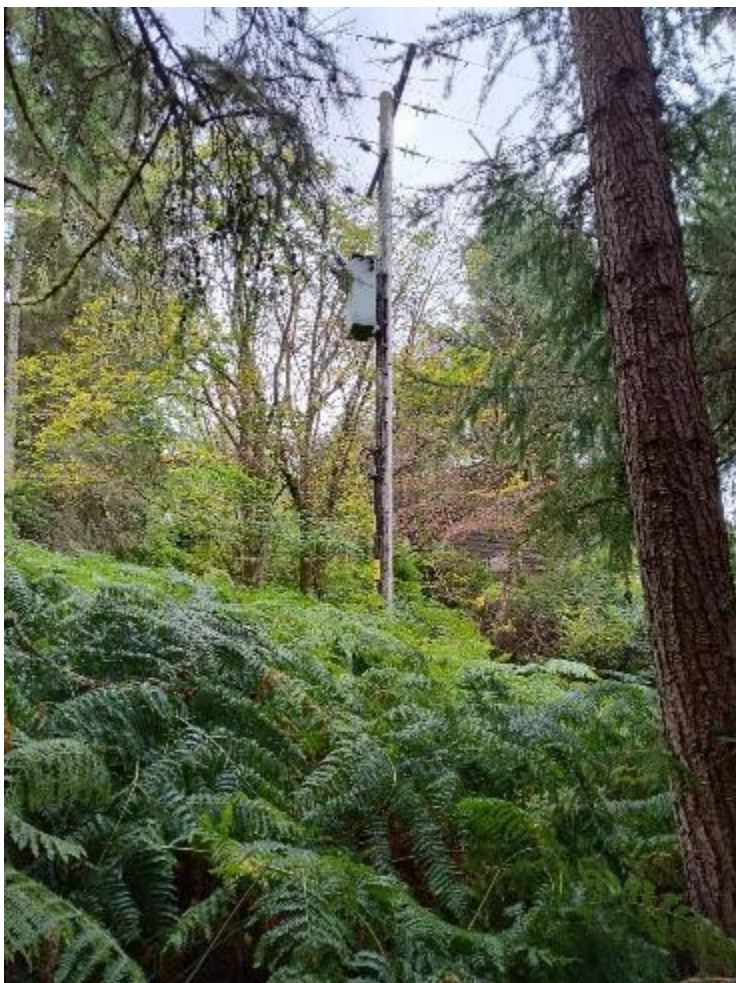
*Plate 15: Distribution overhead powerline*

An overhead distribution powerline (**Plate 15**) on wooden poles was noted at the southern end of the study area. The woodland edge is 7m parallel to the overhead powerline. At present the edge trees appear to be stable but if they were to fail, they would be within falling distance of the powerline and would cause significant damage.

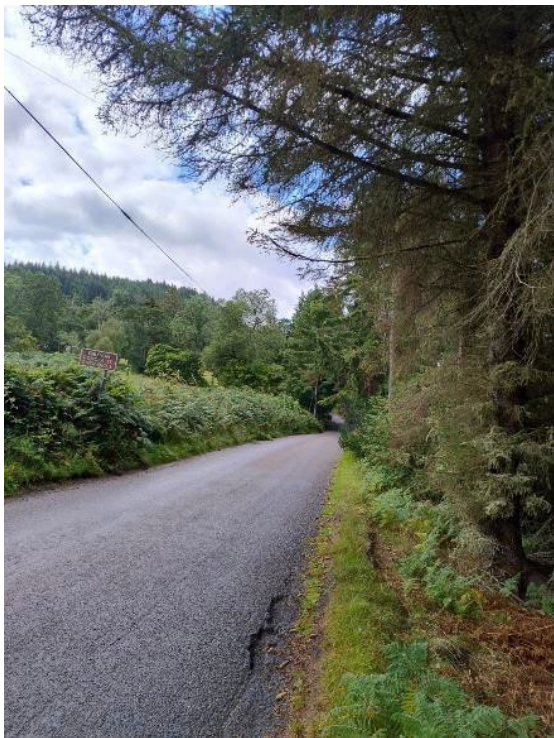
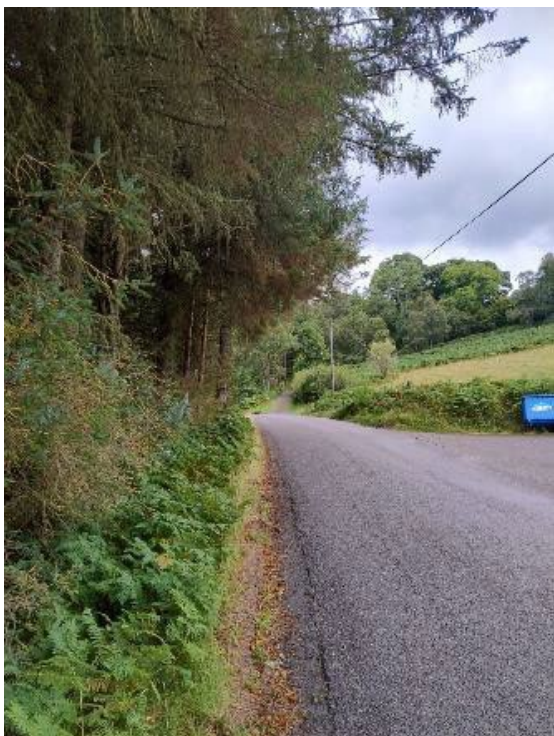
Plates 16 and 17 show the woodland edge along the B852. The front row of spruce is between 2 and 3m from the road. A blind corner is also present opposite a residential property 'Sealladh An Loch'. This is important to recognise as visibility is poor and if trees were to fail and fall across the road a significant accident could occur.

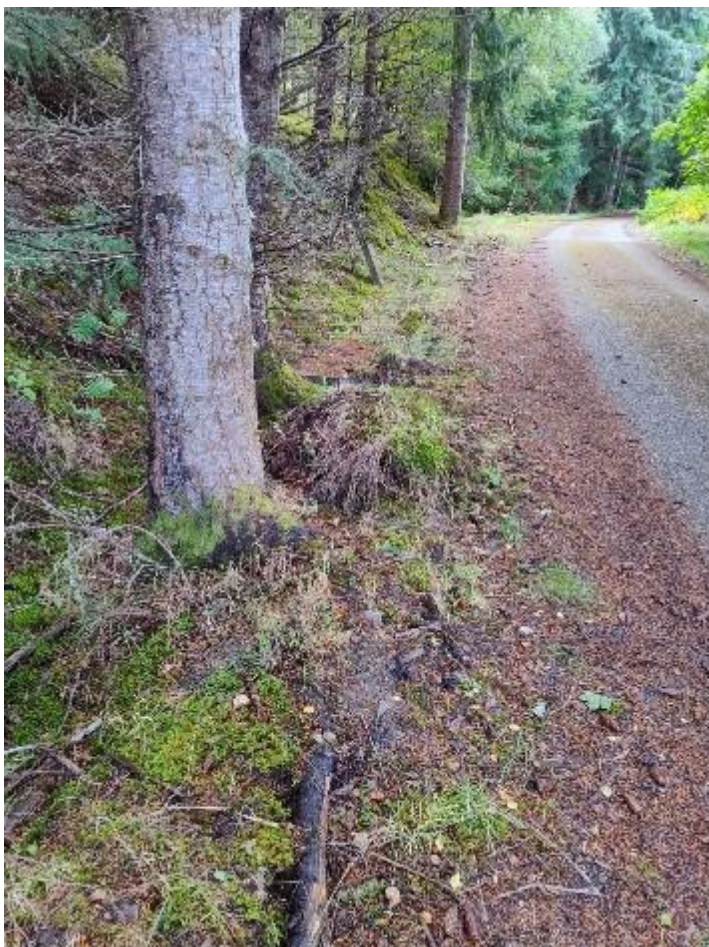
*Plate 18: Douglas fir at roadside*

Plate 18 shows that there are several Douglas fir trees growing in the roadside drain along the single track 'Loch Ness' Road which services the substation. Water levels in the drain were low at the time of the visit but this could have led to shallow rooting which increases the risk of wind blow as the root structure is unable to support the tree during storm periods. Trees tend to blow from the 'sail' effect. If the trees were to fall, they would block access along the road. Due to the proximity to the road the roots will also cause damage to the running surface, splitting the tar.

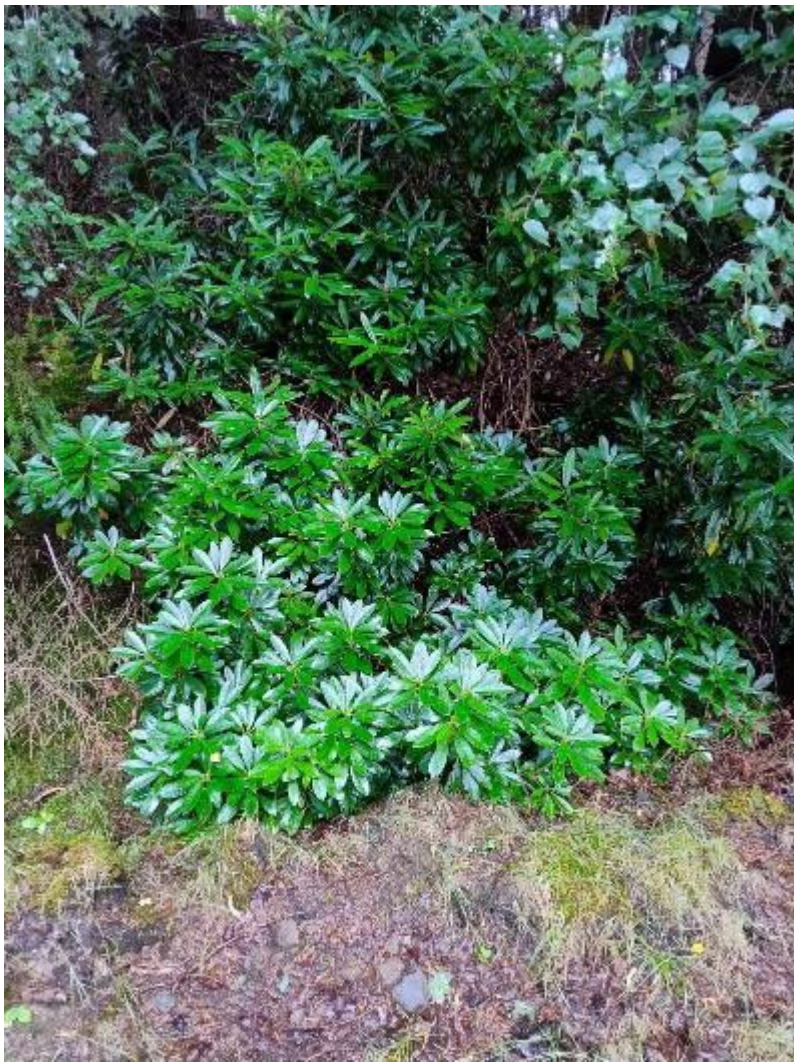
*Plate 19: INNS Rhododendron Ponticum*

Plate 19 shows Invasive Non-Native Noxious Weeds (INNS) are present within the study area. Sporadic Rhododendron was noted and should be included within the management plan for the site. The landowner has a duty to control the population of INNS within their site boundary.

Populations of INNS should be managed and not left to increase in population.
