Environmental Impact Assessment (EIA) Report

LT384 Tealing to Westfield Overhead Line (OHL) 400 kV Upgrade

VOLUME 4: APPENDIX 13.3 - SITE WALKOVER PHOTOS

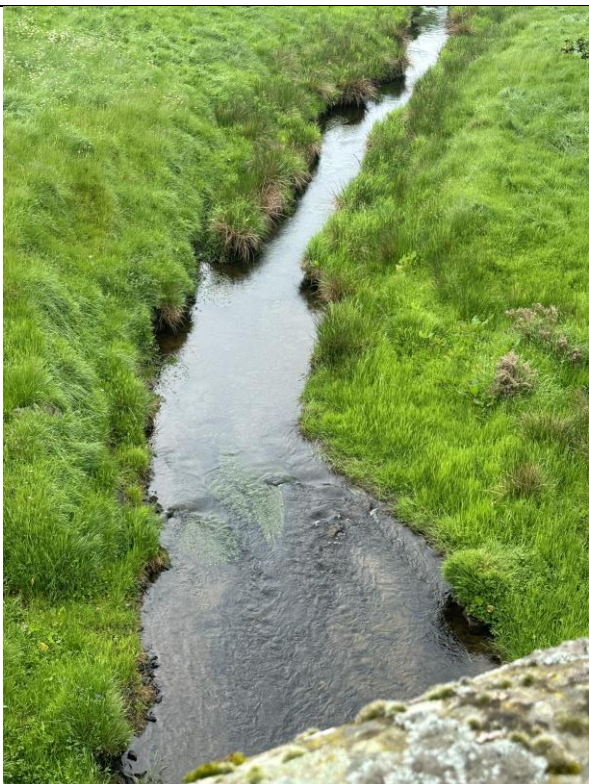
<p>Photo No. 4</p>	<p>Date: 28/05/24</p>

<p>Dunley Burn, photographed on B954, on road crossing.</p> <p>The burn flows between pylons TW165 and TW166.</p> <p>The burn was slightly meandered with vegetation in the water.</p> <p>NGR: NO 33797 36373</p> <p>Camera angle: north-west</p>

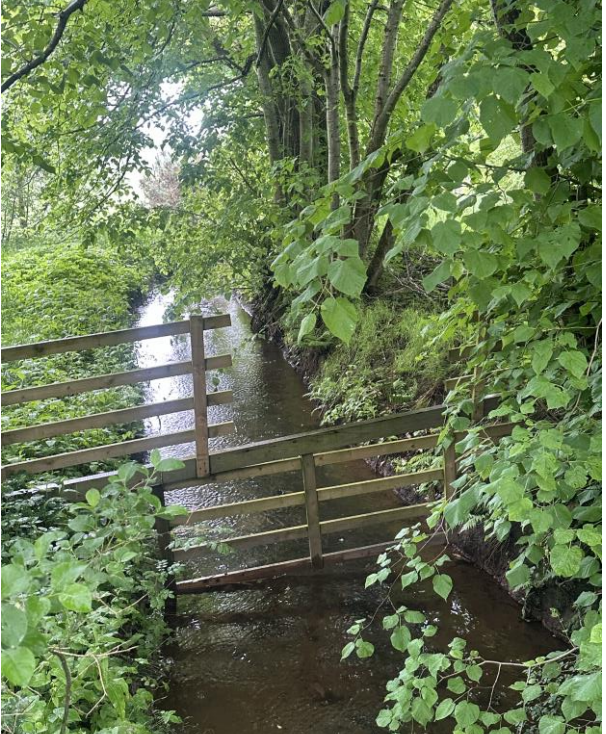
<p>Photo No. 8</p>	<p>Date: 28/05/24</p>

<p>Photograph of the Pow of Errol.</p> <p>The Pow of Erroll flows alongside pylon TW115 downstream, of location of photograph.</p> <p>This river is characterised by large amount of vegetation on the banks.</p> <p>NGR: NO 23303 24231</p> <p>Camera angle: facing east</p>
