## APPENDIX 7.1: WOODLAND REPORT

# 1. WOODLAND REPORT

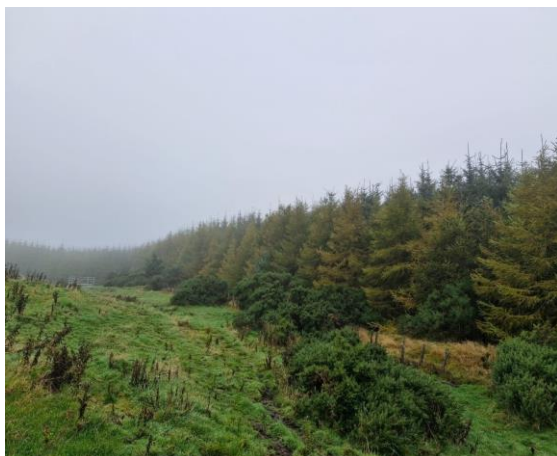
1.2.4 Sitka spruce and larch growing on peaty podzols on generally wet ground conditions, good uniform growth within the crop. Crop is approximately 15-20 years old. Creation of a green edge along the proposed felling boundary will not require additional felling. The age and form of the crop will be sufficient to maintain a wind firm edge to ensure stability of the remaining crop.

Photo 1: Healthy, uniform crop of Sitka spruce and larch (Woodland 1)

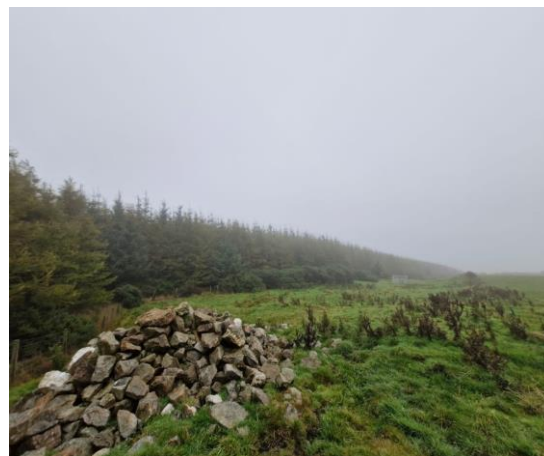
Photo 2: Stable even-aged crop of Sitka spruce and larch (Woodland 1)

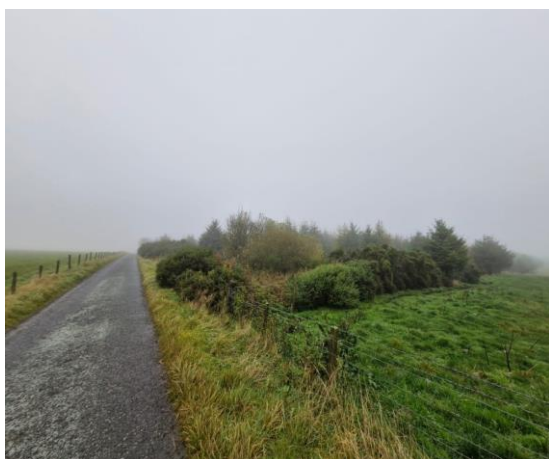
Photo 3: Native, scrub woodland along roadside, unaffected by felling (Woodland 1)

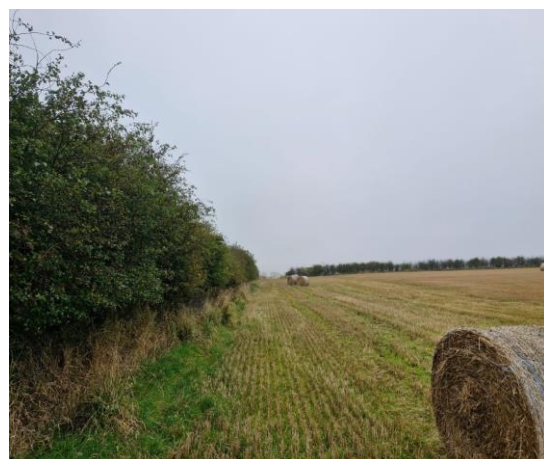
1.2.6 Approximately 1.73 hectares (ha) of mature native hedgerows. Double row planted and fenced. Main species include hawthorn, alder, Guelder rose, blackthorn, and hazel.

Photo 4: Mature hedgerow, approx. 8-10 years old (Woodland 2-9)

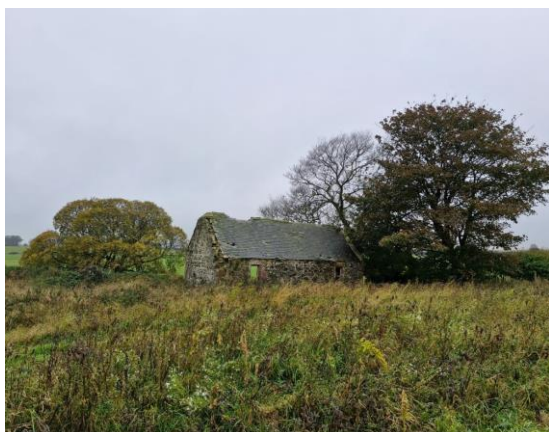
1.2.7 Mature sycamore, Wych elm and willow individual trees located at ruined steading. Some establishing sycamore regeneration. Located along overgrown field drains.

Photo 5: Mature sycamore, Wych elm and willow (Woodland 10 and 11)

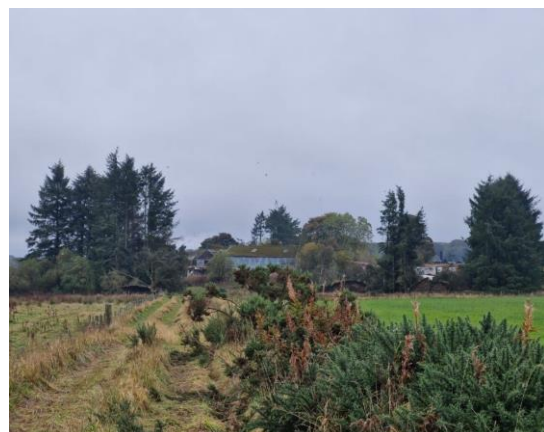
Photo 6: Looking north to the derelict farmyard, overgrown shelterbelts and natural regeneration willow and beech (Woodland 12-16)

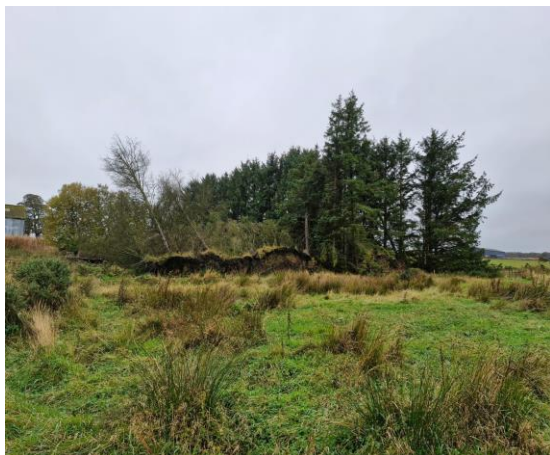
1.2.8 A mix of overgrown and windblown Sitka spruce and larch shelterbelts, mature broadleaves including ash, sycamore and beech. Significant amount of establishing willow and beech natural regeneration throughout farm holding.

Photo 7: Significant windblow damage to Sitka spruce and larch shelterbelts (Woodland 12-16)

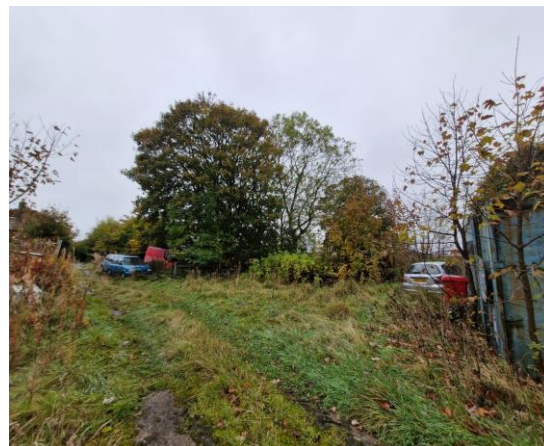
Photo 8: Mature ash and sycamore with significant natural regeneration throughout the farmyard (Woodland 12-16)

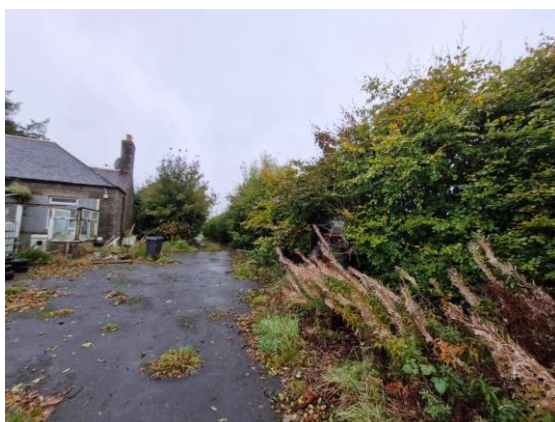
1.2.9 The area around the old farmhouse has become an overgrown garden including a mature beech hedge and mature specimens of beech, sycamore and ash.

Photo 9: Overgrown beech hedge within farmyard and gardens (Woodland 12-16)
