Dunoon to Loch Long 132 kV OHL Rebuild Environmental Impact Assessment Volume 4 | Technical Appendices

Appendix 10.1 – Peat Landslide Hazard and Risk Assessment

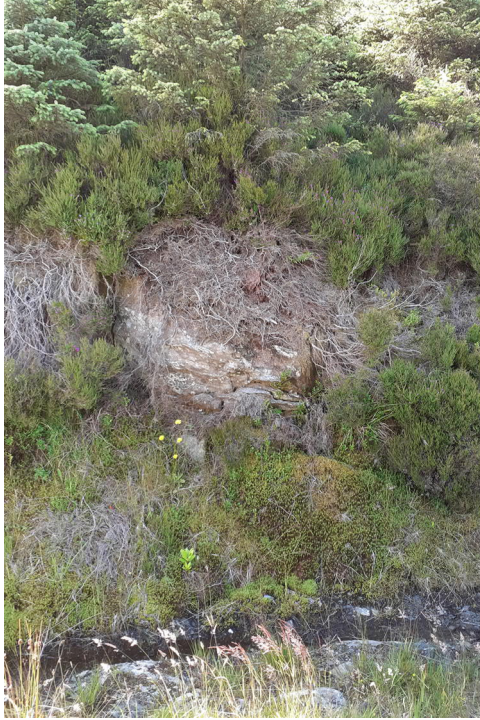
Photograph 3.1: Looking west towards existing forestry track cutting on the eastern slopes of Cruach a' Chaise, from NGR 220110, 691032.

Photograph taken at approximately 190 m AOD showing existing forestry track cutting, approximately 150 m downslope of proposed Tower 7.

There were no signs of instability.

This area is discussed as Peat Stability Assessment (PSA) Area B in **Annex B**.

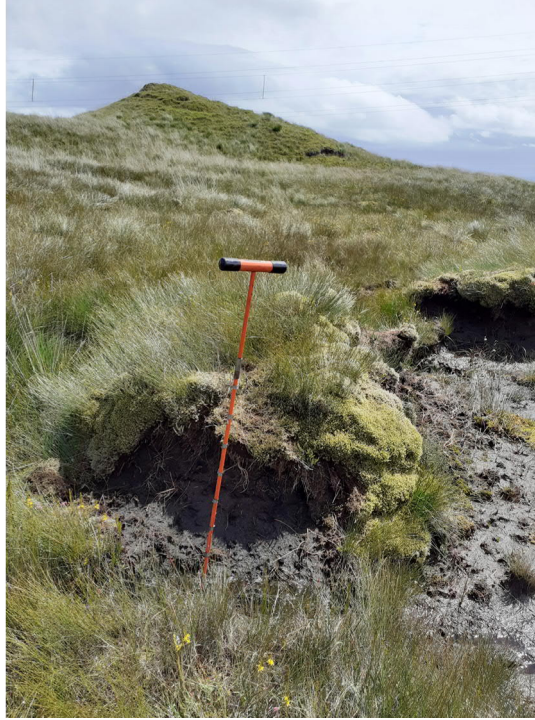
Photograph 3.2: Exposed and eroding peat banks. Looking west towards the proposed OHL, from Cnap Reamhar, taken at NGR 217357, 687633.

Photograph taken at approximately 320 m AOD, 70 m east of peat core C01 location, at Cnap Reamhar in the central part of the Site. The eroded peat banks indicate a local peat depth of approximately 1.00 m. This situation is typical on the central part of the Site, based on depth records and a number of exposures on slopes.

This is not considered a mass movement feature, with no signs of instability apparent.

This area is discussed as PSA Area E in **Annex B**.

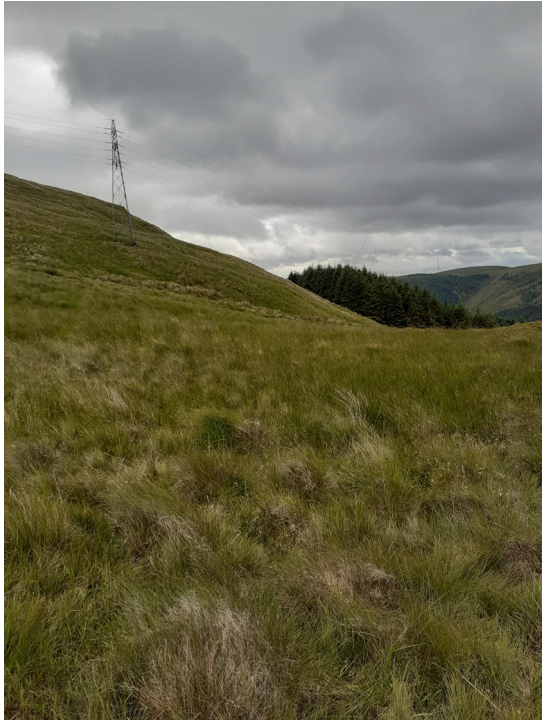
Photograph 3.3: Looking east towards the existing overhead line from the western slopes of the Stronchullin Hill, taken at NGR 216361, 686437.

Photograph taken at approximately 405 m AOD at peat core C02 location on the western slopes of the Stronchullin Hill, where deep peat deposits were identified during the surveys.

Measured peat depths in the area range from 0.20 to 2.50 m. At the location where the photograph is taken, the slope angle is approximately 9°, increasing to 20° upslope where shallower peat was encountered. The slope gradient is gentle to moderate, with no signs of instability noted in the vicinity of the existing overhead line.

There are a number of small streams formed on the steeper slopes, which discharge to the Inverchapel Burn.

Vegetation at this location is dominated by grassland.

This area is discussed as PSA Area F in **Annex B**.

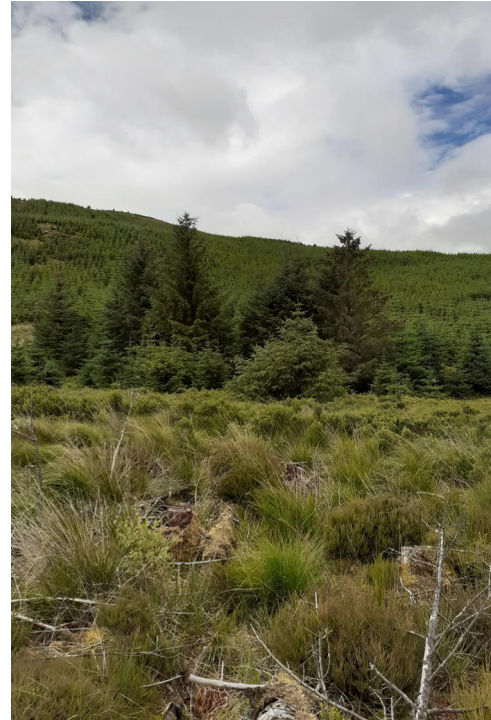
Photograph 3.4: Looking west towards the existing forestry track from the lower slopes of Finbrack Hill, taken at NGR 214676, 680290.

Photograph taken at approximately 150 m AOD on the lower slopes of Finbrack Hill in the southern part of the Site.

Measured peat depths across this area range from 0.65 to 2.67 m. At the location where the photograph is taken, the slope angle is approximately 5°, increasing up to 7° where deeper peat deposits are noted. The slope gradient is gentle to moderate, with no signs of instability noted.

The vegetation on the slopes is grassland, showing a recent clear-felled area with legacy forestry drainage. Tree roots are likely to bind the surface soil.

This area is discussed as PSA Area K in **Annex B**.

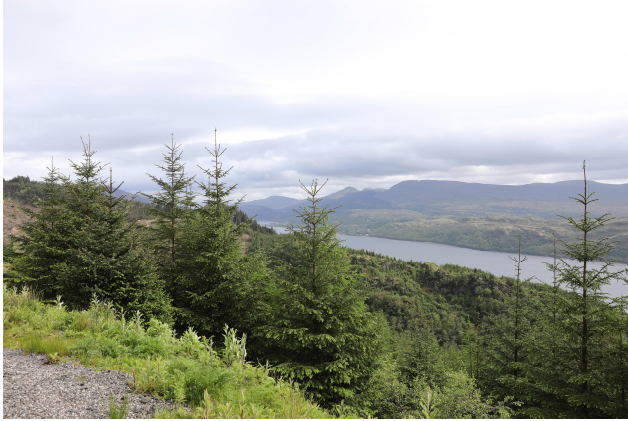
Photograph 3.5: Looking north-east towards Coulport from the existing forestry track on the northern slopes of Cruach a' Chaise, taken at NGR 219811, 690600.

Photograph taken at approximately 180 m AOD, from the northern slopes of Cruach a' Chaise, where shallow peat deposits were identified during the surveys.

Measured peat depths in the area range from 0.00 to 0.50 m. At the location where the photograph was taken, the slope angle is approximately 30°. The slope gradient is steep, with no signs of instability noted.

Vegetation at this location is dominated by forestry conifer plantation.

This area is discussed as PSA Area A in Annex B.

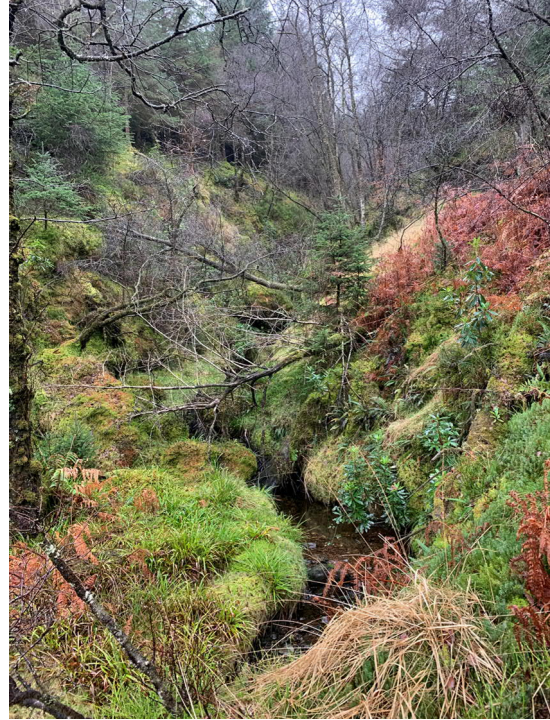
Photograph 3.6: Looking upstream at Allt Mhill Odhair, taken at NGR 217689, 688691.

Photograph taken at approximately 37 m AOD at Allt Mhill Odhair, showing a semi-natural channel within forestry in the north-central part of the Site. The watercourse is located within an incised channel eroding into the peat. The slope gradient is steep at 30°, and the flow observed was fast at the time of visit.

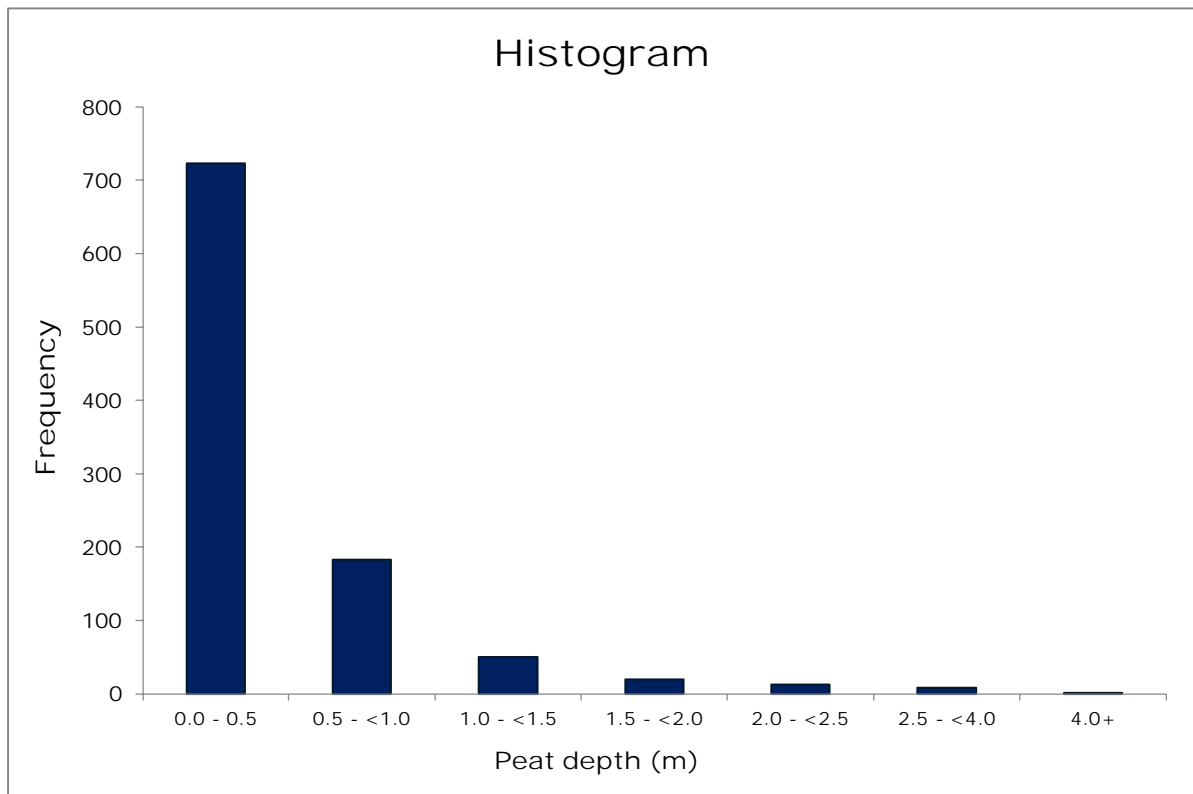
Image 4.1: Peat Probe Depth Histogram

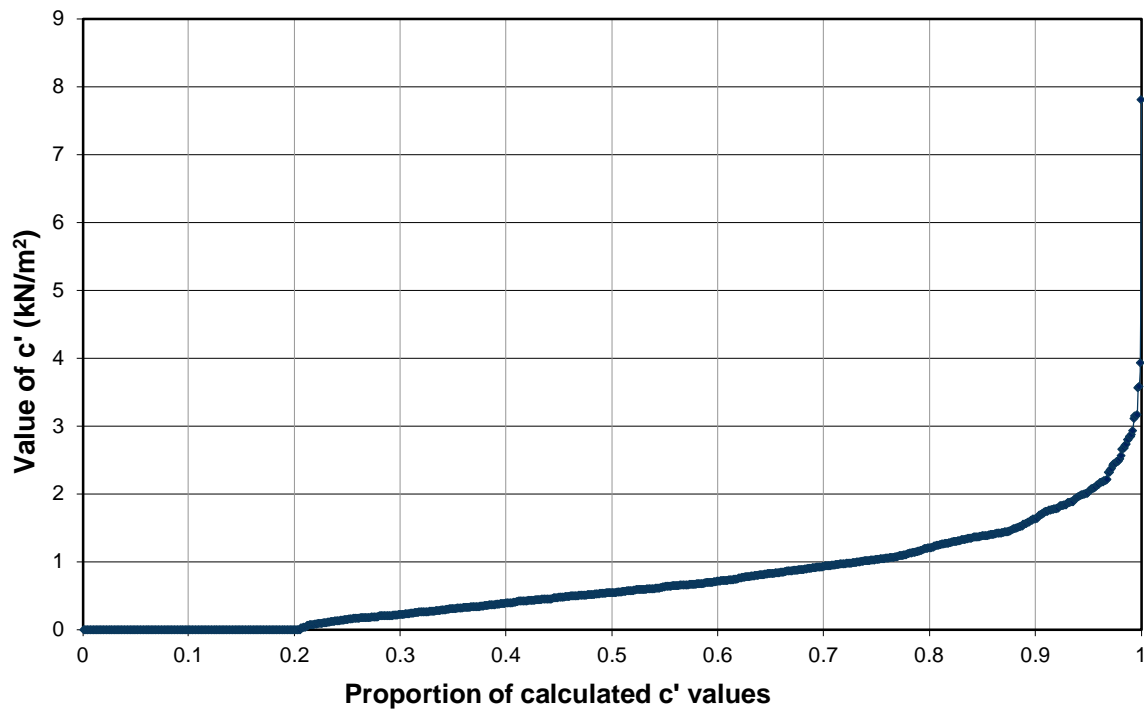
4.2.3 In the Study Area, 998 locations have been probed during the different phases of fieldwork, c' values for each of these have been calculated and the distribution of these values is shown in **Image 4.2**. For example, reading from the graph, 0.8 (or 80%) of the probing locations require a theoretical c' value of 1.20 kN/m^2 or less to be stable and retain peat on the slope.

Image 4.2: Estimate of Minimum Cohesive Strength, c'

4.2.4 From this work it is possible to state, with reasonable confidence, that across the Site as a whole the shear strength of the peat is unlikely to be less than 2.85 kN/m^2 as this is the value of the 99th percentile point on the graph.

4.2.5 A similar approach was undertaken for determining the 99th percentile for grid cells, determined as 4.48 kN/m^2 , this value being higher than the point data due to inclusion of indicative depths for a number of cells.
