Annex B. DETAILED ASSESSMENT DATASHEET DESCRIPTIONS

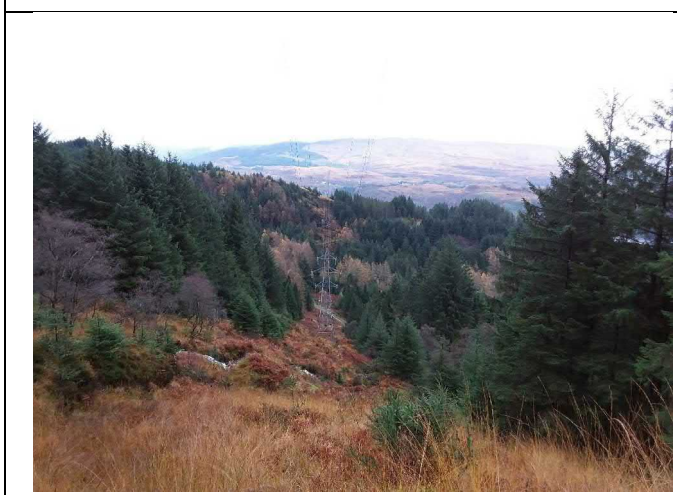
Photograph A1: Looking north-east towards PSA Area A, within the existing overhead line corridor, from NGR 219812, 691539 at approximately 146 m AOD

This area is primarily identified due to the deeper peat deposits combined with steep gradient on the eastern slopes of Creachan Mor. Given the existing overhead line (within 100 m) crossing the entire area, the consequence value is 'Extremely High'. Aerial imagery shows this area as commercial forestry with areas of mire and a network of surface water channels draining these peaty podzols, extensive tree windfall was noted on the edge of the forestry at the north-eastern extent of PSA Area A. No aerial evidence of instability, nor was any noted during the visit. PSA Area A images with OS background and DTM data are also provided in Annex C. BGS GeoSure mapping has identified the south and eastern parts of this area as Class C where 'slope instability problems may be present or anticipated'.

Peat depths over 0.50 m were recorded in this area, ranging up to 0.80 m, with mean depth of 0.36 m. Four peat probe depths were limited to 1.00 m depth due to the Moderate UXO Risk, i.e. not recording full depth. No peat cores were taken in this area due to the Moderate UXO Risk.

Slope angles are typically around 20° in this area, exceeding 35° at the edge of planted forestry. The FoS values for peat probes ranged from 1.13 to 18.70, with the cell where Tower 5 is proposed having an Initial Moderate Risk and a FoS value of 1.31, based on an indicative 0.99 m peat depth and a mean slope of 22°. If applying a shear strength value of 4 kN/m², as literature lower-bound value, to this FoS grid cell, the revised FoS outcome would be 1.17. For information, if applying the lowest hand shear vane outcome; 15 kN/m² (at 0.30 m depth, rather than depth to base of peat) from the cores across the Site, this cell FoS value would be revised to 4.39.

Additional peat stability assessments (including further peat depths using methodology agreed with UXO Engineer) should be undertaken pre-construction to identify local characteristics. Care should be taken to avoid removal of slope support or increasing loading of slope (e.g. stockpiling of materials or heavy plant movement). Should breaks of slope be apparent pre-construction in this locality, monitoring will be undertaken, which may lead to a requirement for slope support or erosion protection, such as use of gabion terraces/mattresses or other measures.

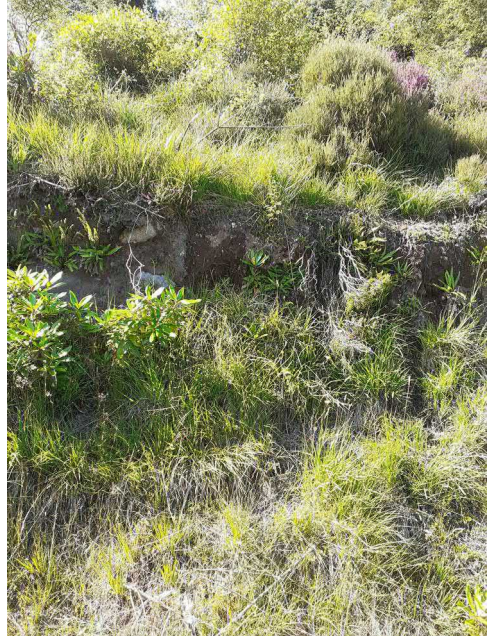
Photograph B1: Looking west towards PSA Area B, from the existing forestry track, from NGR 219919, 690716 at approximately 196 m AOD

This area is primarily identified due to the deeper peat deposits combined with steep gradients at the eastern slopes of Cruach a' Chaise. Given the existing forestry track (within 100 m) crossing the entire area, the consequence value is 'High'. Aerial imagery shows this area as forestry with areas of mire with a network of surface water channels draining these peaty podzols and extensive tree windfall is noted on the edge of the forestry at the northern extent of PSA Area B. No aerial evidence of instability, nor was any noted during the visit. PSA Area B images with OS background and DTM data are also provided in Annex C. BGS GeoSure mapping has identified the majority of this area as Class C where 'slope instability problems may be present or anticipated'.

Peat depths over 0.50 m were recorded in this area, ranging up to 0.85 m, with mean depth of 0.24 m. Four peat depths were limited to 1.00 m depth due to the Moderate UXO Risk, i.e. not recording full depth. No peat cores were taken in this area due to the Moderate UXO Risk. The indicative peat depth is based on two peat depths within the grid, which were beyond 1.00 m (limited record due to Moderate UXO Risk).

Slope angles are typically around 20° in this area, exceeding 35° at the edge of planted forestry.

The FoS values for peat probes ranged from 0.80 to 19.60, with the cell where Tower 6 is proposed having an Initial Moderate Risk cell location and a FoS value of 1.36, based on an indicative 0.99 m peat depth and a mean slope of 21°. Based on the soils mapping, slope angles and peat depths in the vicinity it is deemed that 0.99 m is a conservative depth. If applying a shear strength value of 4 kN/m², as literature lower-bound value, to this FoS grid cell, the revised FoS outcome would be 1.21 m. For information, if applying the lowest hand shear vane outcome; 15 kN/m² (at 0.30 m depth, rather than depth to base of peat) from the cores across the Site, this cell FoS value would be revised to 4.55.

Additional peat stability assessments (including further peat depths using methodology agreed with UXO Engineer) should be undertaken pre-construction to identify local characteristics. Care should be taken to avoid removal of slope support or increasing loading of slope (e.g. stockpiling of materials or heavy plant movement). Should breaks of slope be apparent pre-construction in this locality, monitoring will be undertaken, which may lead to a requirement for slope support or erosion protection, such as use of gabion terraces/mattresses or other measures.

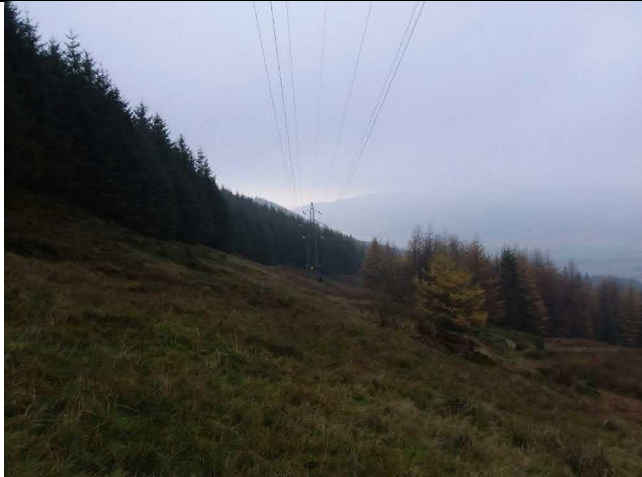
<p>Photograph H1: Looking west from PSA Area H, within the existing overhead line corridor, from NGR 215874, 684685 at approximately 333 m AOD</p>

<p>PSA Area H: Initial Likelihood - Likely; Consequence – Extremely High; Risk - Moderate Revised Likelihood - Unlikely; Consequence – Extremely High; Risk - Low</p>	<p>Area Details</p>
<p>Good Practice and Design Section 1.8 details standard good practice measures. Tower 51 is located 5 m west and in the same topographic level of a cell with a FoS value between 1.0 and 1.4, considered of 'Moderate' risk. No towers are planned within cells of 'Moderate' nor 'High' risk.</p>	<p>This area was highlighted due to the deep peat deposits combined with moderate gradient slopes. Given the existing OHL (within 100 m) and peat over 1.50 m, the consequence values are 'Extremely High' and 'Moderate', respectively. Aerial imagery shows an area of exposed mineral soil to the south-east and no evidence of instability, nor was any noted during the visit, with a network of surface water channels draining these mire-covered slopes. PSA Area H images with OS background and DTM data are also provided in Annex C. BGS GeoSure mapping has identified a small zone of this area as Class C where 'slope instability problems may be present or anticipated'.</p>

<p>Specific Mitigation, Potential Scale and Receptor Section 1.8 lists standard mitigation measures. Additional peat stability assessments and supplementary peat depth surveys closer to existing overhead line will aid detailed design. Micrositing Tower 51 in order to avoid construction close to breaks of slope will reduce the risk of any instability. Care should be taken to avoid removal of slope support or increasing loading of slope (e.g. stockpiling of materials or heavy plant movement) where convex breaks of slope occur. If micrositing is not possible, consideration should be given to the application of debris nets, catch fences, catch ditches and/or deflection systems to protect sensitive receptors and reduce adverse consequences. Such installations should be subject to routine inspection and maintenance. This area should be recorded in the Geotechnical Risk Register. Should peat slide occur; approximated width 50 m, length 50 m, at an average depth of 1.00 m; volume of peat 2,500 m³; Receptor – local hillside, Puck's Glen and existing overhead line.</p>	<p>Due to access issues, only a small number of peat depth records is present within this area, ranging up to 1.65 m, with mean depth of 0.76 m. Slope angles are typically around 12° in this area, exceeding 30° at the break of slope identified from the DTM data. No peat cores were taken in this area due to access issues, with the nearest core C04 taken approximately 1.1 km north, at a location with a higher elevation (360 m AOD) but similar peat depths, considered reasonably representative. Peat core location C04 was taken at a slope angle of 9° at a peat depth of 0.95 m. The core sample recorded Von Post humification class H5; Moderately Decomposed. The hand shear vane's lowest recorded value at a depth of 0.30 m was 26 kN/m². The FoS values for peat probes ranged from 2.85 to 16.67, with the highest concern Initial Risk cell location having a FoS value of 1.10, based on an indicative 0.99 m peat depth and a mean slope of 29° – Tower 51 is located directly west of this cell. If applying a shear strength value of 4kN/m², as literature lower-bound value, to this FoS grid cell, the revised FoS outcome would be 0.98. For information, if applying the lowest hand shear vane outcome from C04; 26 kN/m² (at 0.30 m depth, rather than depth to base of peat), this cell FoS value would be revised to 6.36.</p>

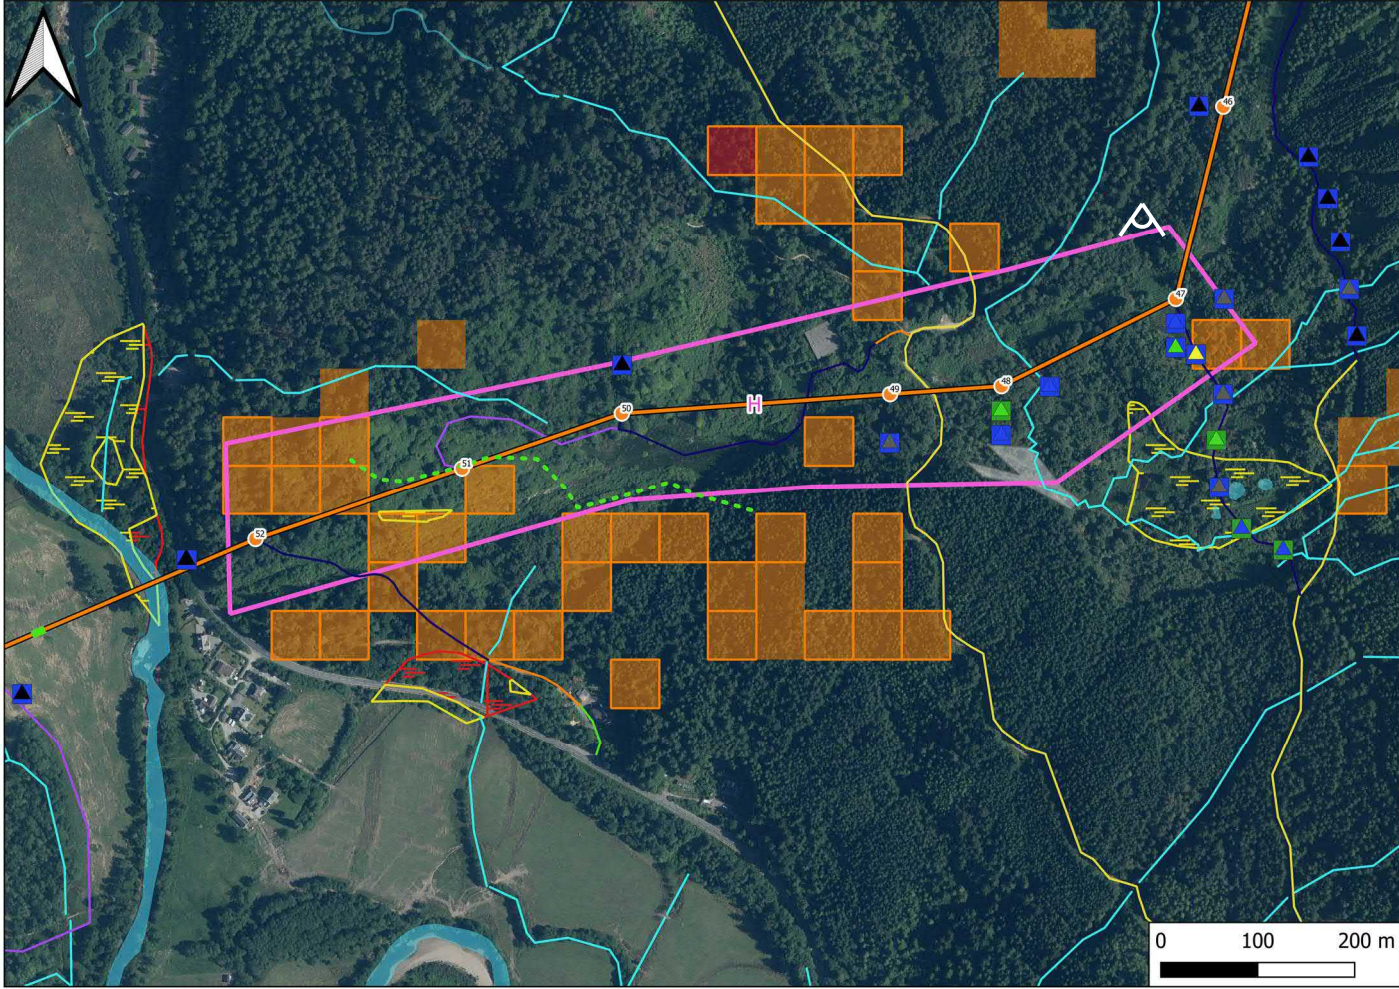
<p>Revised Risk Only a small part of the area is identified by GeoSure as Class C, it has highly modified and variable peatland features with no evidence of peat instability from aerial photograph, including from existing overhead line. Taking account of the peatland morphology, existing drainage, individual peat probe FoS, design and mitigation, peat-related instability is reduced to Unlikely and the Revised Risk is therefore Low.</p>	<p>Image H2: Aerial Image of PSA Area H</p>

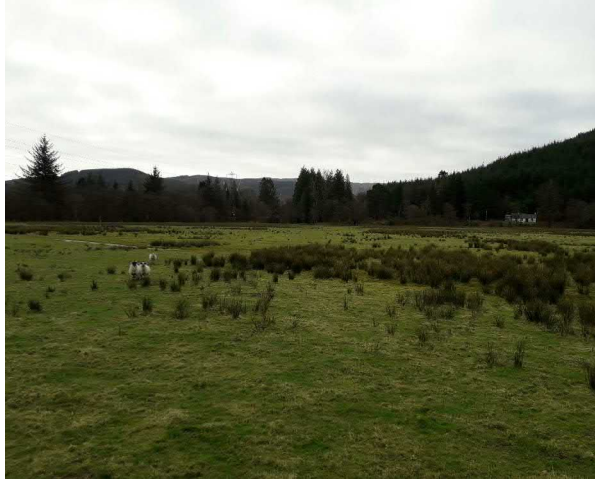
<p>Photograph I1: Looking south towards PSA Area I, from NGR 214387, 683378 at approximately 5 m AOD</p>

<p>PSA Area I: Initial Likelihood - Likely; Consequence – Extremely High; Risk - Moderate Revised Likelihood - Unlikely; Consequence – Extremely High; Risk - <u>Low</u></p>	<p>Area Details This area is primarily identified due to the lack of peat depth records (due to access issues) combined with steep north-eastern slopes of the Ballochyle Hill. Given the local road and existing OHL (both within 100 m), the consequence value is 'Extremely High'. Aerial imagery shows this area as forestry with areas of grassland pasture with no evidence of instability, nor was any noted during the visit. PSA Area I images with OS background and DTM data are also provided in Annex C. BGS GeoSure mapping has identified a small zone of this area as Class C where 'slope instability problems may be present or anticipated'.</p>
<p>Good Practice and Design Section 1.8 details standard good practice measures. Tower 55 is located 80 m east and downslope of a cell with a FoS value between 1.0 and 1.4, considered of 'Moderate' risk. No towers are planned within cells of 'Moderate' nor 'High' risk.</p>	<p>Two peat depths of over 0.50 m were recorded across this area, ranging up to 0.55 m, with mean depth of 0.36 m. Slope angles are typically around 5° in this area, exceeding 20° at the bottom of Ballochyle Hill. No peat cores were taken in this area due to the shallow peat depths.</p>

<p>Specific Mitigation, Potential Scale and Receptor Section 1.8 lists standard mitigation measures. Additional peat stability assessments and supplementary peat depth surveys will aid detailed design. Care should be taken to avoid removal of slope support or increasing loading of slope (e.g. stockpiling of materials or heavy plant movement) where convex breaks of slope occur. Should breaks of slope be apparent pre-construction in this locality, monitoring will be undertaken, which may lead to a requirement for slope support or erosion protection, such as use of gabion terraces/mattresses or other measures. This area should be recorded in the Geotechnical Risk Register. Should peat slide occur; approximated width 50 m, length 30 m, at an average depth of 1.00 m; volume of peat 1,500 m³; Receptors – local hillside and local road.</p>	<p>The FoS values for peat probes ranged from 1.51 to 1.53, with the highest concern Initial Risk cell location (located 80 m west of Tower 55) having a FoS value of 1.29, based on an indicative 0.99 m peat depth and a mean slope of 23°. If applying a shear strength value of 4 kN/m², as literature lower-bound value, to this FoS grid cell, the revised FoS outcome would be 1.15. For information, if applying the lowest hand shear vane outcome from the cores across the Site; 15 kN/m² (at 0.30 m depth, rather than depth to base of peat), this cell FoS value would be revised to 4.32.</p>

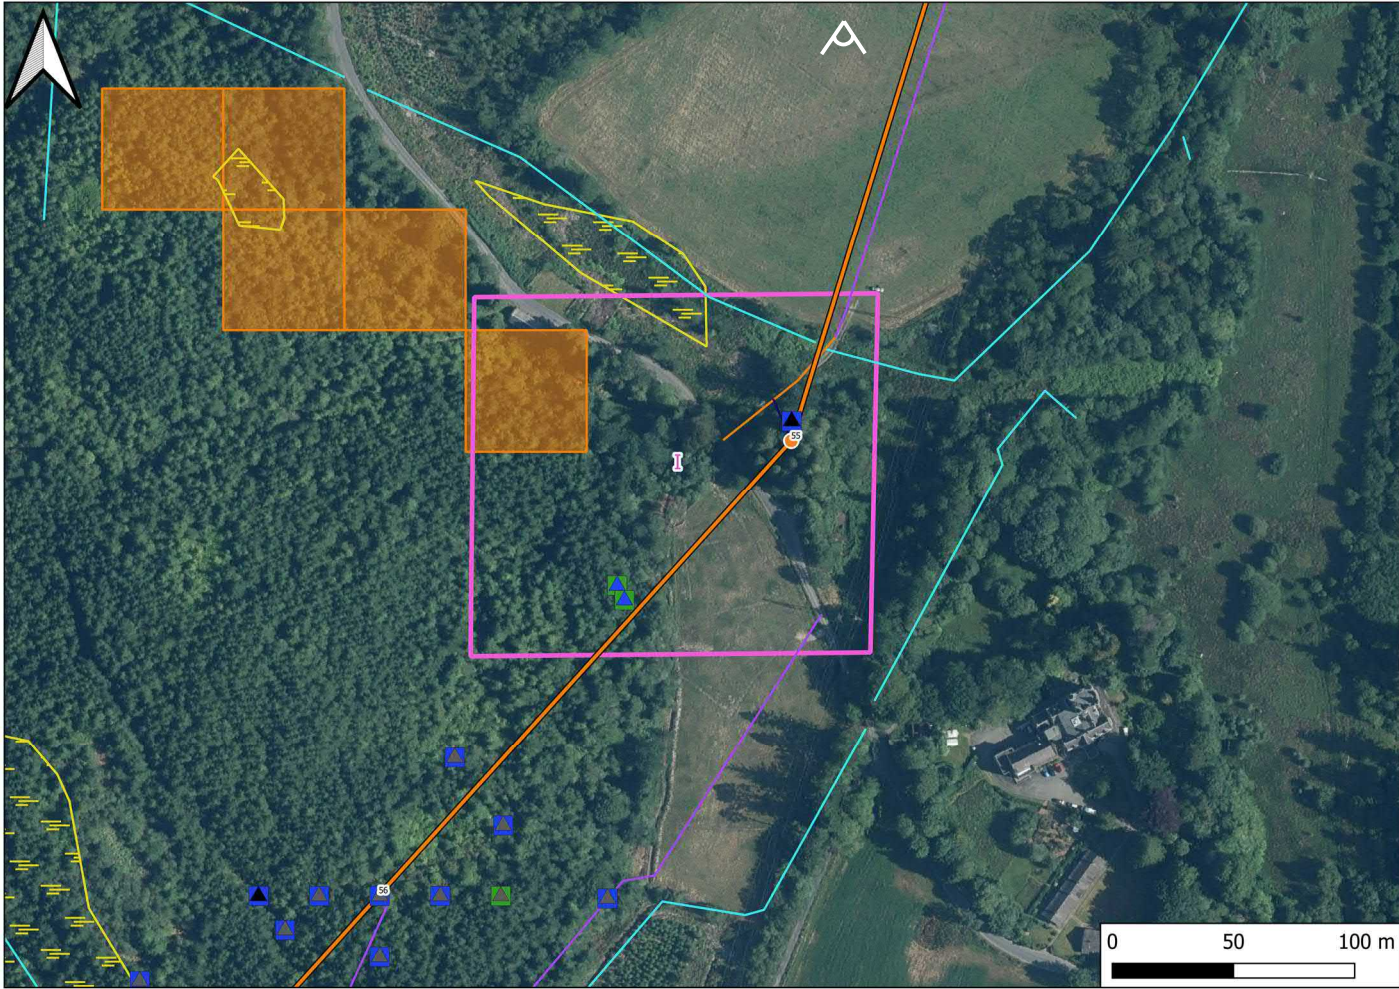
<p>Revised Risk Only a small part of this area is identified by GeoSure as Class C, there was no evidence of peat instability from Site visit or aerial photograph, including from previous road and existing OHL construction. Taking account of the peatland morphology, existing drainage, individual peat probe FoS, design and mitigation, peat-related instability is reduced to Unlikely and the Revised Risk is therefore Low.</p>	<p>Image I2: Aerial Image of PSA Area I</p>

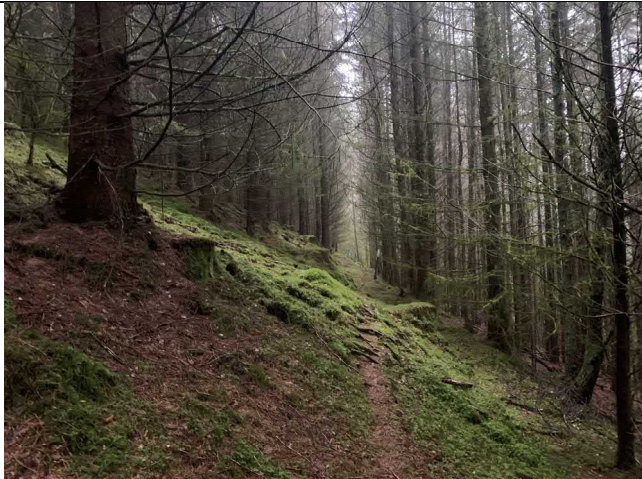
<p>Photograph J1: Looking east from PSA Area J, from NGR 213781, 682240 at approximately 65 m AOD</p>

<p>PSA Area J: Initial Likelihood - Likely; Consequence – High; Risk - Moderate Revised Likelihood - Unlikely; Consequence – High; Risk - <u>Low</u></p>	<p>Area Details This area is primarily identified due to the lack of peat depth records (due to access issues) combined with steep southern slopes of the Ballochyle Hill. Given the Ballochyle archaeological feature (within 100 m), the consequence value is 'High'. Aerial imagery shows this area as forestry with no evidence of instability, nor was any noted during the visit. PSA Area J images with OS background and DTM data are also provided in Annex C. BGS GeoSure mapping has identified a small zone to the south and downslope of this area as Class C where 'slope instability problems may be present or anticipated' and Class D where 'slope instability problems are probably present or have occurred in the past'. Two peat depths of over 0.50 m were recorded across this area, ranging up to 1.00 m, with mean depth of 0.26 m. Slope angles are typically around 15° in this area, exceeding 25° at the base of Ballochyle Hill and adjacent to Balagowan Burn. No peat cores were taken in this area due to the shallow peat depths. The FoS values for peat probes ranged from 1.51 to 1.53, with the highest concern Initial Risk cell location (located 100 m west of Tower 55) having a FoS value of 1.31, based on an indicative 0.99 m peat depth and a mean slope of 22°. If applying a shear strength value of 4 kN/m², as literature lower-bound value, to this FoS grid cell, the revised FoS outcome would be 1.17. For information, if applying the lowest hand shear vane outcome from the cores across the Site; 15 kN/m² (at 0.30 m depth, rather than depth to base of peat), this cell FoS value would be revised to 4.40.</p>

<p>Good Practice and Design Section 1.8 details standard good practice measures. Tower 60 is located 100 m east and upslope of a cell with a FoS value between 1.0 and 1.4, considered of 'Moderate' risk. No towers are planned within cells of 'Moderate' nor 'High' risk.</p>	<p>Specific Mitigation, Potential Scale and Receptor Section 1.8 lists standard mitigation measures. Additional peat stability assessments and supplementary peat depth surveys will aid detailed design. Care should be taken to avoid removal of slope support or increasing loading of slope (e.g. stockpiling of materials or heavy plant movement) where convex breaks of slope occur. Should breaks of slope be apparent pre-construction in this locality, monitoring will be undertaken, which may lead to a requirement for slope support or erosion protection, such as use of gabion terraces/mattresses or other measures. This area should be recorded in the Geotechnical Risk Register. Should peatslide occur; approximated width 50 m, length 100 m, at an average depth of 1.00 m; volume of peat 5,000 m³; Receptors – local hillside, Balagowan Burn, forestry track and existing overhead line.</p>

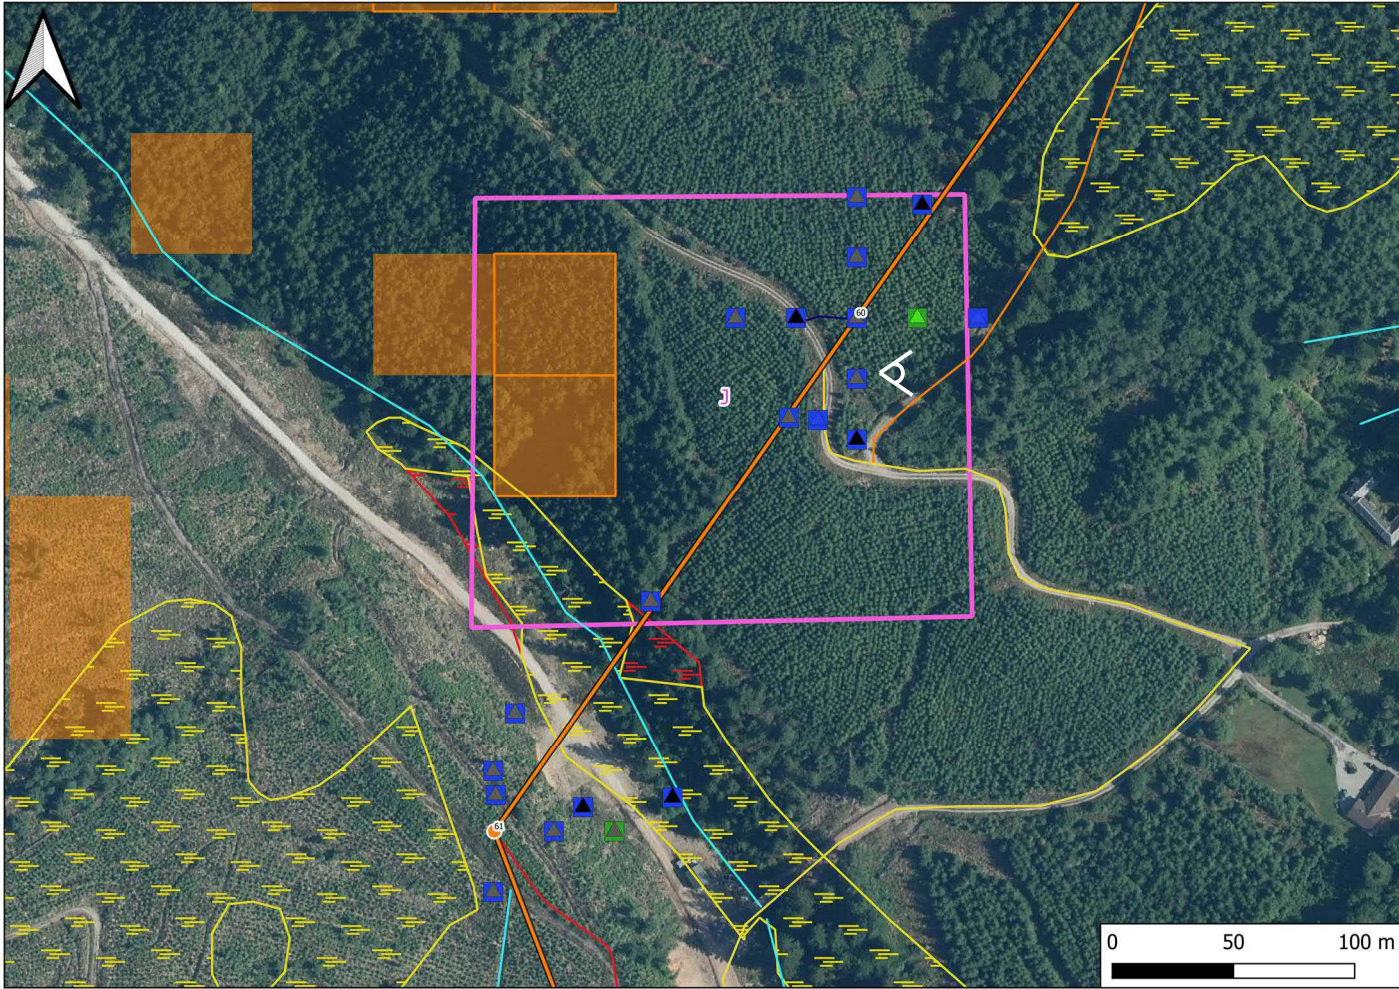
<p>Revised Risk Although a small part of this general area is identified by GeoSure as Class C and D, it has highly modified and variable peatland features with no evidence of peat instability from Site visit or aerial photograph, including from previous forestry track construction. Taking account of the peatland morphology, existing drainage, individual peat probe FoS, design and mitigation, peat-related instability is reduced to Unlikely and the Revised Risk is therefore Low.</p>	<p>Image J2: Aerial Image of PSA Area J</p>

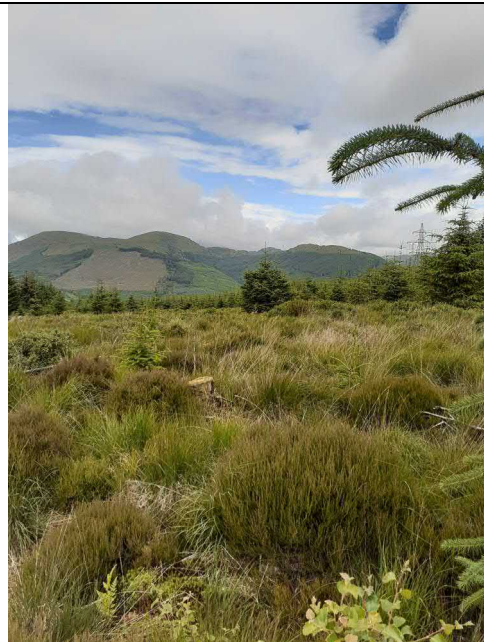
Photograph K1: Looking north from PSA Area K towards Dalinlongart Hill, with existing OHL visible, from NGR 214676, 680290 at approximately 150 m AOD

This area is primarily identified due to the lack of peat depth records (due to access issues) combined with steep southern slopes of the Ballochyle Hill. Given the existing OHL (within 100 m), the consequence value is 'Extremely High'. Aerial imagery shows this area as forestry with no evidence of instability, nor was any noted during the visit. PSA Area K images with OS background and DTM data are also provided in Annex C. B GS GeoSure mapping has identified a small zone to the south of this area as Class C where 'slope instability problems may be present or anticipated' and Class D where 'slope instability problems are probably present or have occurred in the past'.

Peat depths were generally over 1.00 m, ranging up to 2.67 m, with mean depth of 1.08 m. Slope angles are typically around 12° in this area.

Peat core location C05 was taken at slope angle of 4° at peat depths of 1.52 m. The core samples recorded Von Post humification class H6 - Moderately Highly Decomposed. This data suggests that amorphous catotelmic peat is found at depth of 1.52 m locally. The hand shear vane's lowest recorded value at a depth of 0.30 m was 15 kN/m².

The FoS values for peat probes ranged from 0.72 to 141.65, with an Initial Moderate Risk cell location (located 70 m north of C05 / 100 m north-east of Tower 70) having a FoS value of 1.21, based on an indicative (and precautionary) 2.49 m peat depth and a mean slope of 9°. If applying a shear strength value of 4 kN/m², as literature lower-bound value, to this FoS grid cell, the revised FoS outcome would be 1.08. For information, if applying the lowest hand shear vane outcome from the cores across the Site; 15 kN/m² (at 0.30 m depth, rather than depth to base of peat), this cell FoS value would be revised to 4.05.

Additional peat stability assessments and supplementary peat depth surveys will aid detailed design. Care should be taken to avoid removal of slope support or increasing loading of slope (e.g. stockpiling of materials or heavy plant movement) where convex breaks of slope occur. S hould breaks of slope be apparent pre-construction in this locality, monitoring will be undertaken, which may lead to a requirement for slope support or erosion protection, such as use of gabion terraces/mattresses or other measures.

This area should be recorded in the Geotechnical Risk Register.
 Should peatslide occur; approximated width 50 m, length 100 m, at an average depth of 2.50 m; volume of peat 12,500 m³; Receptors – local hillside and forestry track.

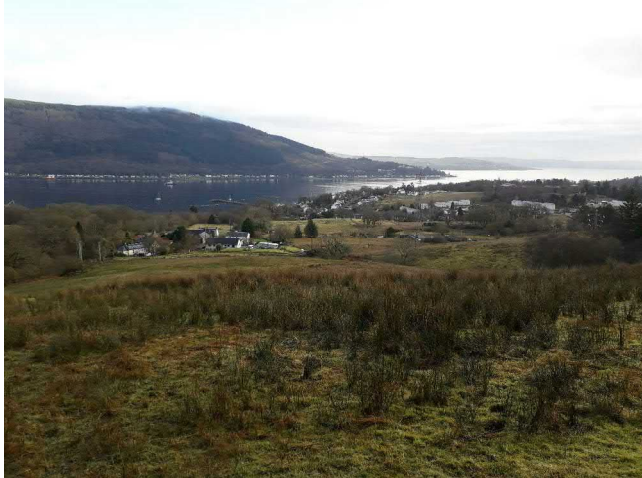
<p>Photograph L1: Looking east from PSA Area L, towards Sandbank, from NGR 215756, 679822 at approximately 100 m AOD</p>

<p>PSA Area L: Initial Likelihood – Likely; Consequence – Extremely High; Risk - Moderate Revised Likelihood - Unlikely; Consequence – Extremely High; Risk - Low</p>	<p>Area Details This area is primarily identified due to the lack of peat depth records outside the Proposed Development, combined with steep gradient slopes. Given the existing OHL (within 100 m), the consequence value is 'Extremely High'. Aerial imagery shows this area as forestry and grassland with no evidence of instability, nor was any noted during the visit. PSA Area L images with OS background and DTM data are also provided in Annex C. BGS GeoSure mapping has identified small part of this area as Class C where 'slope instability problems may be present or anticipated'.</p>
<p>Good Practice and Design Section 1.8 details standard good practice measures. Tower 75 is located 50 m south-west of a cell with a FoS value between 1.0 and 1.4, considered of 'Moderate' risk. No towers are planned within cells of 'Moderate' nor 'High' risk.</p>	<p>Peat depths are less than 0.50 m in this area, ranging up to 0.30 m, with mean depth of 0.09 m, however nearby indicative grid peat depths are 0.99 m due to the lack of data outwith the Proposed Development. Slope angles are typically around 15° in this area, exceeding 20° at the break of slope identified from the DTM data at the southern boundary, which was not apparent on site due to the forestry plantation. No peat cores were taken in this area due to the shallow peat depths.</p>

<p>Specific Mitigation, Potential Scale and Receptor Section 1.8 lists standard mitigation measures. Additional peat stability assessments and supplementary peat depth surveys will aid detailed design. Care should be taken to avoid removal of slope support or increasing loading of slope (e.g. stockpiling of materials or heavy plant movement) where convex breaks of slope occur. Should breaks of slope be apparent pre-construction in this locality, monitoring will be undertaken, which may lead to a requirement for slope support or erosion protection, such as use of gabion terraces/mattresses or other measures. This area should be recorded in the Geotechnical Risk Register. Should peatslide occur; approximated width 50 m, length 150 m, at an average depth of 0.50 m; volume of peat 3,750 m³; Receptors – local hillside, Allt a' Chromain and existing overhead line.</p>	<p>The FoS values for peat probes ranged from 1.20 to 76.89, with the highest concern Initial Risk cell location (located 50 m north-east of Tower 75) having a FoS value of 1.24, based on an indicative 0.99 m peat depth and a mean slope of 24°. If applying a shear strength value of 4 kN/m², as literature lower-bound value, to this FoS grid cell, the revised FoS outcome would be 1.11. For information, if applying the lowest hand shear vane outcome from the cores across the Site; 15 kN/m² (at 0.30 m depth, rather than depth to base of peat), this cell FoS value would be revised to 4.17.</p>

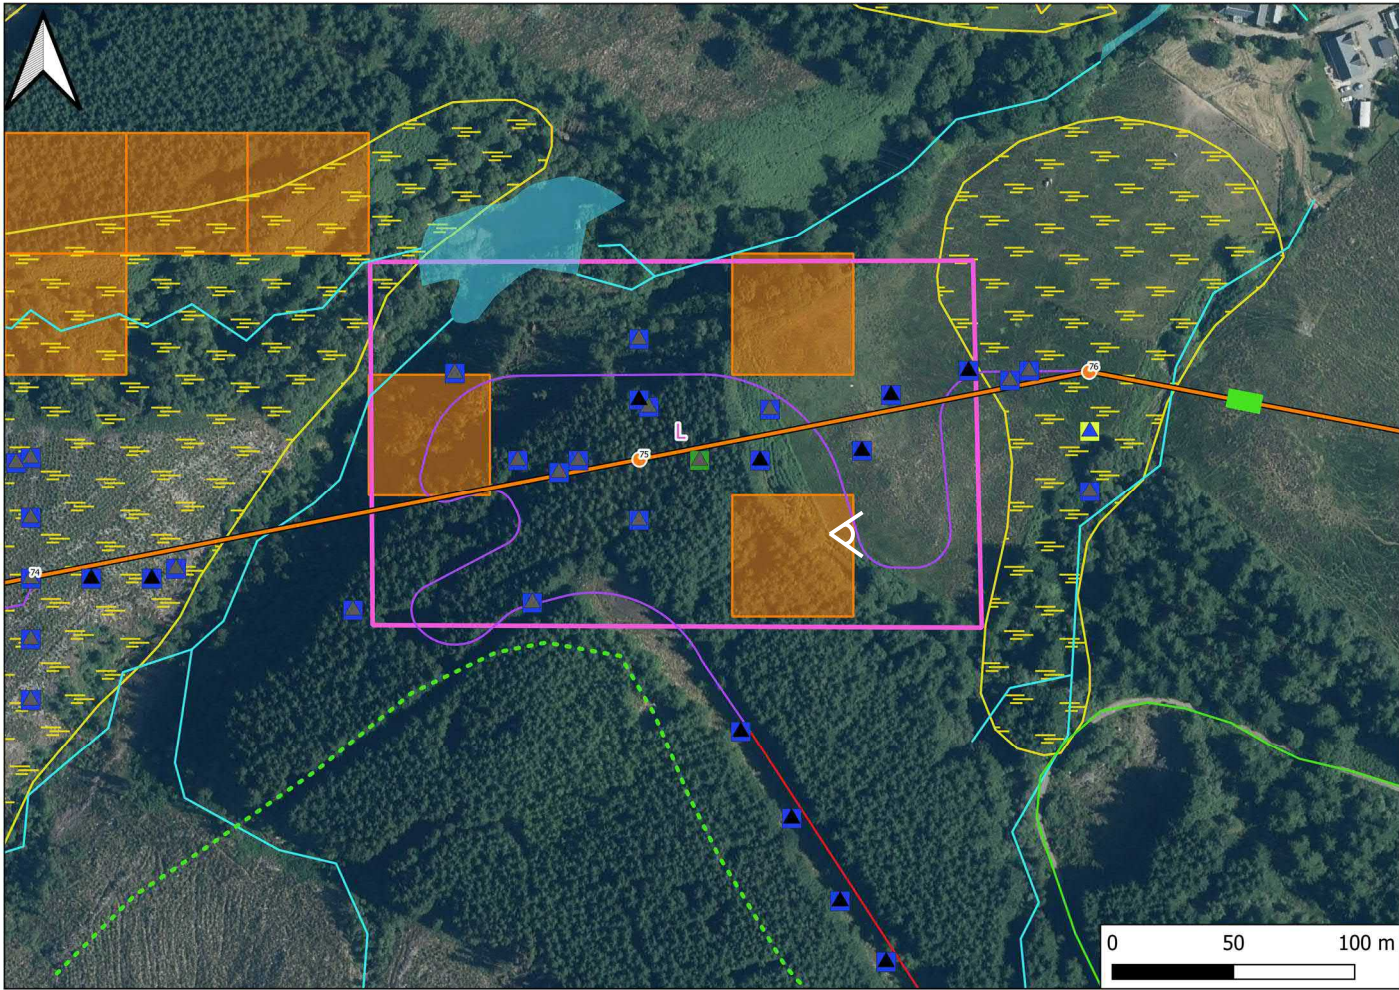
<p>Revised Risk Although a small peripheral zone of this area is identified by GeoSure as Class C, it has highly modified and variable peatland features with no evidence of peat instability from Site visit or aerial photograph, including from previous forestry track and existing OHL construction. Taking account of the peatland morphology, existing drainage, individual peat probe FoS, design and mitigation, peat-related instability is reduced to Unlikely and the Revised Risk is therefore Low.</p>	<p>Image L2: Aerial Image of PSA Area L</p>
