# St Fergus Gas 132/11 kV Substation

Extended Phase 1 Habitat Survey

11 September 2019

Project No. 0478671

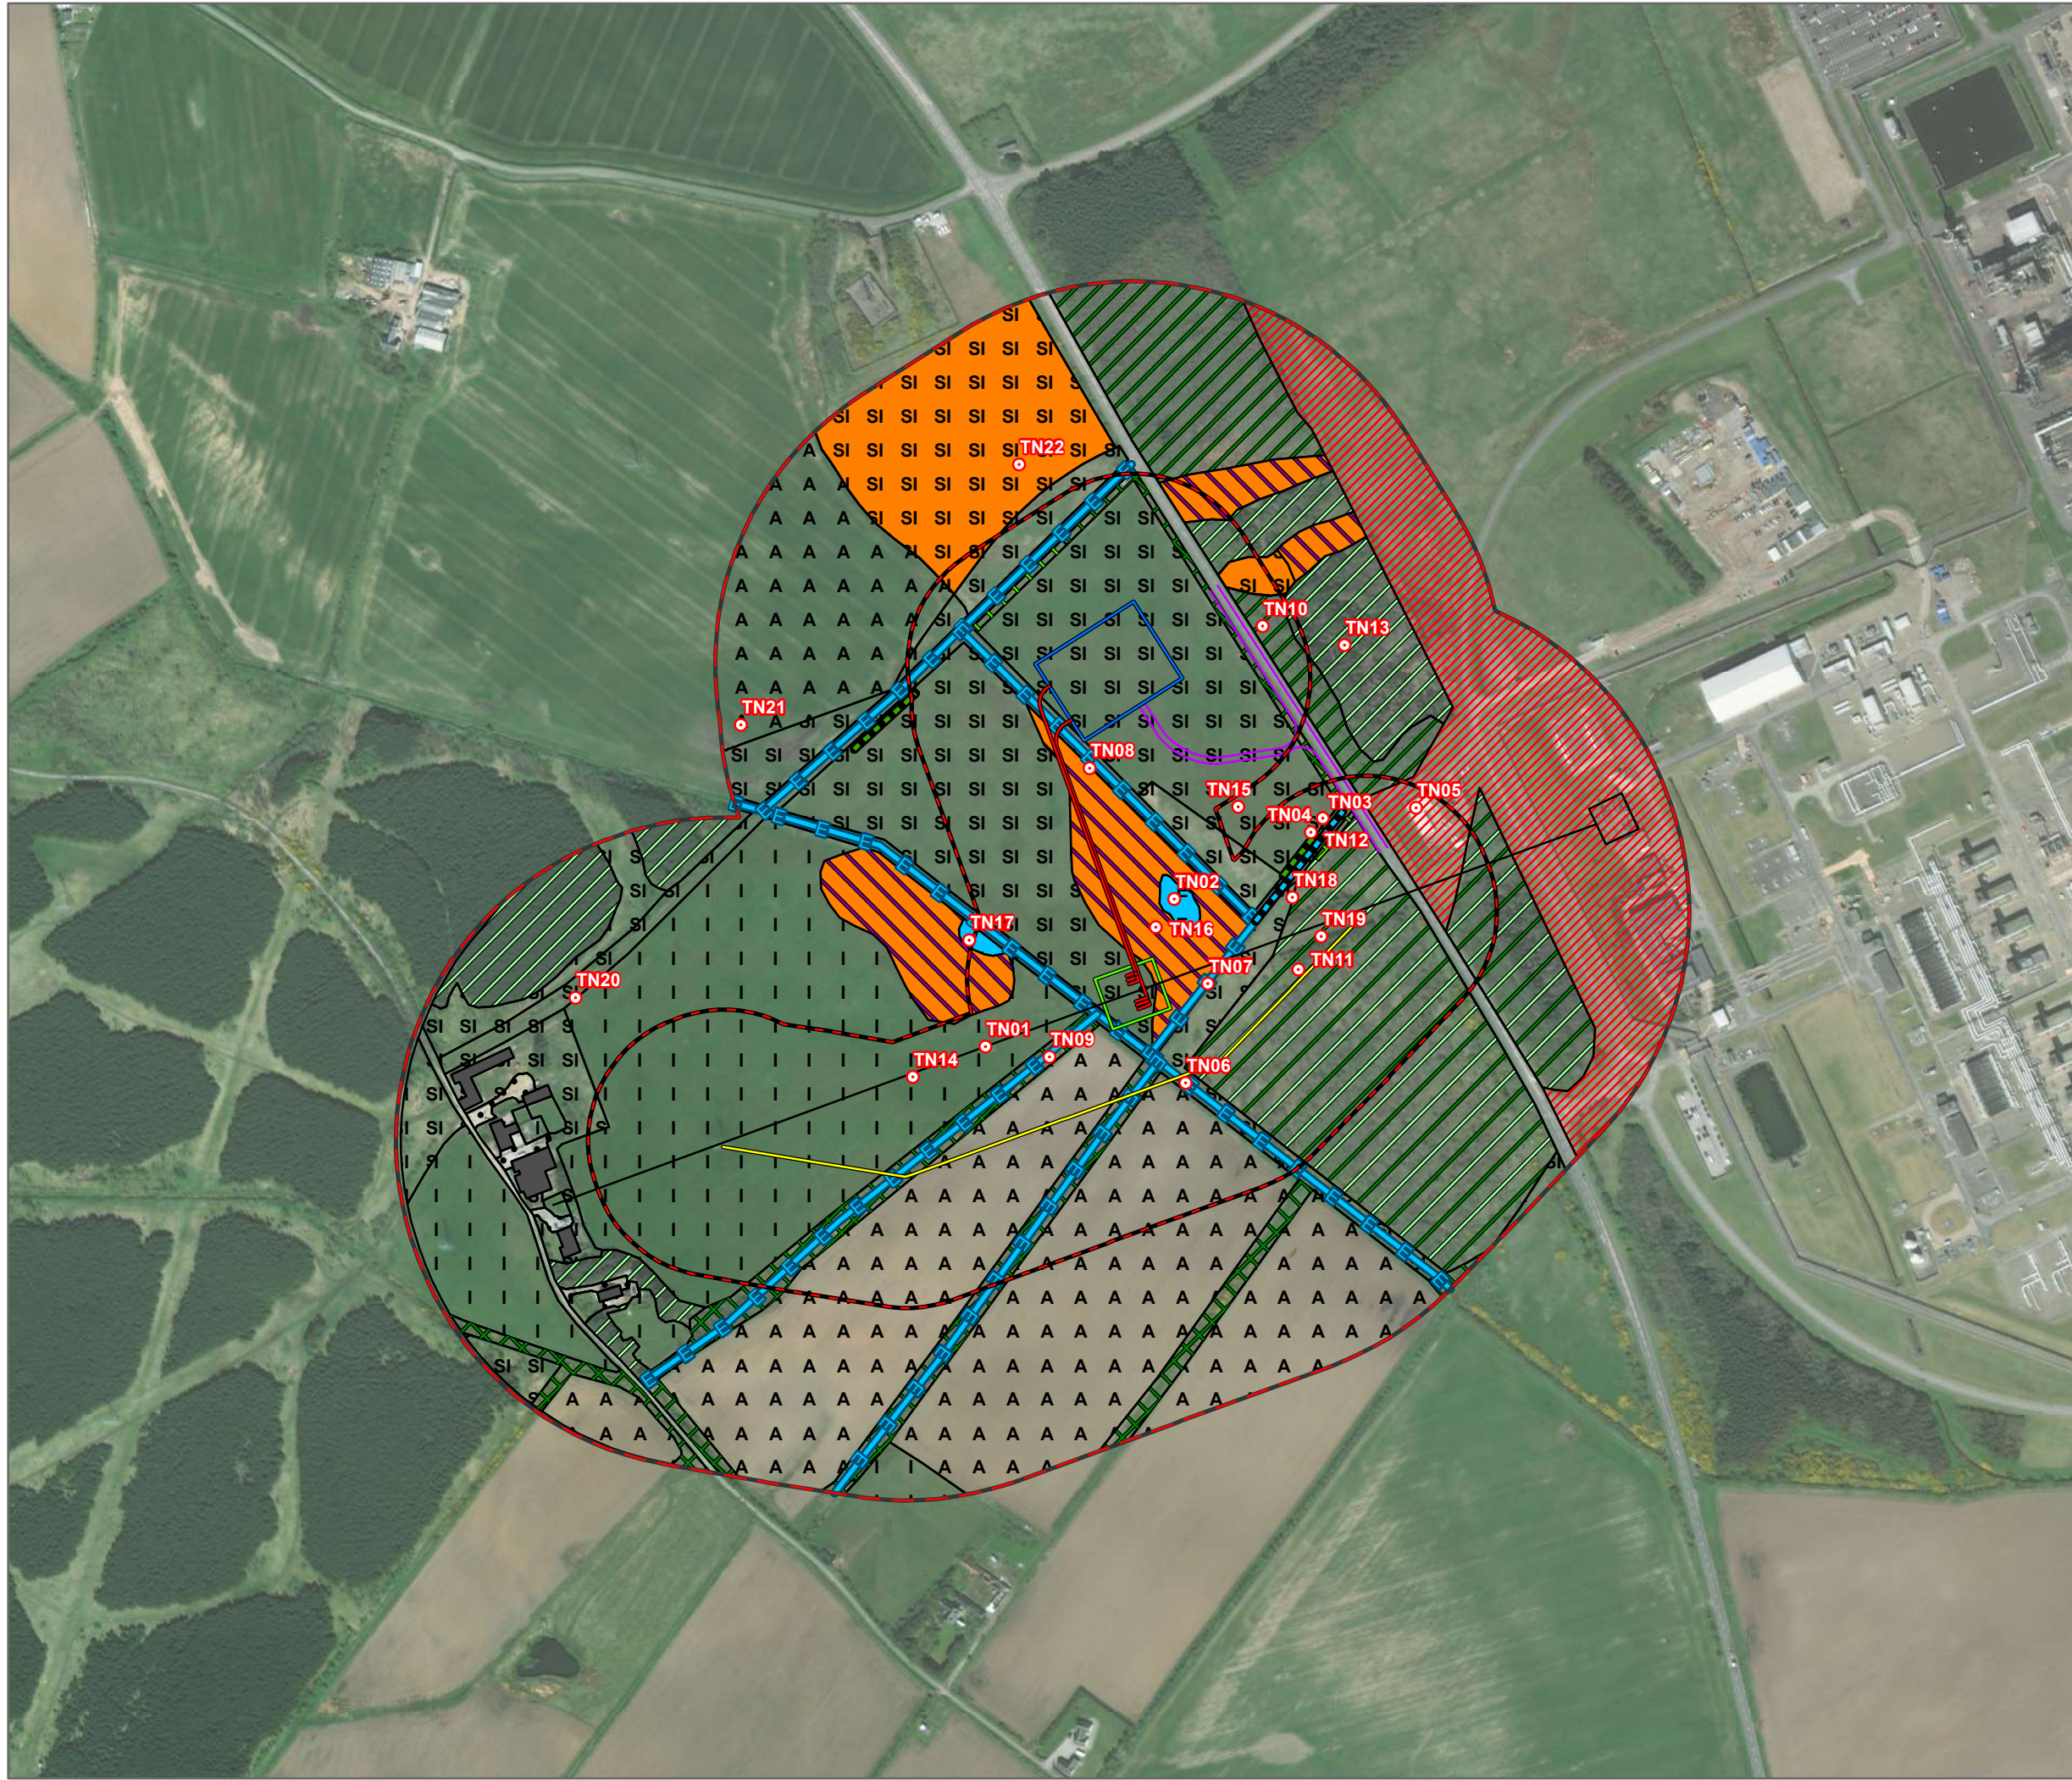
**Figure 4.1**  
**St. Fergus Gas 132/11kV Substation**  
**Phase 1 Extended Survey Map**

- Target Note
- 100m Buffer of Illustrative Footprint
- 250m Buffer of Illustrative Footprint
- New Cable
- Temporary OHL
- Existing OHL
- Proposed Access Road
- CSE Compound
- New Substation
- Old Substation
- Phase 1 Habitat Type:**
- A2.2 - Scrub - scattered
- G2.1 - Running water - eutrophic
- J2.2.2 - Defunct hedge - species-poor
- J2.6 - Dry ditch
- No Access Available
- A1.1.2 - Broadleaved woodland - plantation
- A1.2.2 - Coniferous woodland - plantation
- A1.3.2 - Mixed woodland - plantation
- A2.1 - Scrub - dense/continuous
- A2.2 - Scrub - scattered
- B2.2 - Neutral grassland - semi-improved
- B4 - Improved grassland
- B5 - Marsh/marshy grassland
- B6 - Poor semi-improved grassland
- G1.1 - Standing water - eutrophic
- J1.1 - Cultivated/disturbed land - arable
- J3.6 - Buildings
- J4 - Bare ground
- J5 - Other habitat

Some parts of the St Fergus Gas Grid facility (hatched in red in *Figure 4.1*) were not accessible during the survey. Based on views across these areas, including using binoculars, they appeared to comprise primarily semi-improved neutral grassland, an area of marshy grassland and industrial buildings. The marshy grassland looked similar to another accessible area of the same habitat type, and hence was assumed to have a similar species composition and value.

Three snipe (*Gallinago gallinago*) were noted in the marshy grassland which surrounds the pond at *Target Note 2* (see *Figure 4.1*). Badger fur was found on wire fence and a badger latrine was also found nearby (see *Target Notes 3 and 4* in *Figure 4.1*). This appeared to be associated with a foraging route passing between the mixed plantation woodland to the south and east of the fence, and the semi-improved grassland habitat to the north and west. No badger setts were recorded during the survey and no other signs of protected, or notable species were found. No trees with suitable roost features were noted in the site and 100 m buffer and the only building within 100 m was assessed as having negligible bat roost potential. Signs of roe deer (*Capreolus capreolus*), mole (*Talpa europaea*) and rabbit (*Oryctolagus cuniculus*) were recorded.

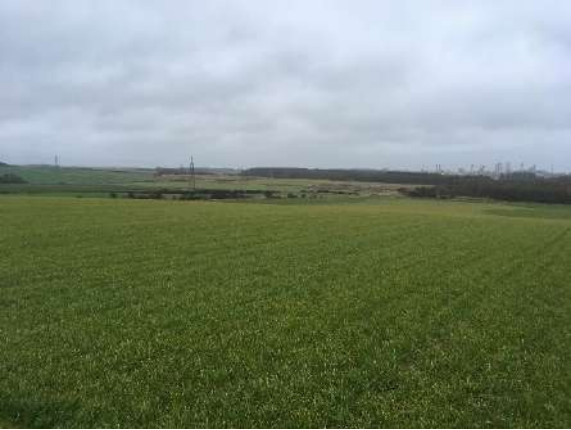
Target Note number	Approximate grid reference	Description of evidence/feature	Photograph
1	NK 08656 53610	Overview of survey area from the centre west. Tower 206 is visible centre left. This is the approximate location of the proposed cable seal-end tower taking the OHL underground via a cable.

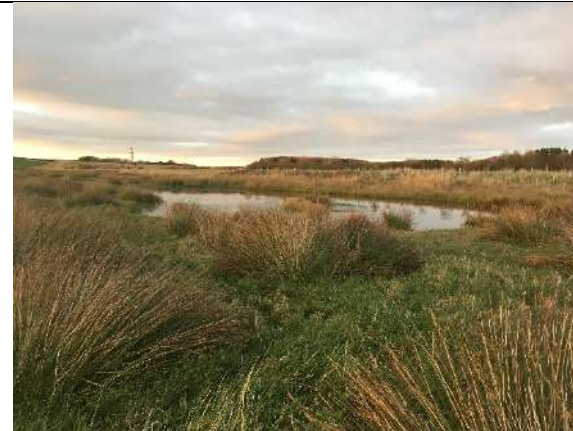
2 NK 08803 53725 Pond west of the proposed sub-station location. The pond supports a variety of aquatic plant species including *Potamogeton natans*, *Lemna minor*, *Glyceria fluitans*, *Nasturtium officinale*, *Veronica beccabunga*, *Sparganium erectum* and *Equisetum fluviatile*.

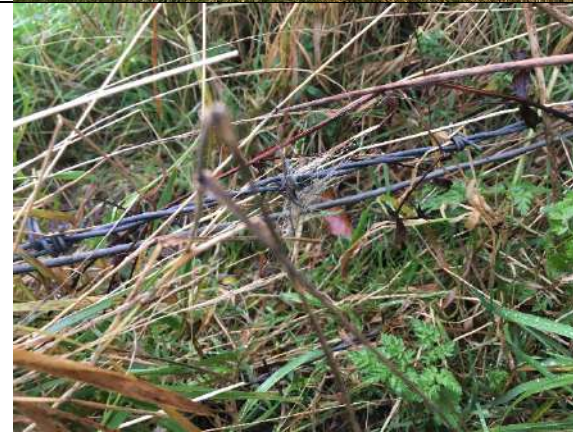
3 NK 08919 53788 Badger fur found on fence south of proposed sub-station location. A badger path is present beneath the fence which leads between woodland habitat and semi-improved grassland.

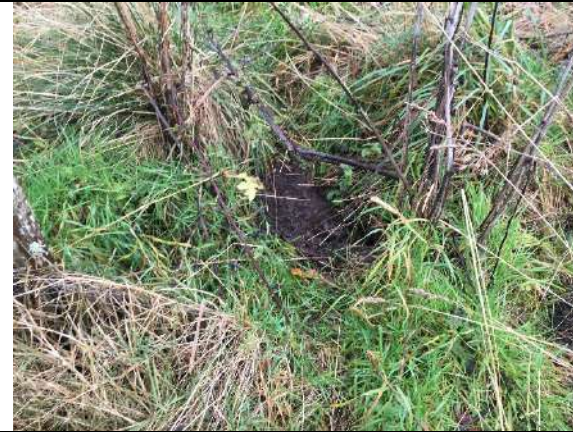
4 NK 08919 53788 Badger latrine found on bank of rank grassland south of proposed sub-station location close to above badger path under barbed wire fence.

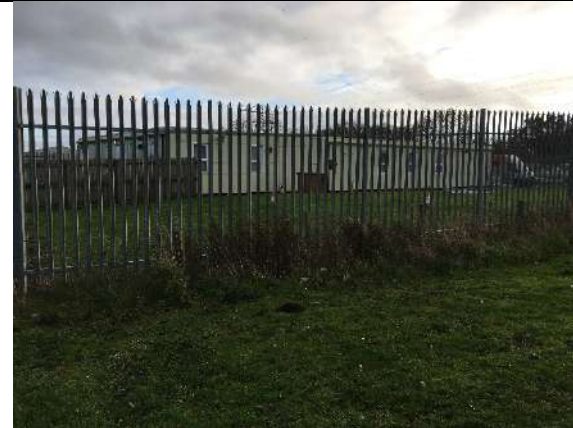
5 NK 08992 53796 Building with negligible bat roost potential located within 100 m of the Project site to the east of the A90 within the St.Fergus Gas Grid Facility. This land was not accessible for survey.

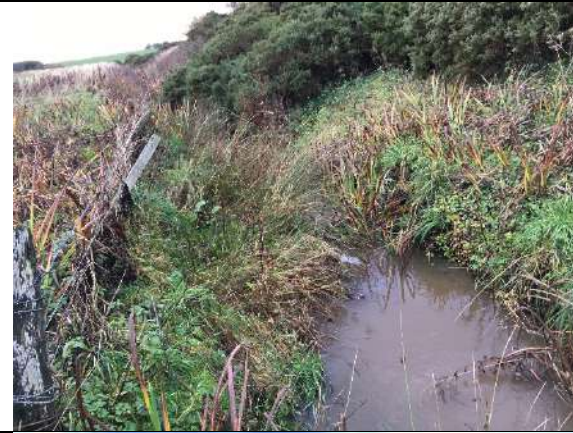
6 NK 08812 53581 Black Water River. The river is 1-2 m wide with an average depth of approximately 30 cm. A variety of substrates are present, comprising gravel and pebbles with some cobbles and a build-up of silt in places. Emergent macrophytes are common in the river.

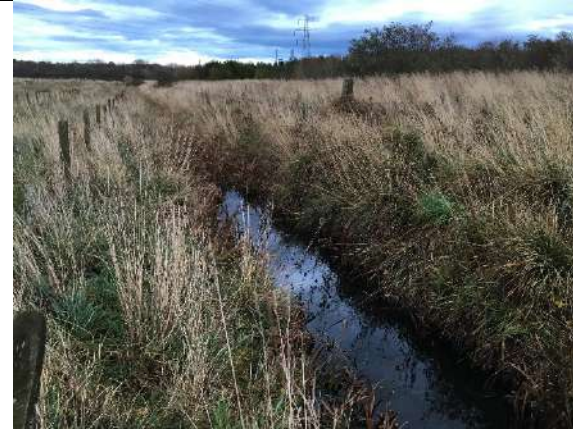
7 NK 08829 53659 Ditch to the south of the pond described in Target Note 2. This ditch is approximately 0.75 m wide, primarily silty and was on average 40 cm deep at the time of survey.

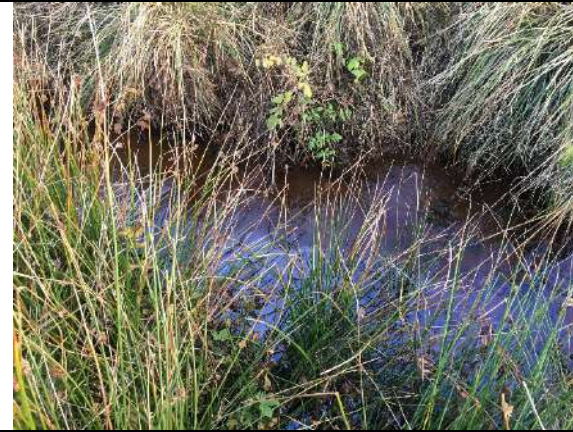
- 8 NK 08737 53827 Ditch to be crossed by underground cable. This ditch is approximately 1 m wide and extremely deep (>2 m) in places. The substrate is predominantly deep silt and *Phalaris arundinacea* is abundant. An oily sheen was present on the surface of the water in places, as shown in the photograph.

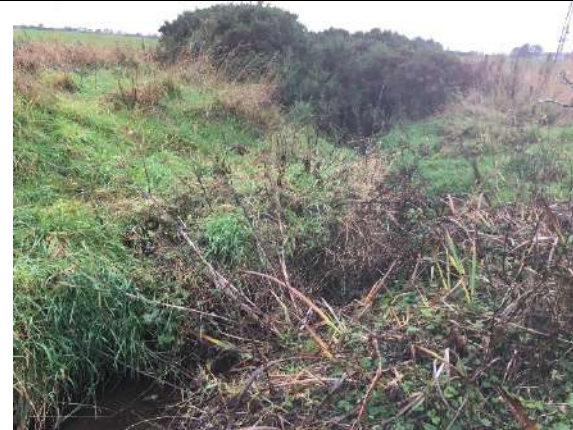
- 9 NK 08706 53602 Dense gorse scrub on banks of a ditch within the Project site boundary. This ditch is on a gradient with an obvious flow and a substrate primarily comprising pebbles, cobbles and bare clay. Water depth in this ditch is shallow (<5 cm).

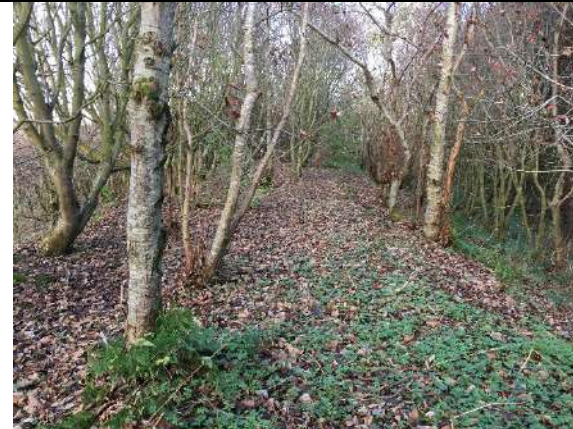
10 NK 08872 53938 Broad-leaved plantation woodland planted on a bund within the 100 m buffer, east of the A90.

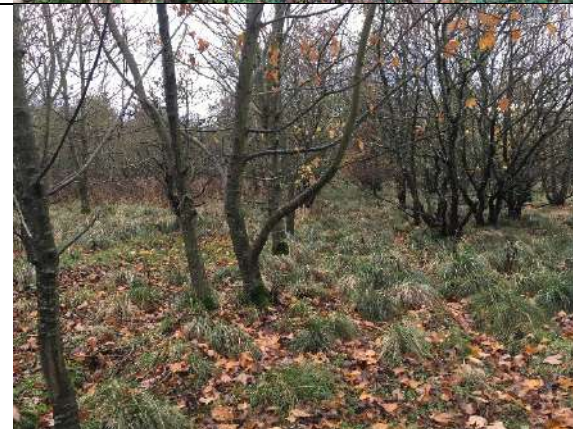
11 NK 08900 53670 Mixed plantation woodland with predominantly *Deschampsia caespitosa* understorey overlapping the Project site boundary in the east. Trees in this plantation are primarily mixed broadleaf with only patchy conifers.

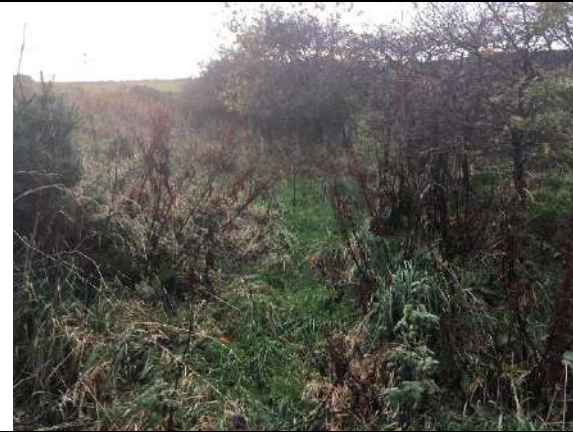
- 12 NK 08910 53777 Defunct planted hazel and hawthorn hedge extending for a length of approximately 20 m along an upper ditch section, which was dry at the time of survey.

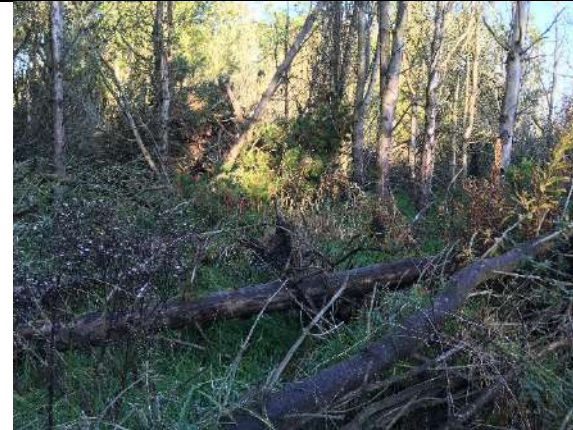
- 13 NK 08936 53923 Non-native coniferous plantation woodland within the 100m buffer of the Project site, east of the A90. This plantation is located in a sunken area surrounded by a bund upon which broadleaved trees are planted. Numerous fallen pines are present.

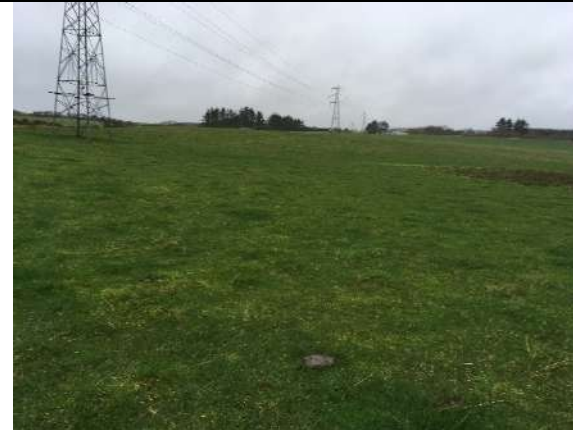
14 NK 08599 53586 Improved grassland, which is the dominant habitat in the west of the survey area. Photograph faces east.

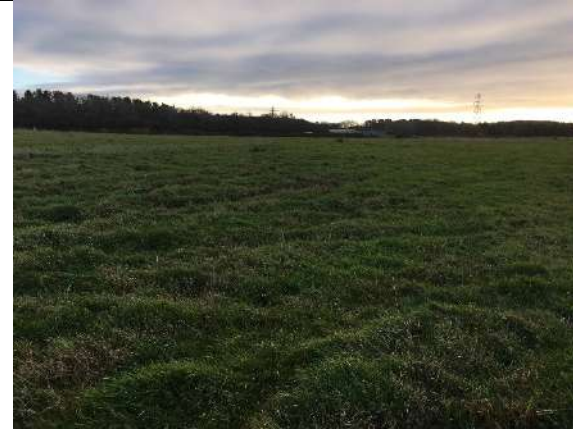
15 NK 08853 53797 Poor semi-improved grassland within the proposed sub-station site.

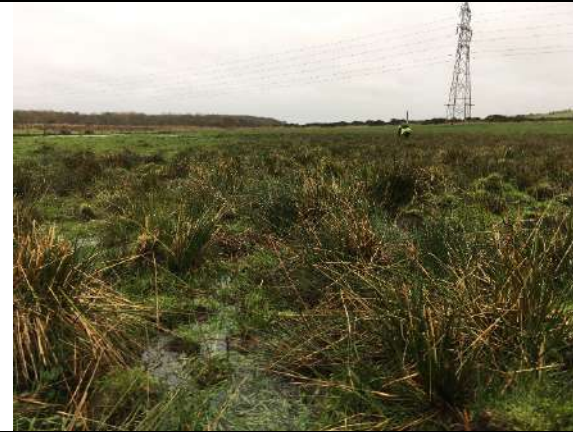
16 NK 08789 53703 Marshy grassland around the pond described in Target Note 2. Three snipe were flushed from this area during the survey.

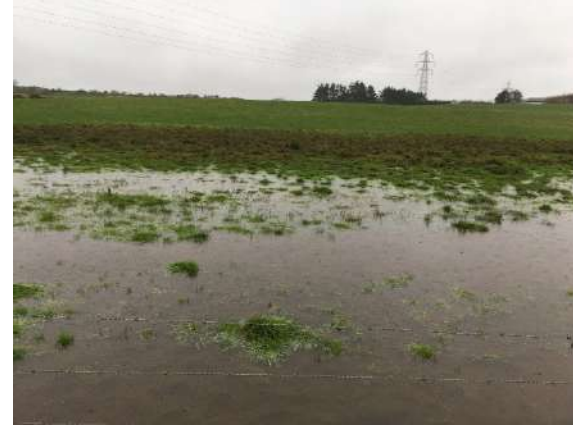
17 NK 08643 53693 Western area of marshy grassland by the River Black Water, next to inundation habitat which has been badly poached by livestock.

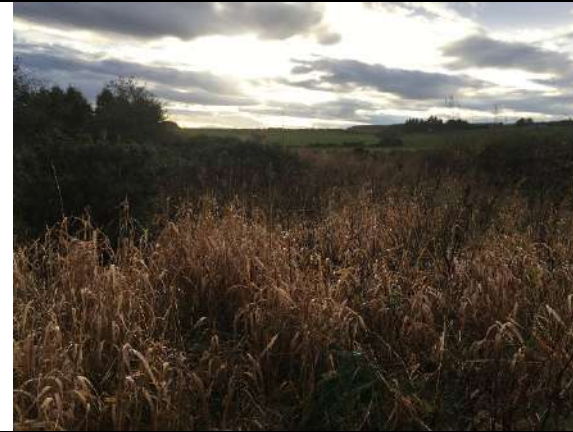
18 NK 08896 53726 Rank semi-improved grassland adjacent to the mixed plantation woodland. This habitat supports *Phalaris arundinacea* at the base of the bank in places, indicating damp conditions.

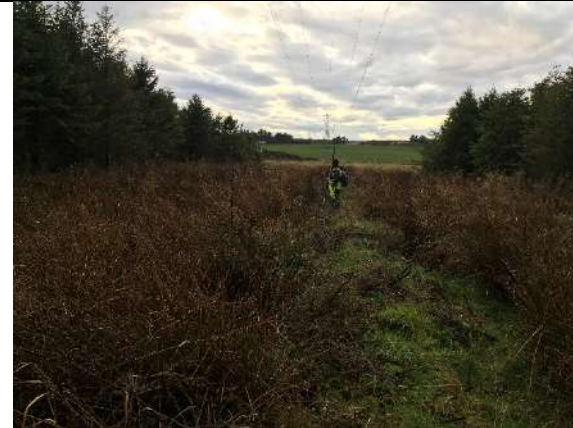
19 NK 08918 53696 Disturbed area within mixed plantation through which the existing overhead line runs. This area is free of trees, instead comprising rank grassland habitat (primarily *Deschampsia caespitosa* and *Dactylis glomerata* with frequent *Juncus effusus*) which is similar to the understorey within the broader plantation but a little more damp. Two linear areas of Sitka spruce have been planted on either side of the cleared area.

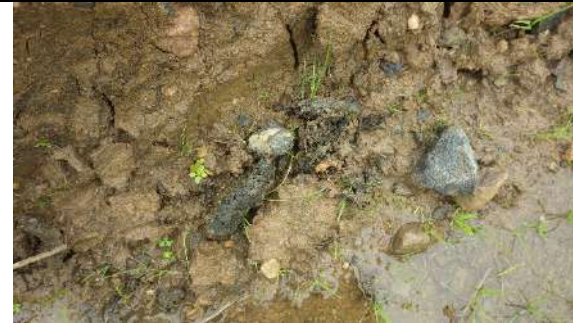
20 NK 08336 53648 Badger dropping found on well-used farm track to the north-west of the proposed sub-station.

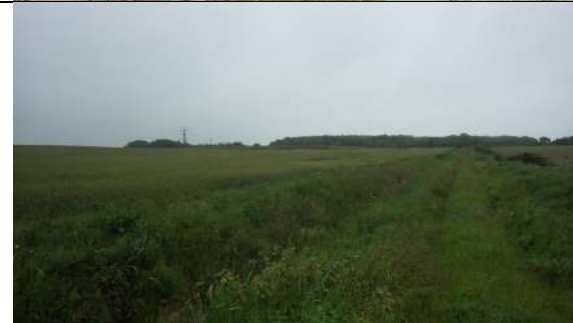
21 NK 08468 53806 Field in north-west noted to be in use for growing crops during June 2019.

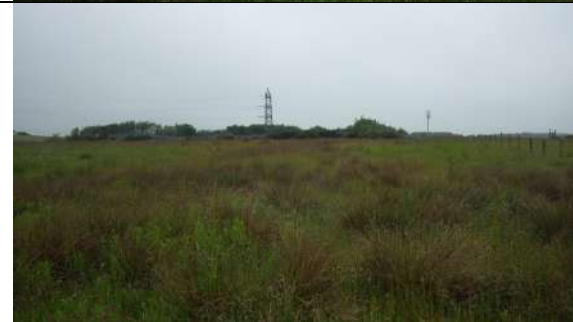
22 NK 08682 54064 Field of semi-improved neutral grassland to the north of the existing substation. The presence of rushes indicative of damp ground conditions. Vegetation is dominated by *Holcus lanatus* and *Dactylis glomerata*, with *Juncus effusus*, *Ranunculus acris*, *Plantago lanceolata*, *Trifolium repens* and *Cirsium arvense*. *Lotus corniculatus*, *Potentilla anserina* and *Leucanthemum vulgare*. *Dactylorhiza purpurella* was noted, and also a patch of *Phragmites australis*.
