Environmental Impact Assessment (EIA) **Report**

LT383 Alyth to Tealing Overhead Line (OHL) ***400kV Upgrade***

VOLUME 4: APPENDIX 12.2 – SITE WALKOVER PHOTOS

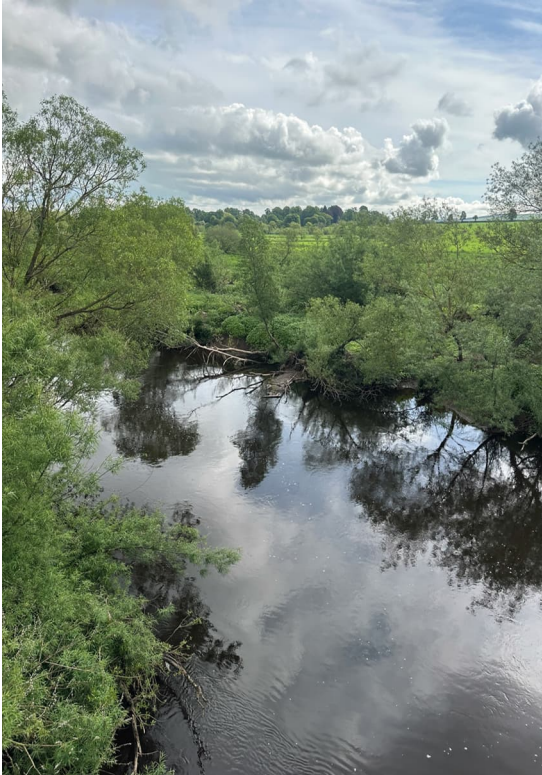
<p>Photo No. 2</p>	<p>Date: 28/05/24</p>

<p>Crossing at River Isla, along the B954. Located south-west of Alyth Substation and Towers 641 – 646.</p> <p>The river was populated with vegetation and broken trees. Shallow banks, with flooded brown water.</p> <p>NGR: NO 27930 45431</p> <p>Camera angle: facing east</p>

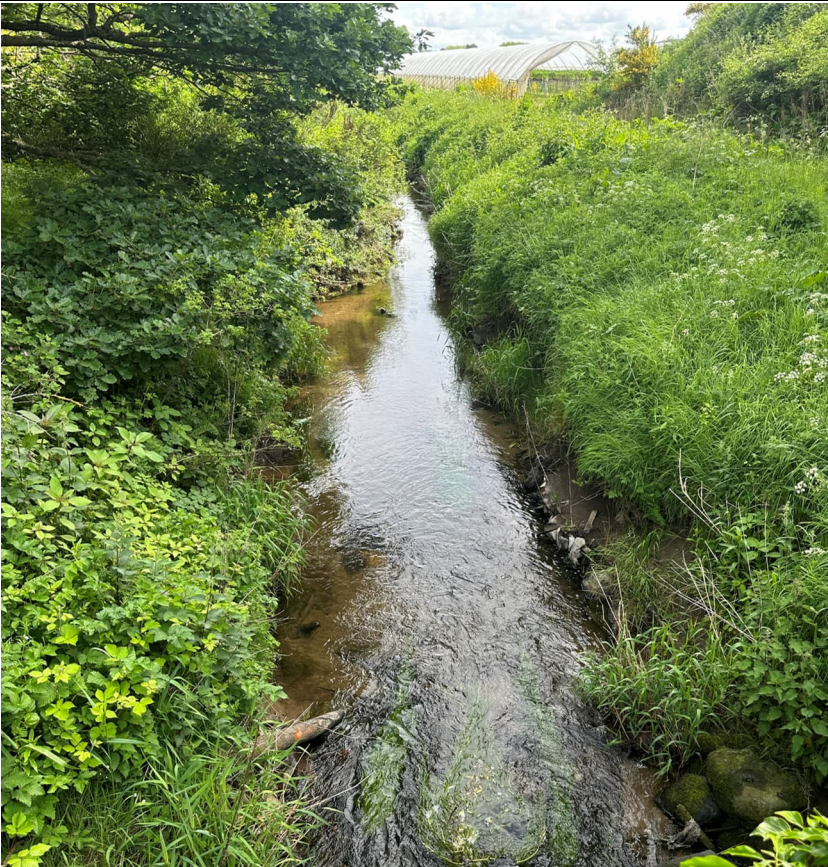
<p>Photo No. 4</p>	<p>Date: 28/05/2024</p>

<p>Downstream of Denend Burn located south-west of OHL. This Burn is a tributary to the Kirkinch Burn.</p> <p>The Burn exhibited clean water with instream vegetation and silty bed with stone and bricks.</p> <p>Downstream had a narrower channel. The channel flows in from the field.</p> <p>NGR: NO 30652 41950</p> <p>Camera angle: facing north-west</p>

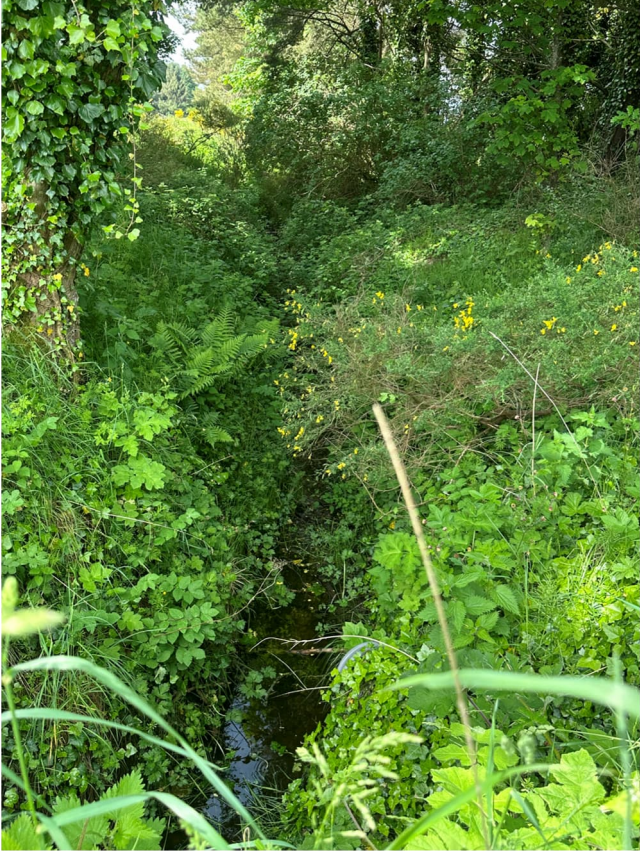
<p>Photo No. 5</p>	<p>Date: 15/01/2024</p>

<p>Man-made drainage ditch, upstream of the Denend Burn.</p> <p>Denend Burn was surrounded by vegetation and trees. Slow moving water which could be dried out in summer.</p> <p>Local Knowledge (farmer): Stated the council put in burn a couple of years ago, which has caused flooding to their property and along the road.</p> <p>NGR: NO 30658 41945</p> <p>Camera angle: north-east</p>

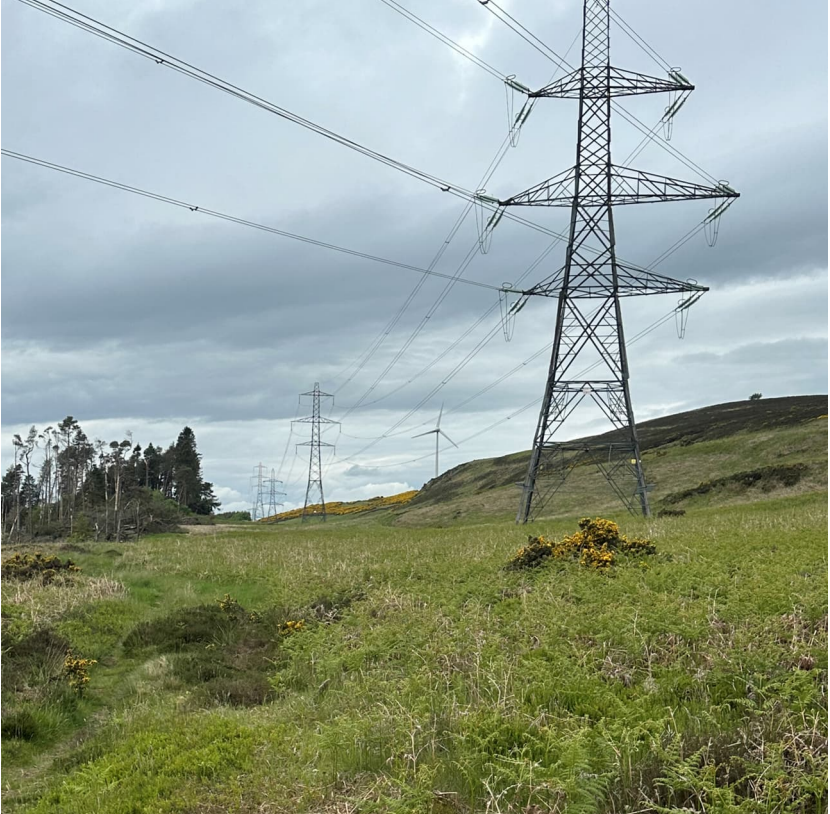
Photo No. 7	Date: 28/05/2024

<p>Towers 670-673.</p> <p>These are located at the bottom of Auchterhouse Hill.</p> <p>Camera angle: facing west</p> <p>NGR: NO 34683 39672</p>
