Annex Q - Cultural Heritage Appraisal and Site Gazetteer

Figure 7-1
An Suidhe Substation Cultural Heritage Receptors

An Suidhe, Craig Murrail, Crarae, and Crossaig North proposed 275kV Substations, Argyll Archaeological Walkover Survey Report

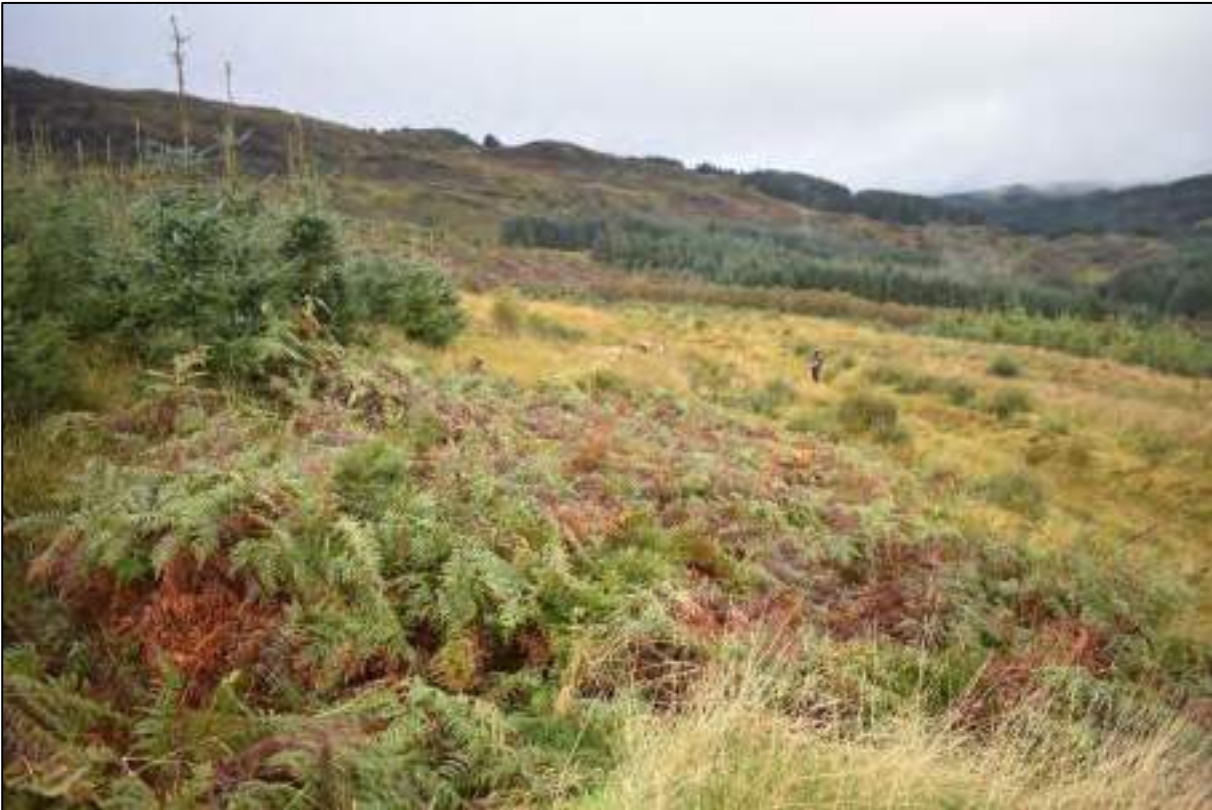
Plate 3: Overgrown drystone dyke AS01, facing northwest

- 5.1.2 One previously unrecorded asset was noted within the study area, located near the southeast corner of the substation footprint. The asset (AS01) comprised the remains of a drystone wall, heavily overgrown with moss and bracken, measuring c.1.2m high and 0.6m wide (**Plate 3**). It appears to have been previously truncated by the installation of existing access tracks, though it is possible further remains survive under thick vegetation within the wider area.

- 7.1.2 At An Suidhe, there is high potential for direct impact upon asset AS01, the remains of a drystone dyke that ran partly across the study area. Construction works may necessitate the partial or complete removal of the asset. In the first instance, avoidance of the monument with a 5m buffer zone is the preferred mitigation, however if this is not possible, recording of the structure prior to its removal may be required under archaeological evaluation or watching brief conditions. There is also potential for minor direct impacts to other drystone walls AS02-03 during access track improvements. The impact to these walls overall is considered to be relatively low due to the low significance of the monument type and the extensive remains of the walls that will be unaffected. No impact is anticipated for drystone wall AS04. The general ground conditions of the area have low potential for the survival of buried archaeological remains, except possibly along stream courses where the ground has been less disturbed by forestry planting and felling.

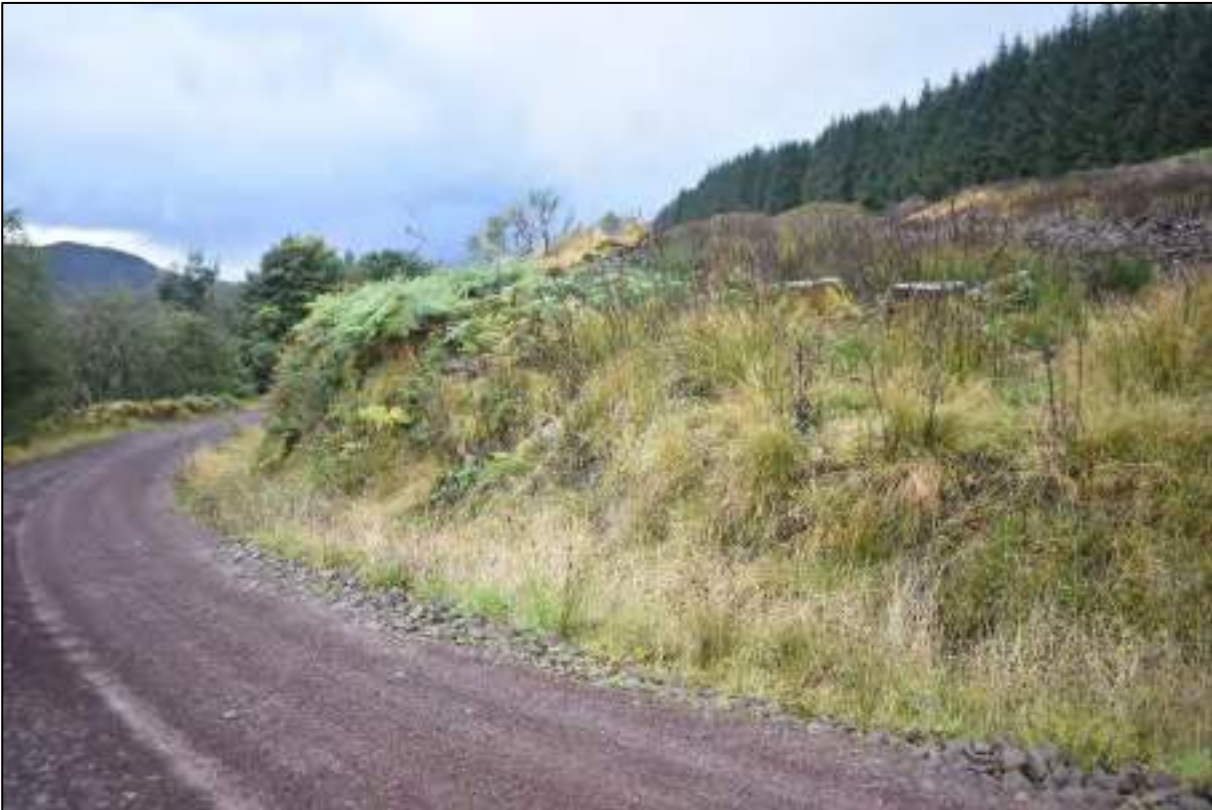
Plate 5: Overgrown drystone dyke AS03, facing southwest

- 5.1.5 The access to the Site runs on an existing gravel track predominantly bordered by forestry, with some improved fields near the entrance from the A83. Three previously recorded archaeological assets (AS02-04) were present along the route, comprising drystone walls of similar construction to AS01 (**Plate 5**). These walls form large,

interconnected enclosures visible on both modern and historic mapping and are likely part of a field system associated with the post-medieval settlement at Killean. Walls AS02-03 both end alongside the existing track and have possibly been previously truncated by the track.

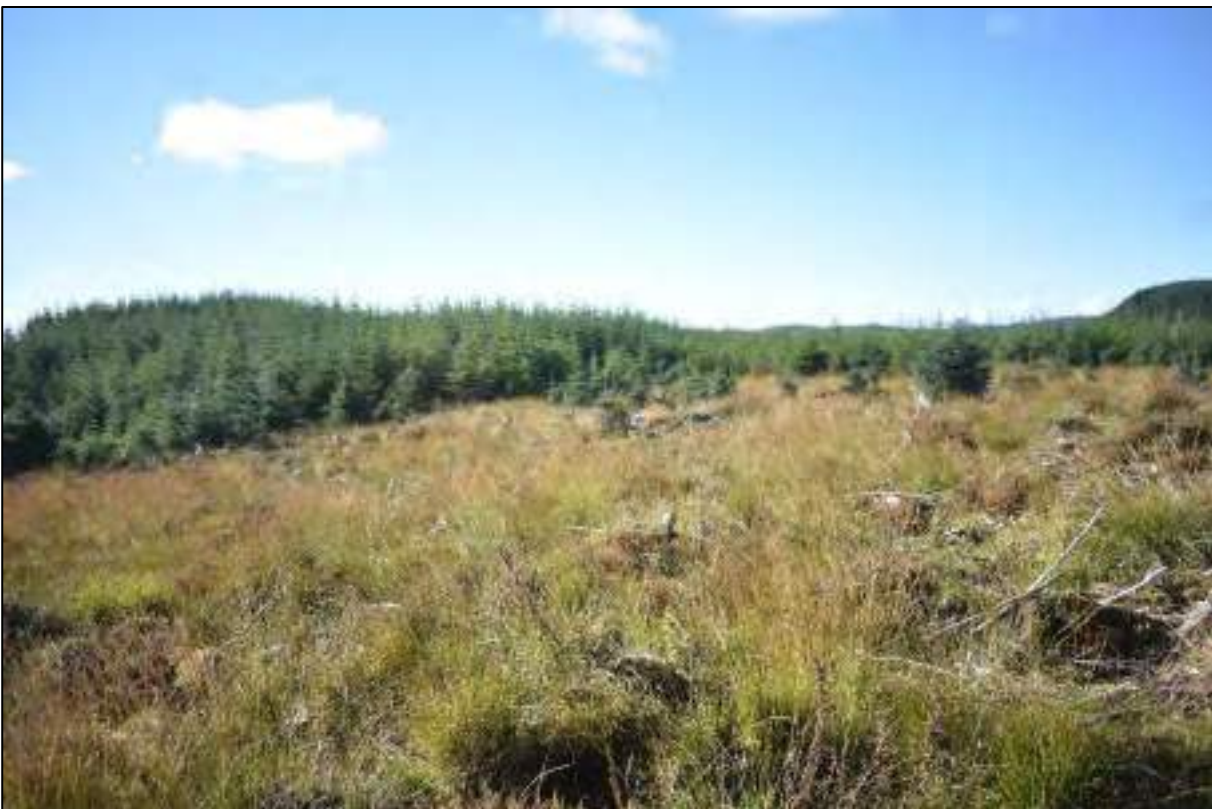
Plate 8: Location shot of Auchoish cairn (CM02) and shieling (CM03), showing dense forestry, facing southwest

- 5.2.2 No previously unrecorded assets were identified within the study area and the presence of large areas of clear fell and dense forestry suggest the potential for archaeological remains to survive is poor. Two previously known assets (CM02-03) are located on the west side of the study area, however, they could not be accessed during the survey due to their location within dense forestry (**Plate 8**). The assets comprise Auchoish long cairn (SM173), a scheduled chambered cairn, and a shieling located nearby. Based on aerial imagery, both assets survive within a small woodland clearing.

- 7.1.3 At Craig Murrail, there is medium potential for direct impacts upon two assets within the study area: Auchoish long cairn (CM02), a Scheduled Monument of national significance, and a shieling (CM03). Based on the current proposed footprint for the substation, direct disturbance of the assets should be avoidable, however, there is potential for impacts from associated works related to access tracks or tree felling. It is recommended that a minimum 20m buffer zone is maintained around these assets and that construction works avoid the northwest-facing slope where the cairn is situated to avoid impact to its wider setting. No impact is anticipated for cup-marked stone CM01, which lies alongside the access track, however, due to its proximity to access track demarcation of a 20m buffer zone is recommended during improvement works. The general ground conditions of the study area have low potential for the survival of buried archaeological remains due to the presence of forestry plantation and felling, however, it is recommended that any groundbreaking works on the northwest-facing slope (near the cairn) are subject to watching brief due to the potential presence of significant prehistoric archaeology.

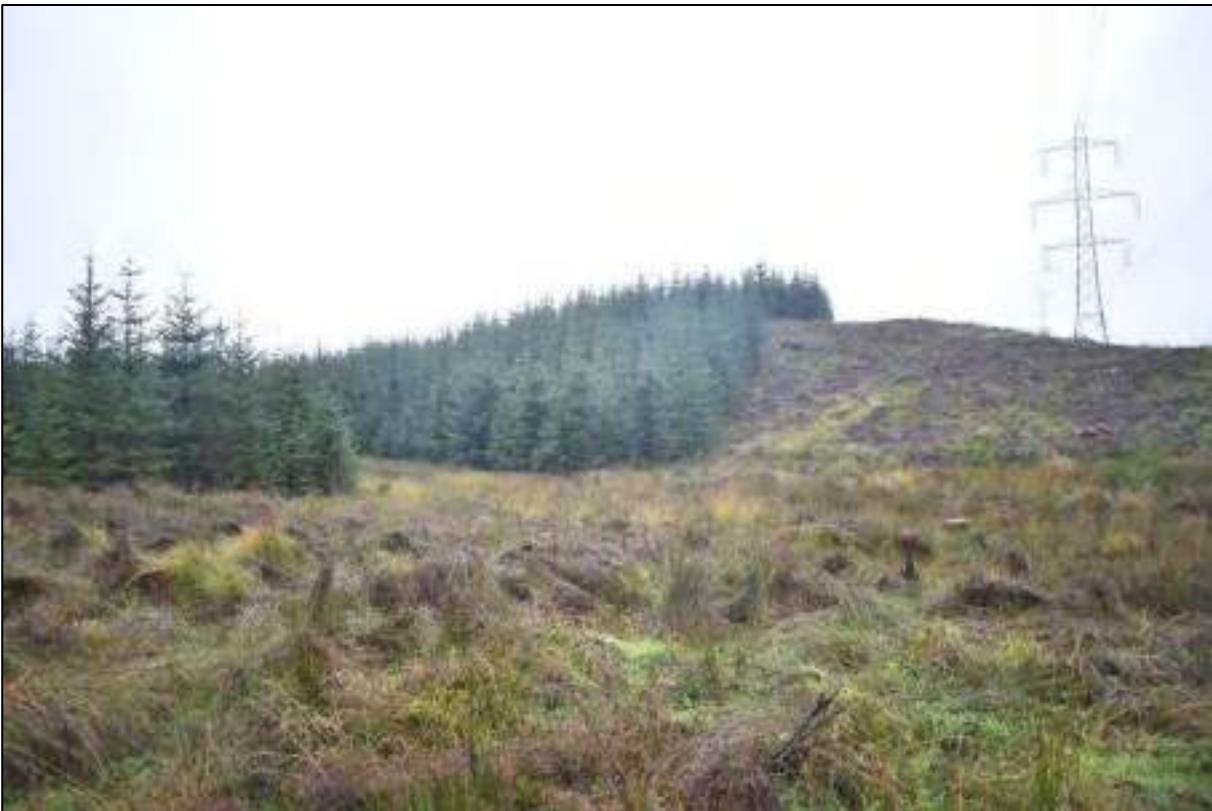
Plate 10: Landscape view of Crarae and location of shieling CR06 in forestry, facing southwest

- 5.3.1 The proposed Crarae substation lies on a north-facing slope within forested and recently felled ground between Garvachy and Feorlin, on the east side of Feorlin reservoir (**Figures 7-9; Plate 10**). It lies approximately 2km northwest of Minard and is accessed via a track off the A83 near Birdfield, with a second access track leading to Crarae from Craig Murrail substation. It should be noted that due to landowner permissions, survey was not carried out on the northeast part of the study area (outside the forestry plantation) nor on the access track leading from Garvachy around the north side of the substation to Feorlin and then west to Tom a' Churaidh. The OHL tie-in locations were also not accessible due to landowner permissions.

- 7.1.4 At Crarae, there is high potential for direct impact upon the shieling at CR06, which lies within the proposed substation footprint. Construction works may require the complete removal of the asset, in which case a programme of archaeological evaluation and excavation would be required in order to record the asset and any associated buried remains. There is also medium potential for impacts to standing stone CR10 which lies within the wider study area and it is recommended that a buffer zone of 10m is demarcated around the asset. Potential for direct impacts to assets within the area of land that was inaccessible during this survey also exists. It is recommended that this area is surveyed prior to construction works commencing to allow an appropriate mitigation strategy to be put in place. The majority of ground conditions within the study area have low potential for the survival of buried archaeological remains due to the presence of forestry plantation and felling. Along the access routes to Crarae, two bridges (CR03 & CR05) will be directly impacted by track improvement works. These bridges are of relatively recent date and the significance of the impacts would be low. There is low potential for impacts to other known assets along the routes, however, depending on the scope of track improvements, it may be necessary to demarcate buffer zones of 10m around the post-medieval structures.

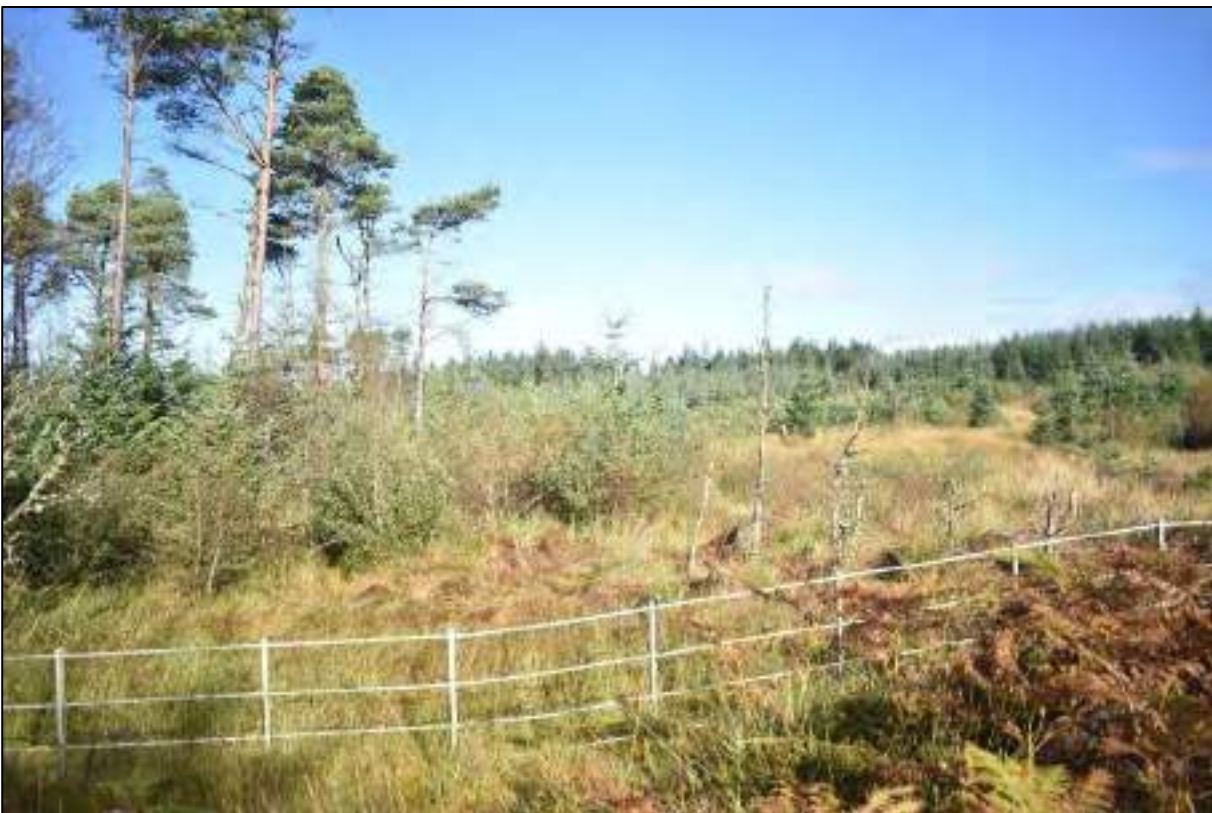
Plate 26: Landscape condition around Achabreck rock carvings CM05-06, facing north

- 6.6 The two Scheduled **Achnabreck prehistoric rock carvings** (SM90006; CM05; SM12957; CM06; see Figure 6) lie approximately 1.7km to the southwest of the proposed Craig Murrail substation and within 100m-300m of the access track. Together they comprise possibly the most extensive and elaborate concentration of prehistoric rock carvings in Scotland, with major groupings of cup-and-ring marks and other grooves (**Plates 24-26**). The carvings are set into natural bedrock outcrops which form large flat slabs and are situated on the lower slopes of the Auchoish Burn and Badden Burn valleys. The function of the carvings is not known but is thought to have ritual or spiritual importance with high significance placed on their landscape position. Although now within forestry plantation, they would have had views along the valley south to Lochgilphead and west to Cairn Baan, where another set of rock carvings are present (SM13211). Two prehistoric standing stones are located nearby (SM168; SM213) and Auchoish Long Cairn is situated further up the valley. The carvings lie within the much wider ritual landscape of Kilmartin Glen, which contains a significant amount of Neolithic and Bronze Age burial monuments.

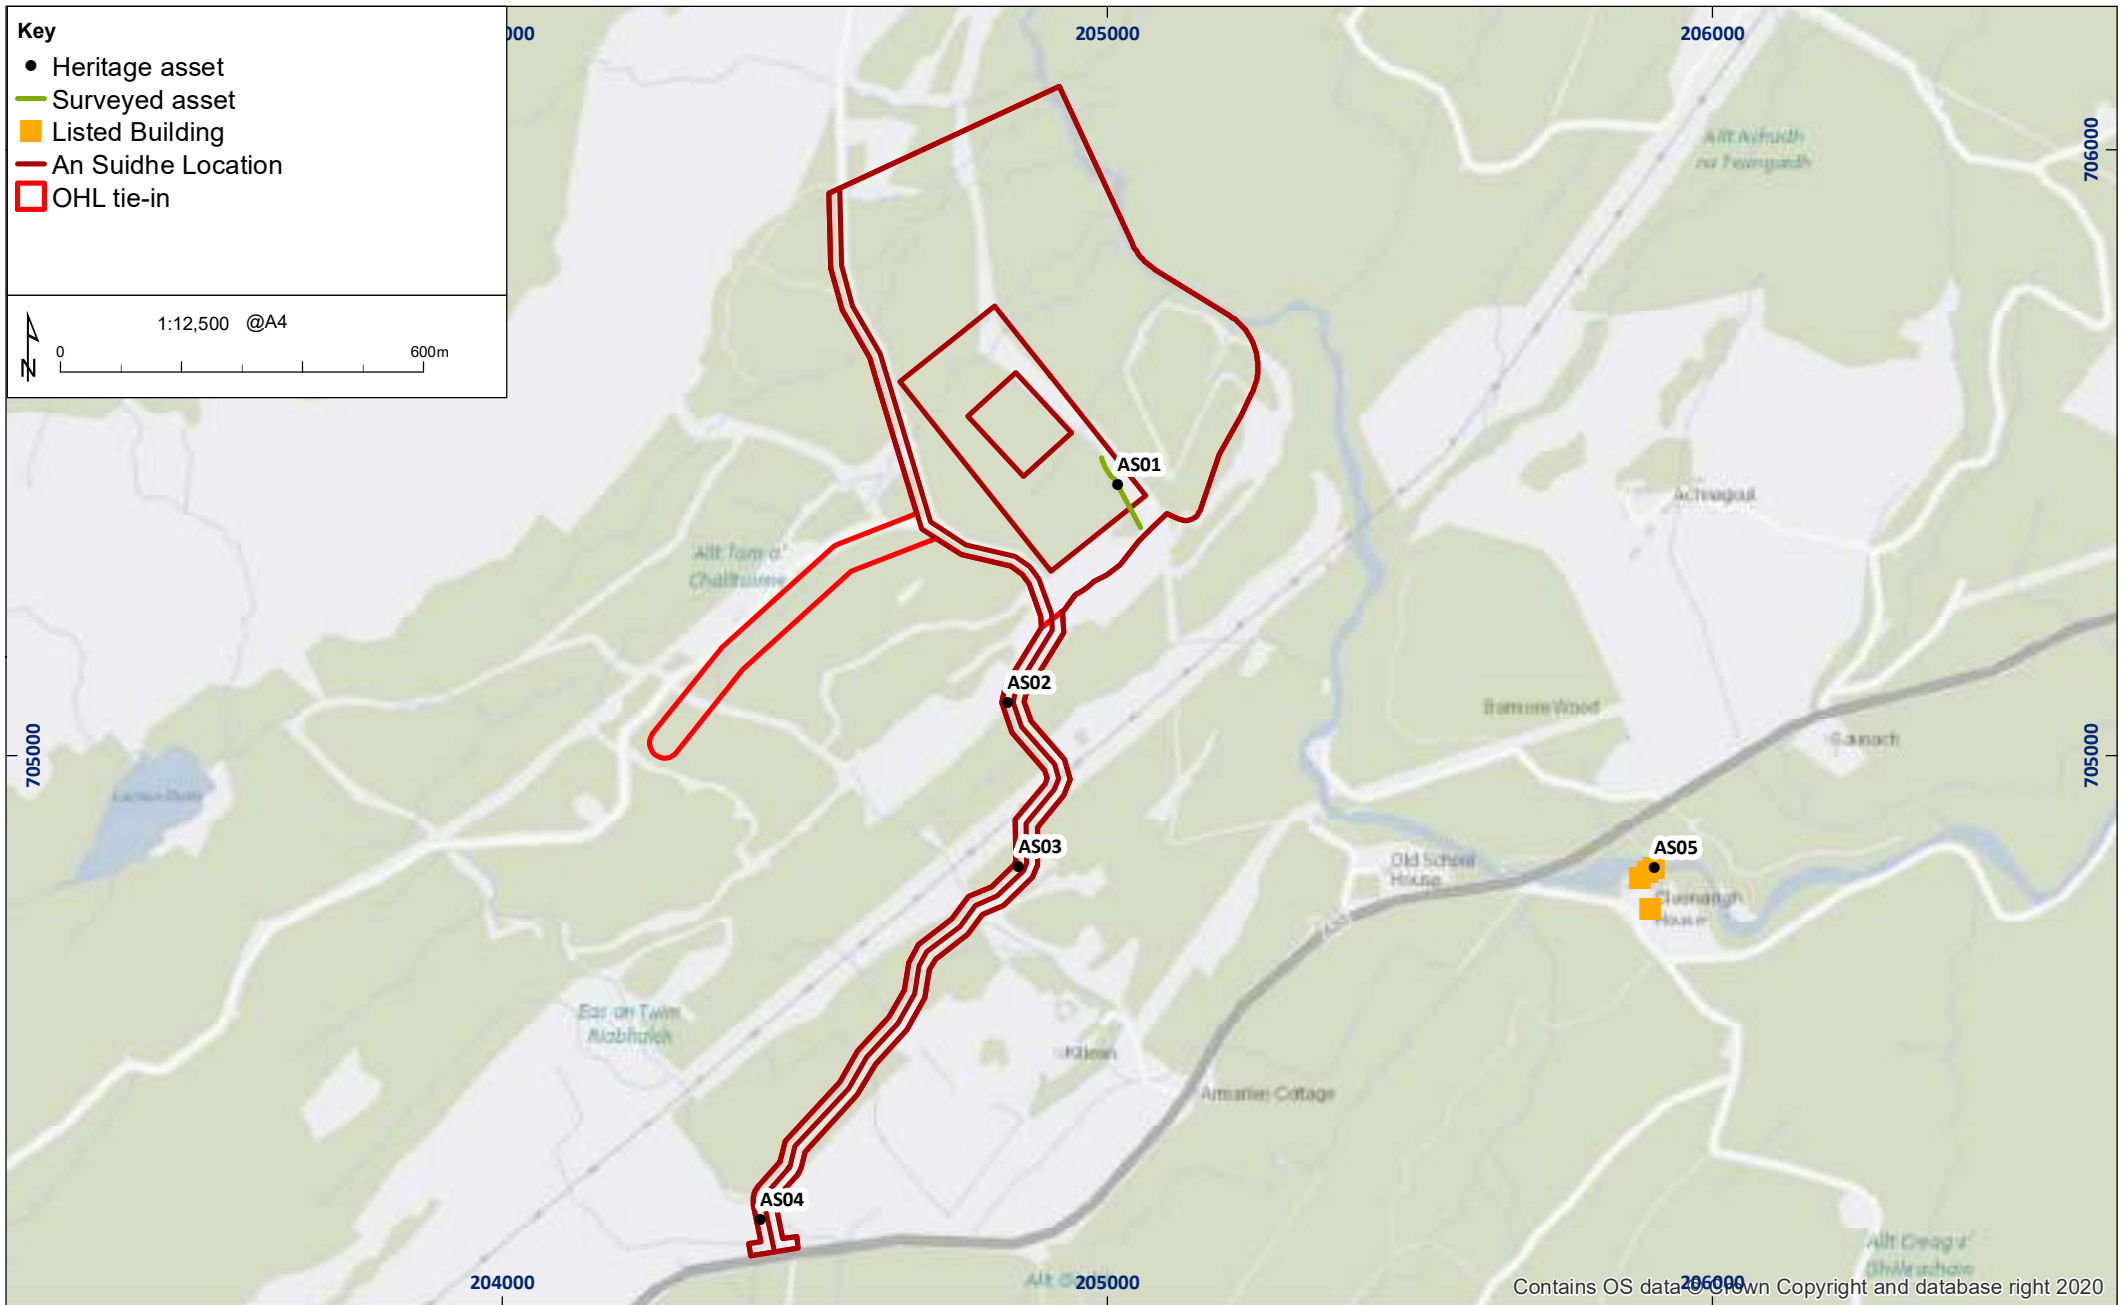
Figure 5: An Suidhe survey results

- 5.1.1 The proposed An Suidhe substation lies on a steep east-facing slope within forested and recently felled ground on the west side of Douglas Water, north of Killean (**Figure 5; Plates 1-2**). It lies approximately 6km southwest of Inveraray and is accessed via a track from the A83 near Killean, Inveraray. The existing substation lies c.500m to the south. Due to the presence of dense forestry, it was not possible to access all parts of the study area.
