**Creag Dhubh to Inveraray 275kV Connection
Environmental Impact Assessment
Volume 4 | Appendix 10.1**

Peat Depth Results Report

June 2022

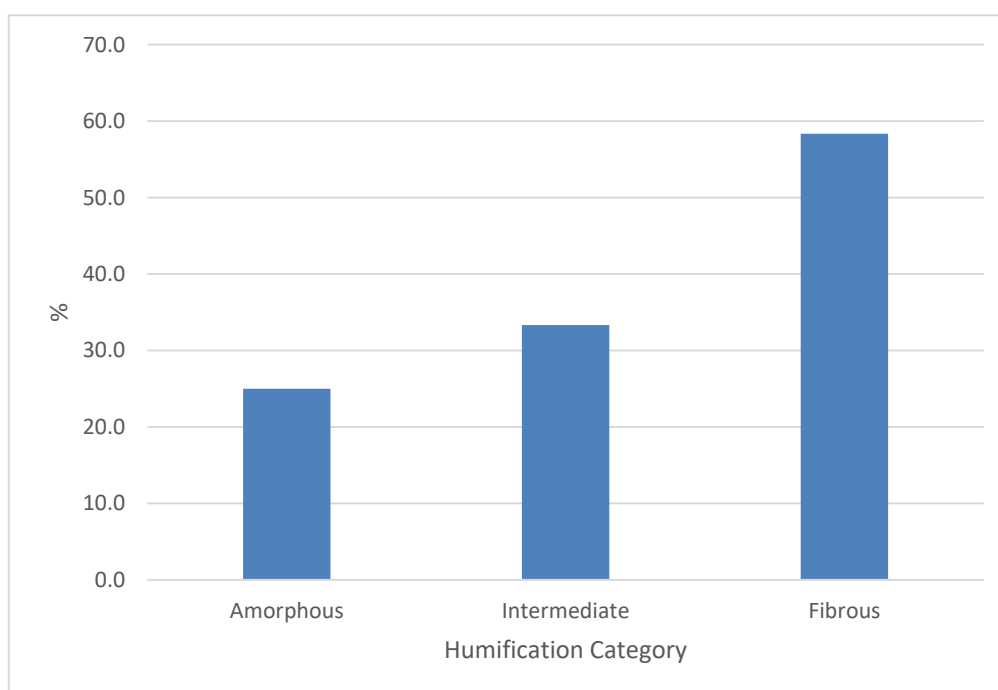
Graph 3.3: Degree of Humification

3.3.11 **Graph 3.3** summarises the degree of humification, which indicated that most of the samples are classed as fibrous, which is suggestive of low humification in the samples. However, 58.3% of the samples are classified as either amorphous or intermediate which indicates that there is a degree of humification present.

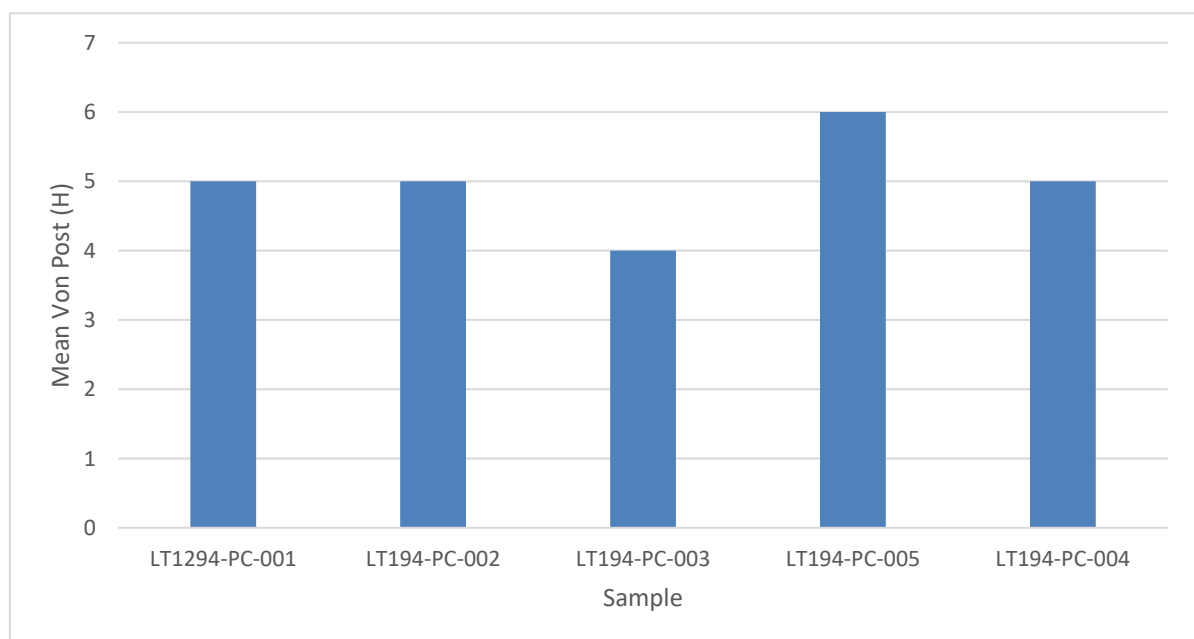
Graph 3.6: Mean Von Post

3.3.15 The results are shown in **Graph 3.6** below, where the vertical axis refers to the Von Post scale of peat decomposition (on a scale of H1 to H10).

3.3.16 The results indicate that all the samples were found to be between H4 and H6 on the Von Post scale, indicating weakly decomposed to well decomposed peat. This is reflective of the intensively managed nature of the Site, where there are significant areas of commercial forestry plantation and felling, and artificial drainage. In some areas diffuse natural drainage systems were also noted. It is likely that the acrotelmic and peat is highly modified as result of desiccation associated with forestry and drainage.

- The results of the Von Post indicate that the majority of the samples tested scored relatively high on the Von Post scale (H4+) indicating weakly to well decomposed peat. Areas of the Site have historically been intensively managed with significant areas of commercial forestry plantation and felling, with artificial drainage measures used. In some areas diffuse natural drainage systems were also noted. Within the commercial plantation and forestry areas it was noted that the acrotelmic peat was highly modified as a result of planting and felling activities. No evidence of peat erosion or instability were generally noted within the forestry areas;
