**Creag Dhubh to Inveraray 275 kV  
Connection Environmental Impact  
Assessment  
Volume 4 | Technical Appendix 10.3  
Peat Landslide Hazard and Risk Assessment**

**July 2022**

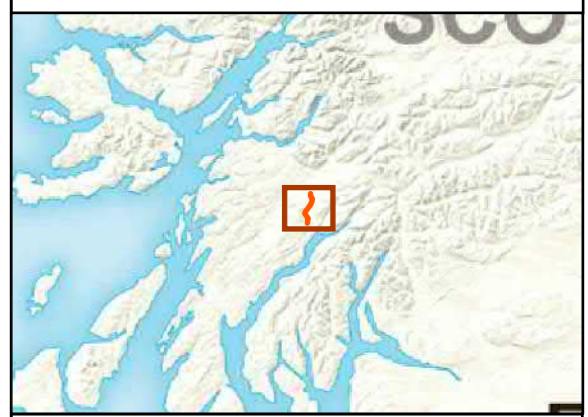
- Proposed Alignment Towers
- Proposed Alignment
- Proposed Creag Dhubh Substation (Separate Application)
- Inveraray - Crossaig Towers
- Inveraray - Crossaig OHL
- Temporary Diversions**
- ITE / ITW 132 kV Diversion
- 275 kV Diversion
- ITE / ITW 132 kV Diversion Poles
- 275 kV Diversion Towers
- Access Tracks**
- Creag Dhubh Access Track
- Access Tracks - Track To Be Maintained
- Proposed Access Route (Perm)
- Proposed Access Route (Temp)
- Existing Access Tracks Upgrade
- BGS Bedrock Geology**
- UNNAMED IGNEOUS INTRUSION, LATE SILURIAN TO EARLY DEVONIAN - FELSIC-ROCK
- ARGYLL GROUP - PSAMMITE, SEMIPELITE AND PELITE
- SOUTHERN HIGHLAND GROUP - PSAMMITE AND PELITE
- UNNAMED EXTRUSIVE ROCKS, NEOPROTEROZOIC - MAFIC LAVA AND MAFIC TUFF
- UNNAMED IGNEOUS INTRUSION, NEOPROTEROZOIC - MAFIC IGNEOUS-ROCK

- 3.1.5 Dalradian Supergroup, Metagabbro and Metamicrogabbro metamorphic rock is also noted to be present where igneous intrusions have occurred.
- 3.1.6 A fault zone is shown to be present to the south west of Tower T21 trending north east to south west.

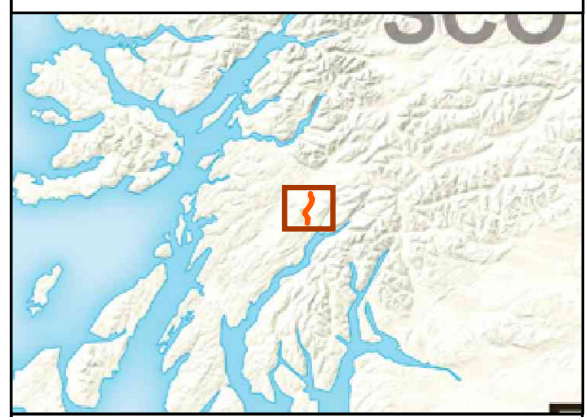
- ### Legend
- Proposed Alignment Towers
  - Proposed Alignment
  - Proposed Creag Dhubh Substation (Separate Application)
  - Inveraray - Crossaig Towers
  - Inveraray - Crossaig OHL
  - Temporary Diversions**
  - ITE / ITW 132 kV Diversion
  - 275 kV Diversion
  - ITE / ITW 132 kV Diversion Poles
  - 275 kV Diversion Towers
  - Access Tracks**
  - Creag Dhubh Access Track
  - Access Tracks - Track To Be Maintained
  - Proposed Access Route (Perm)
  - Proposed Access Route (Temp)
  - Existing Access Tracks Upgrade
  - BGS Superficial Geology**
  - Alluvium - Clay, Silt and Sand
  - Raised Marine Deposits - Sand and Gravel
  - Till - Diamicton
  - Unknown
