CROSSAIG NORTH SUBSTATION

ANNEX M PRIVATE WATER SUPPLY RISK ASSSESSMENT

FEBRUARY 2023

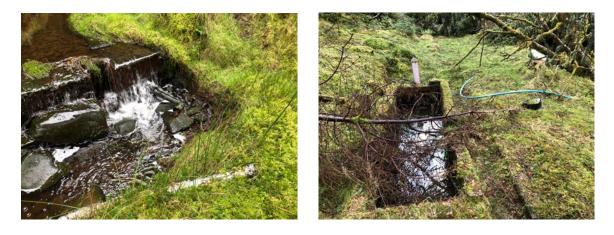
The existing source infrastructure was located 35 m east of proposed tower locations and 48 m south of the existing access track, although no exact intake location was confirmed. An open topped brick tank was observed which was previously connected with a metal pipe underground, but broken with no water entering the tank. It was assumed the pipe has previously collected water from the nearby watercourse. The water in the tank was stagnant with forestry branches and brash. A blue plastic pipe was exposed along the banks of the watercourse but it is not known whether this pipe is functional. Please refer to photographs in Plate 3.2.

A meeting was held with the residents of Crossaig Lodge and South Crossaig on the same day. Arcus personnel were informed that the PWS was no longer functioning due to ongoing construction works having damaged the PWS with the pipe assumed to be cut downslope of the source. At the time of this assessment, this supply was non-functional and supplied no water to residents. Therefore, it has been treated as a historical PWS and is no longer subject to potential effects from the Project.

Plate 3.2 PWS source structures for PWS Crossaig Lodge and South Crossaig, NGR: NR 82848 50643 (Left: old weir intake pipe which is broken, right: debris covered weir tank with blue pipe disconnected from tank).
