**Hurlie 400kV Substation
Environmental Impact Assessment (EIA)
Volume 4 | Appendix 10.3**

Protected Species Survey Report

November 2024

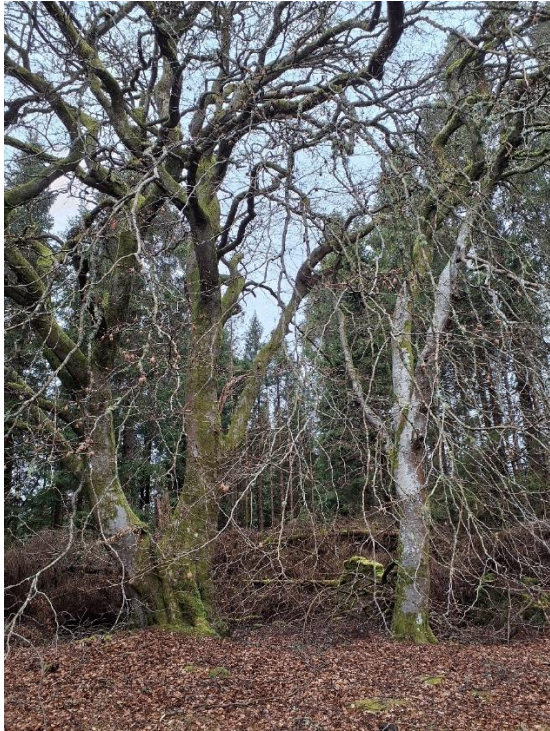
Photo 1: Bat roost potential was identified as low and negligible throughout the site.

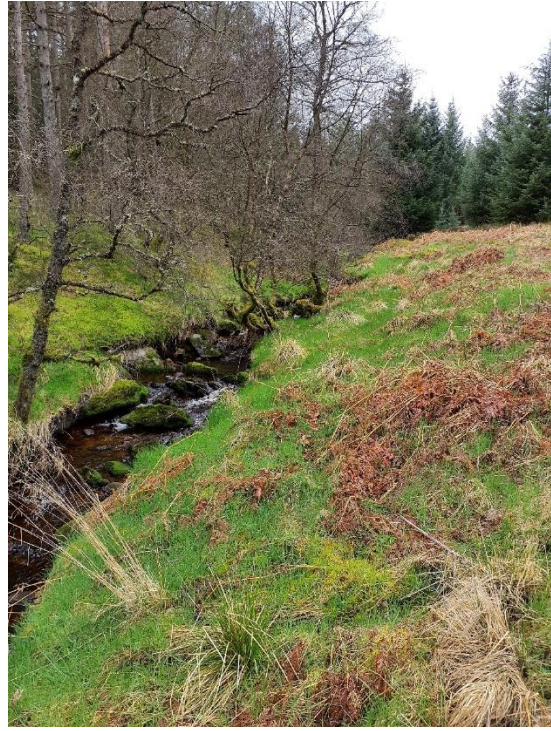
Photo 2: Some watercourses provide suitable habitat for otter.

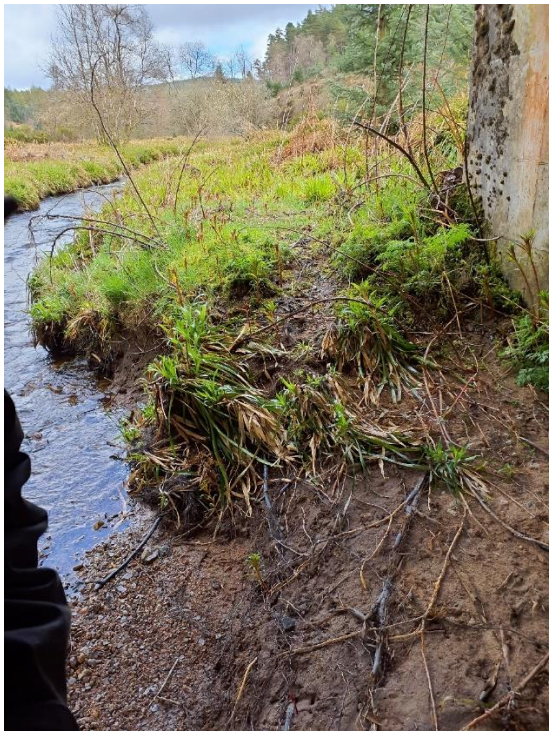
Photo 3: Otter evidence was identified under the bridge over Cowie Burn.

- 3.2.20 One old spraint was identified on the Cowie Burn, under the existing forestry track within the Access Track during the 2024 surveys. No evidence of otter was identified during surveys of the ESA in 2023. No resting sites were identified during any survey.

4.2.1 Evidence of otter was identified on the Cowie Burn under the Access Track, and watercourses within the ESA were generally considered to be suitable for foraging and commuting otter. No evidence of resting sites was identified, and the ESA is considered unlikely to form a core part of an otter's territory.

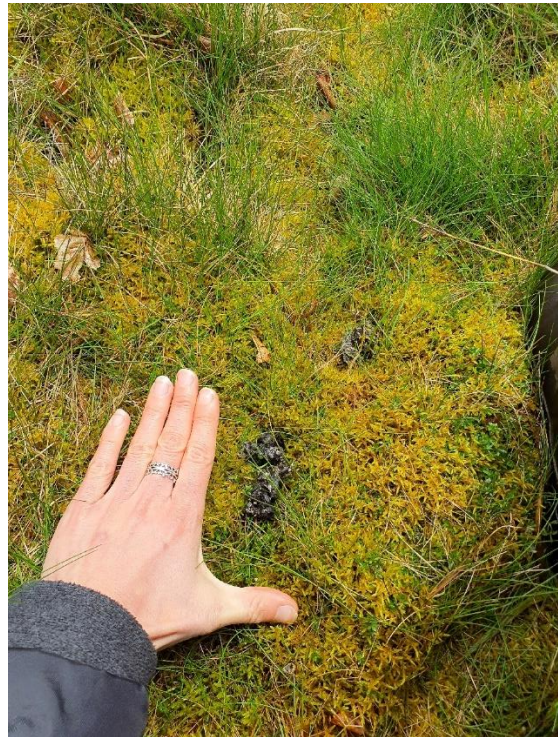
Photo 4: Pine marten signs were noted within the Access Track ESA.

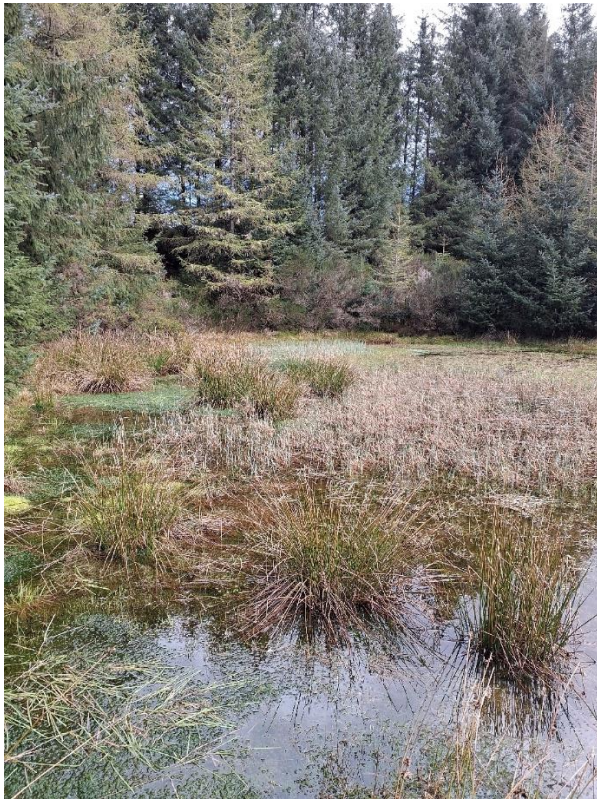
Photo 5: Waterbodies and wet habitats may provide suitable habitat for common species of amphibians.

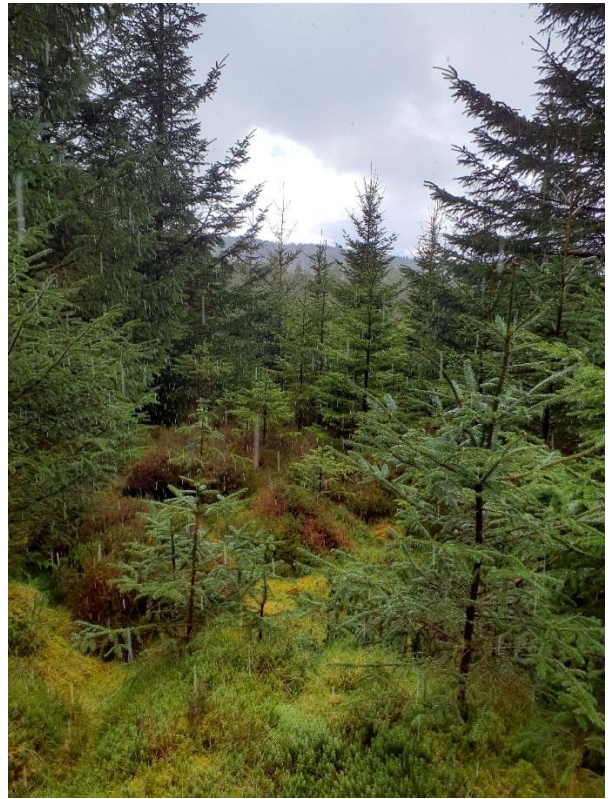
Photo 6: Typical example of coniferous woodland habitat within the Site which has limited potential for protected species.

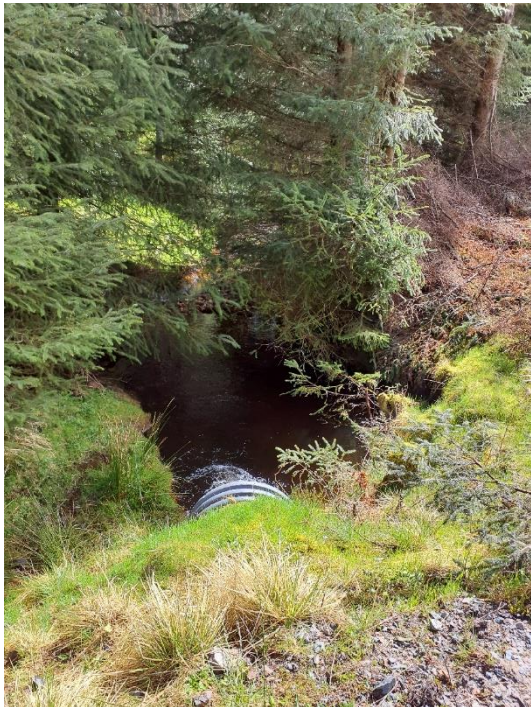
Photo 7: Example of the typical pipe culverts and watercourses present within the Site

- 3.2.4 The Access Track to the Substation Site follows an existing forestry track from the A957 Slug Road to the north, and from the public road network from Hill of Quithel to the southwest. Named watercourses cross under the existing track within the Site via either box or pipe culverts: the upper reaches of the Burn of Elfhill in the southwest; the Cowie Water, West Dumer Burn, East Dumer Burn and Irish Burn in the west; and the Black Burn in the north. In addition, the existing track crosses the Burn of Day in the centre of the Substation Site via a pipe culvert.

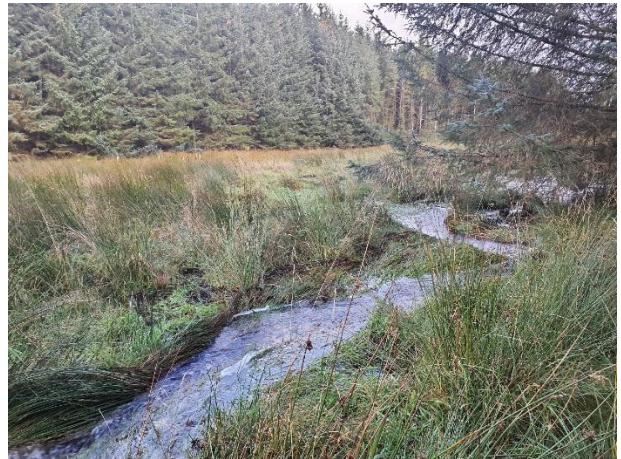
Photo 8: Burn of Day within the centre of the Substation Site, illustrating the lack of suitability for water vole.

- 3.2.24 Surveys identified limited habitat within the ESA with the potential to support water vole. One watercourse, the Burn of Day, was located within the Substation Site which was considered suitable for water vole in short sections where the watercourse was not shaded by commercial forestry and where it formed a channel with suitable bank habitats for water vole. However, these areas were few and separated by more extensive unsuitable habitat illustrated in Photo 8 in **Annex 10.3.1**, therefore limiting the overall suitability of the watercourse for water vole. Other watercourses were considered not suitable for water vole due to overshadowing, rocky or overhanging banks as shown in Photos 2, 3 and 7 in **Annex 10.3.1**. No evidence of water vole was identified during surveys in 2023 or 2024.

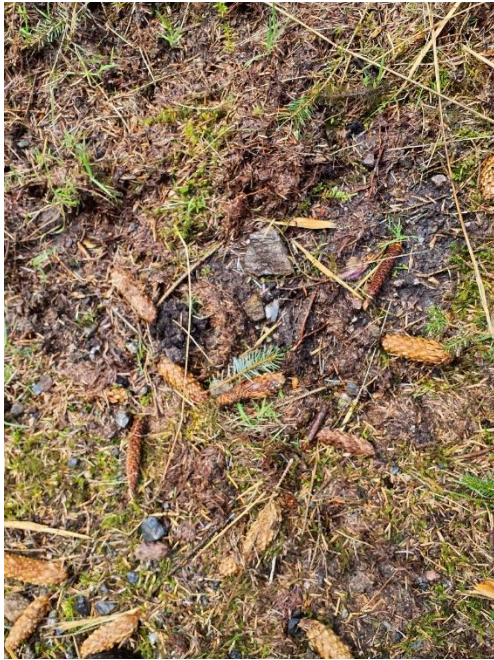
Photo 9: Red squirrel feeding station within the Access Track ESA

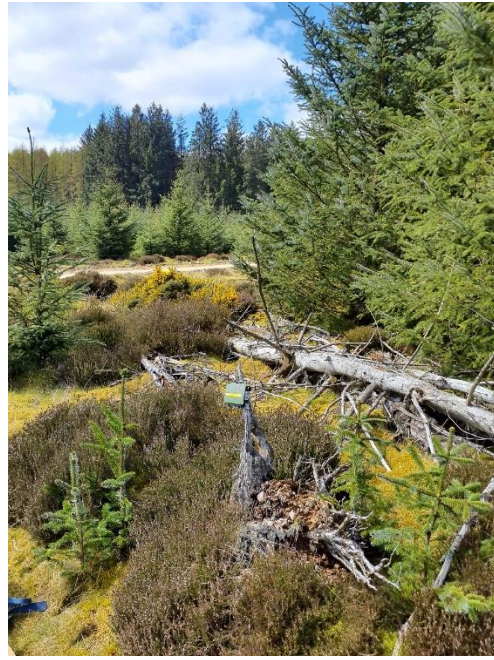
Photo 10: Static bat detector deployed on a fallen tree
