Hurlie 400kV Substation Environmental Impact Assessment (EIA) Volume 4 | Appendix 12.2

Watercourse Crossing and Buffers Assessment

November 2024

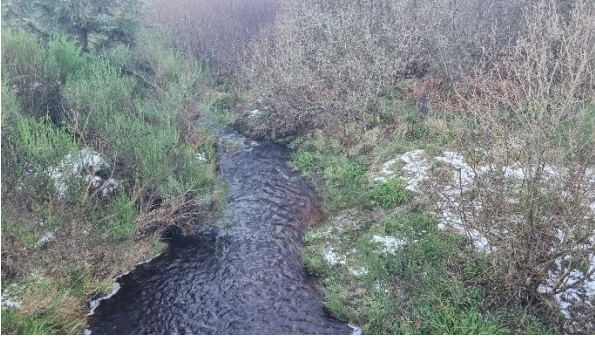
ID – A (Existing track crossing)	Black Burn
<u>Description:</u> At the crossing location, the Black Burn is crossed by an existing large bridge crossing in a ~2.4 m wide channel.	
NGR Ref: 378949 789314	
Photo – Black Burn looking downstream

Width of watercourse (m)	2.4 m
Bed Sediment	Mix of pebble and cobble
Bank Erosion	Yes some bank erosion observed near crossing
Natural Channel	Yes
Crossing Type	Existing Bridge – no upgrade proposed.
Additional Mitigation	Additional SuDS and pollution control measures (e.g. silt fences) at this location during construction phase.
Catchment (km ²)	7.85 km ²
Minor Watercourse ²	No
CAR Authorisation Required	No

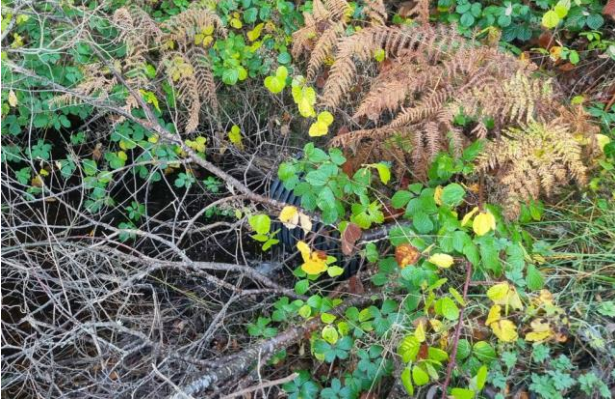
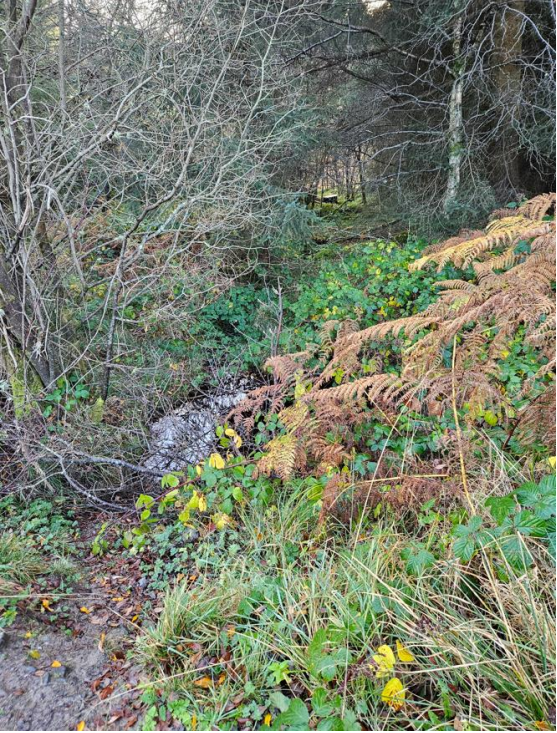
ID – C (Existing track crossing)	Unnamed Watercourse
<p><u>Watercourse Description:</u> Small unnamed burn flows beneath existing track to the south and is culverted under the track. A Private Water Supply (PWS) offtake and tank was observed approximately 30 m downstream of the existing track crossing. It is assumed that this is the PWS for the Tillybreak property.</p>	
NGR Ref: 378268 788409	
Photo – watercourse/ culvert looking upstream from track	Photo – watercourse looking downstream from track

Width of watercourse/ drain (m)	~0.2 – 0.4 m
Bed Sediment	Mixed sediment
Bank Erosion	No
Natural Channel	Yes
Crossing Type	Existing Culvert (400 mm diameter)– no upgrade proposed.
Additional Mitigation	Additional SuDS and pollution control measures (e.g. silt fences) at this location during construction phase.
Catchment (km ²)	0.14 km ²
Minor Watercourse	Yes
CAR Authorisation Required	No

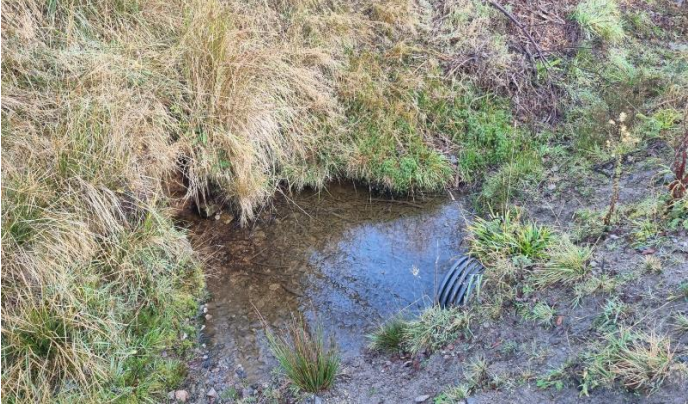
ID – D (Existing track crossing)	Unnamed Drain
<u>Watercourse Description:</u> Small unnamed forestry drain which flows beneath existing track in a 500 mm diameter culvert.	
NGR Ref: 378211 788385	
Photo – upstream of track

Width of watercourse/ drain (m)	~0.3 m
Bed Sediment	Mixed
Bank Erosion	No
Natural Channel	No
Crossing Type	Existing Culvert (500 mm diameter)– no upgrade proposed.
Additional Mitigation	Additional SuDS and pollution control measures (e.g. silt fences) at this location during construction phase.
Catchment (km ²)	0.05 km ²
Minor Watercourse	Yes
CAR Authorisation Required	No

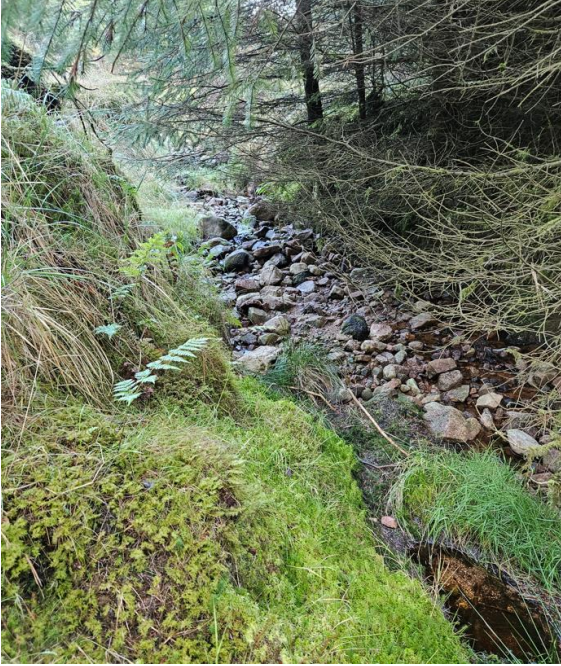
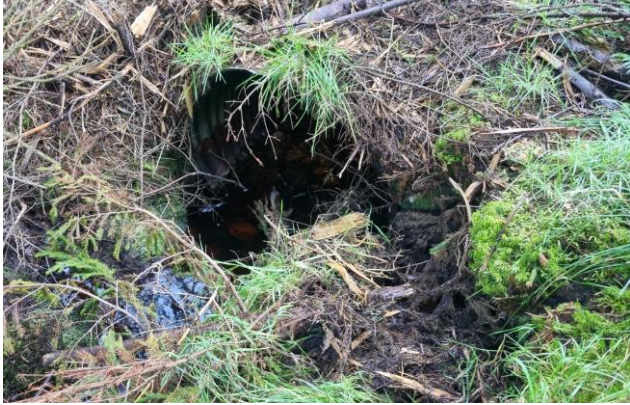
ID – E (Existing track crossing)	Irish Burn
<p><u>Watercourse Description:</u> Irish Burn flows beneath existing track, as a natural gravel and cobble bed channel with 1000 mm diameter culvert under the track.</p>	
NGR Ref: 377110 788249	
Photo – Irish burn (upstream of track)	Photo – Irish burn (culvert - downstream of track)

Width of watercourse/ drain (m)	1.3 m
Bed Sediment	Gravel, cobble, boulder
Bank Erosion	No
Natural Channel	Yes
Crossing Type	Existing culvert (1000 mm diameter) – no upgrade proposed.
Additional Mitigation	Additional SuDS and pollution control measures (e.g. silt fences) at this location during construction phase.
Catchment (km ²)	0.53 km ²
Minor Watercourse	No
CAR Authorisation Required	No

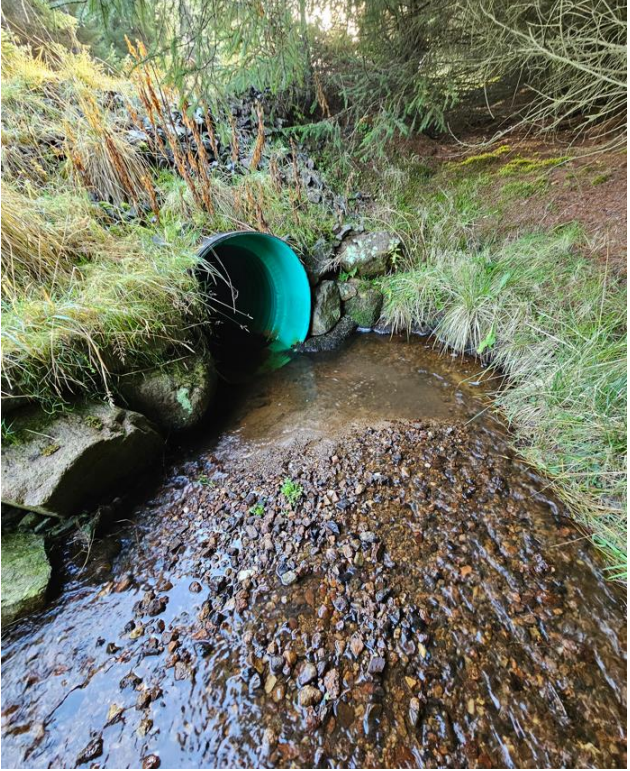
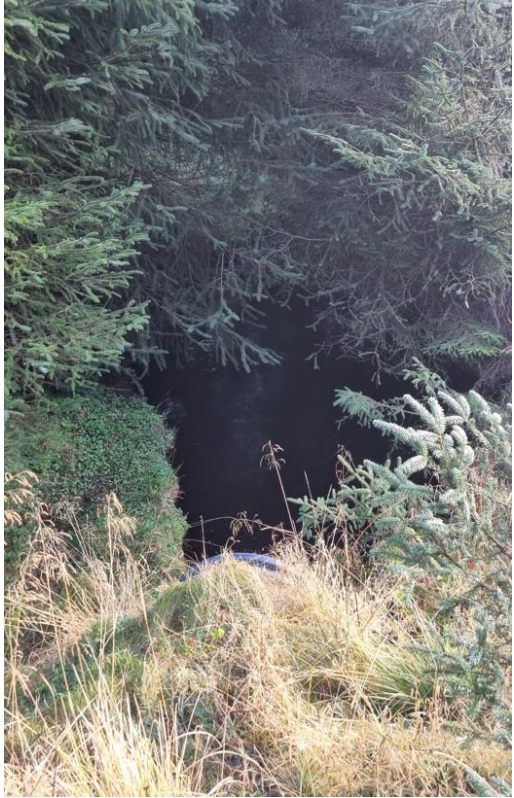
ID – G (Existing track crossing)	West Dumer Burn
<u>Watercourse Description:</u> West Dumer Burn flows beneath existing track via a 1000 mm diameter culvert	
NGR Ref: 376548 787859	
Photo – West Dumer Burn - upstream of the track	West Dumer Burn - downstream of the track

Width of watercourse/ drain (m)	1.3 m
Bed Sediment	Pebble, gravel
Bank Erosion	No
Natural Channel	Yes
Crossing Type	Existing culvert (1000 mm) – no upgrade proposed.
Additional Mitigation	Additional SuDS and pollution control measures (e.g. silt fences) at this location during construction phase.
Catchment (km ²)	1.35 km ²
Minor Watercourse	No
CAR Authorisation Required	No

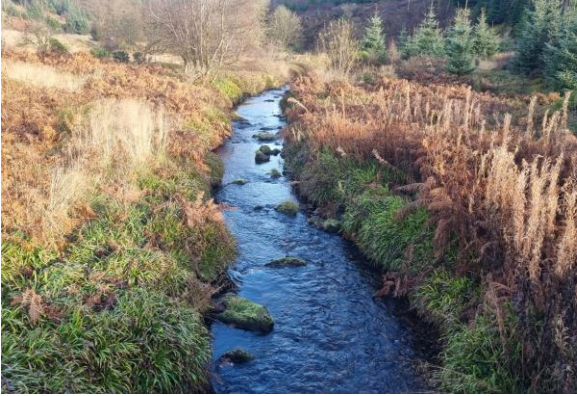
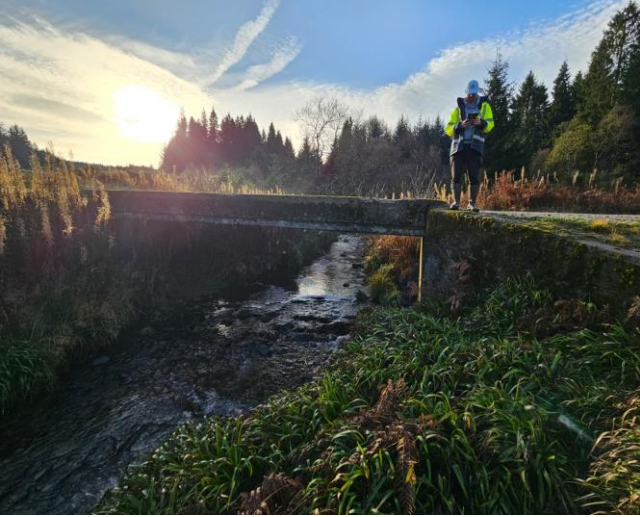
ID – H (Existing track crossing)	Cowie Water
<p><u>Watercourse Description:</u> Cowie Water flows beneath existing single span bridge crossing. SEPA future flood mapping indicates that the 200-year + climate change floodplain at the crossing location is approximately 70m wide, indicating that some of the nearby tracks will have some floodwater during extreme events.</p>	
NGR Ref: 376448 787359	
Photo – Cowie Water – looking upstream from bridge crossing	Cowie Water – bridge - looking downstream

Width of watercourse/ drain (m)	2.9 m Bridge deck is 2.2m high above channel bed and 6m wide
Bed Sediment	Cobble, boulder
Bank Erosion	No
Natural Channel	Yes
Crossing Type	Single span bridge– no upgrade proposed. An overbridging system is proposed at this crossing to allow passing of abnormal loads during the construction phase. This is a temporary 'overbridge' which will sit on the deck of the existing bridge/track. There will be no work in the watercourse and no impact to the bed and bank.

Additional Mitigation	Additional SuDS and pollution control measures (e.g. silt fences) at this location during construction phase.
Catchment (km ²)	13.2 km ²
Minor Watercourse	No
CAR Authorisation Required	No

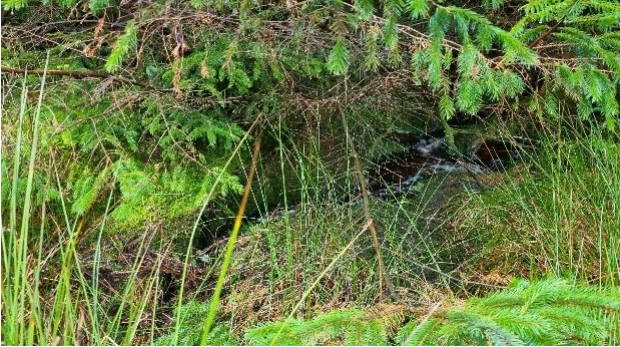
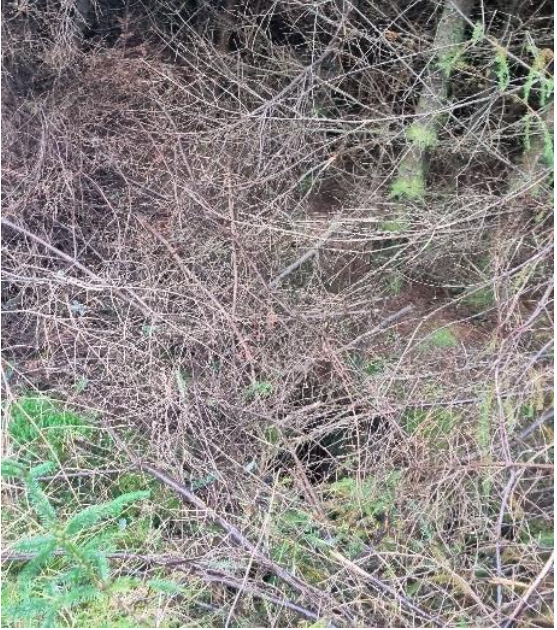
ID – J (Existing track crossing)	Burn of Elfhill
<u>Watercourse Description:</u> Burn of Elfhill flows beneath existing track crossing to the south, culvert dimensions unknown.	
NGR Ref: 379042 786220	
Photo –	Photo –

Width of watercourse/ drain (m)	0.4 m
Bed Sediment	Pebble
Bank Erosion	No
Natural Channel	Yes
Crossing Type	Existing culvert – no upgrade proposed.
Additional Mitigation	Additional SuDS and pollution control measures (e.g. silt fences) at this location during construction phase.
Catchment (km ²)	0.36 km ²
Minor Watercourse	Yes
CAR Authorisation Required	No

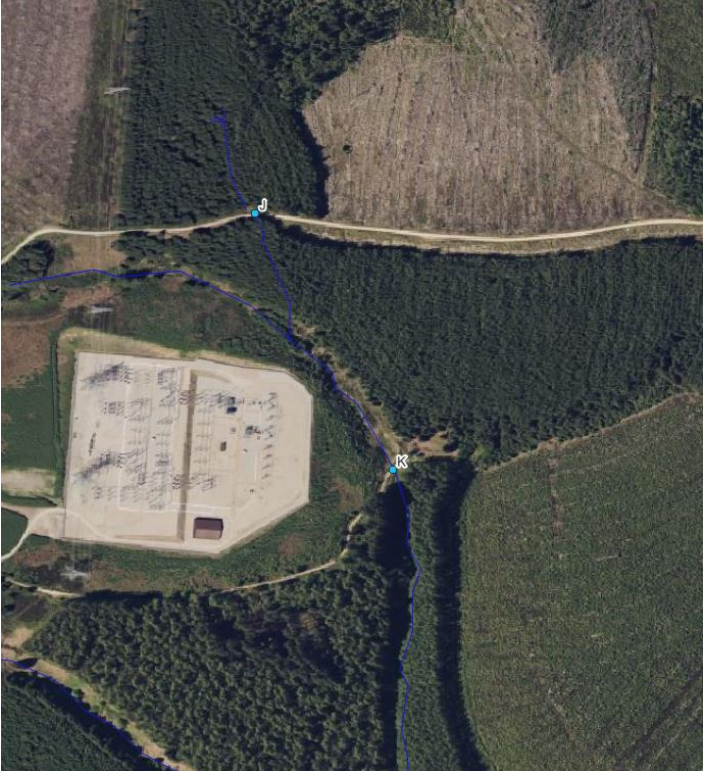
ID – K (Existing track crossing)	Burn of Elfhill
<p><u>Watercourse Description:</u> Burn of Elfhill flows beneath existing track crossing to the south. There is an existing culvert, but culvert dimensions are unknown at the time of writing. This crossing is on the Burn of Elfhill and is approximately 300 m downstream from crossing J. There was no access to crossing K at the time of writing.</p>	
<p>NGR Ref: 379197 785944</p>	
<p>Photo – Burn of Elfhill (from Bing aerial imagery)</p>

<p>Width of watercourse/ drain (m)</p>	<p>Estimated ~ 0.5 m</p>
<p>Bed Sediment</p>	<p>Unknown – likely mixed/pebble</p>
<p>Bank Erosion</p>	<p>-</p>
<p>Natural Channel</p>	<p>Yes</p>
<p>Crossing Type</p>	<p>Existing culvert (dimensions unknown) – no upgrade proposed.</p>
<p>Additional Mitigation</p>	<p>Additional SuDS and pollution control measures (e.g. silt fences) at this location during construction phase.</p>

<p>Catchment (km²)</p>	<p>0.60 km²</p>
<p>Minor Watercourse</p>	<p>No</p>
<p>CAR Authorisation Required</p>	<p>No</p>

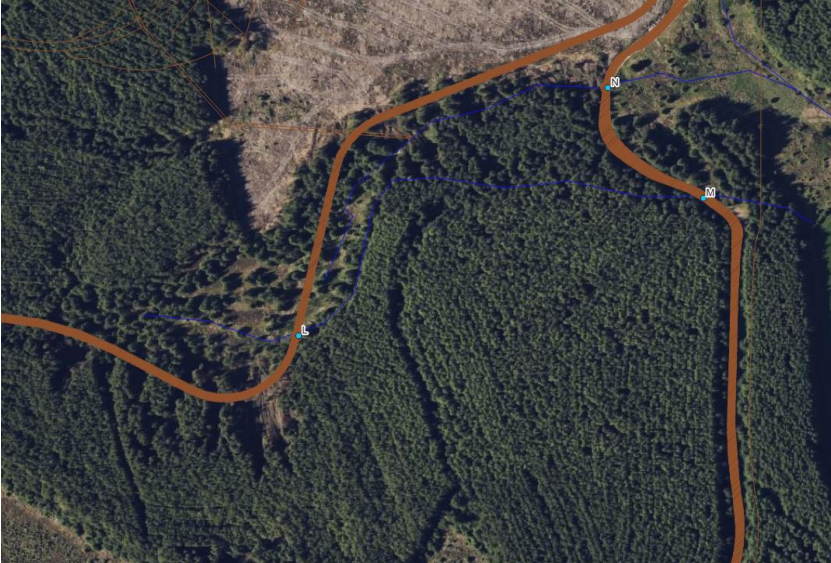
ID – L (New temporary construction track crossing)	Unnamed Drain
<p><u>Watercourse Description:</u> Crossing L is over a land drain (as mapped on Ordnance Survey 1:10,000 mapping). There was no access to crossing L at the time of writing and it is not known if it is present on Site. During detailed design this drain will be considered and either the construction haul route will be locally realigned if necessary, or a new culvert included for the drain.</p>	
NGR Ref: 379983 785960	
Photo – Unnamed Drain (from Bing aerial imagery)

Width of watercourse/ drain (m)	Estimated ~ 0.2 m
Bed Sediment	Unknown
Bank Erosion	-
Natural Channel	No
Crossing Type	New culvert crossing required for temporary construction track
Additional Mitigation	Additional SuDS and pollution control measures (e.g. silt fences) at this location during construction phase.
Catchment (km ²)	0.10 km ²
Minor Watercourse	Yes
CAR Authorisation Required	No

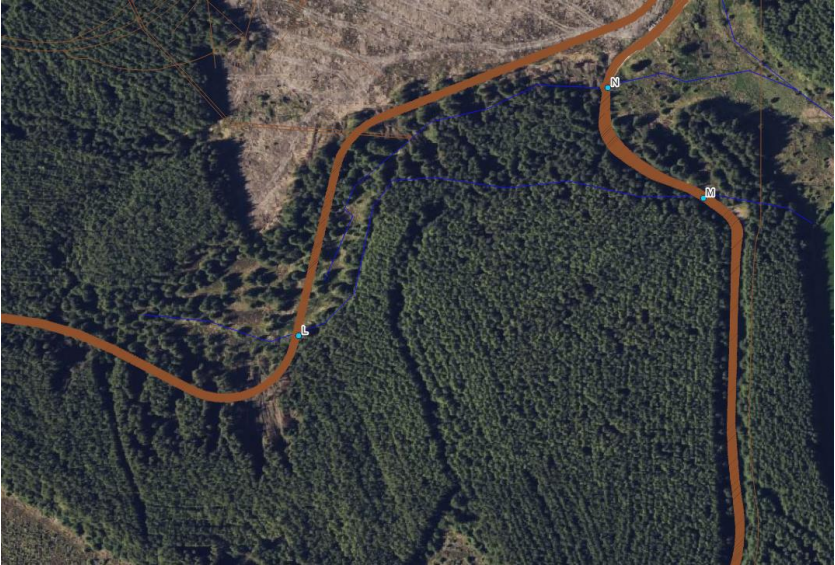
ID – M (Existing track crossing)	Unnamed Drain
<p><u>Watercourse Description:</u> Crossing M is over a land drain (as mapped on Ordnance Survey 1:10,000 mapping). There was no access to crossing M at the time of writing and it is not known if it is present on Site. If this existing access route is to be used to access the Proposed Development, there will be an existing culvert and its suitability will be assessed at detailed design stage.</p>	
<p>NGR Ref: 380265 786055</p>	
<p>Photo – Unnamed Drain (from Bing aerial imagery)</p>

<p>Width of watercourse/ drain (m)</p>	<p>Estimated ~ 0.2 m</p>
<p>Bed Sediment</p>	<p>Unknown</p>
<p>Bank Erosion</p>	<p>-</p>
<p>Natural Channel</p>	<p>No</p>
<p>Crossing Type</p>	<p>Existing culvert (dimensions unknown)</p>
<p>Additional Mitigation</p>	<p>Additional SuDS and pollution control measures (e.g. silt fences) at this location during construction phase.</p>

<p>Catchment (km²)</p>	<p>0.17 km²</p>
<p>Minor Watercourse</p>	<p>Yes</p>
<p>CAR Authorisation Required</p>	<p>No</p>

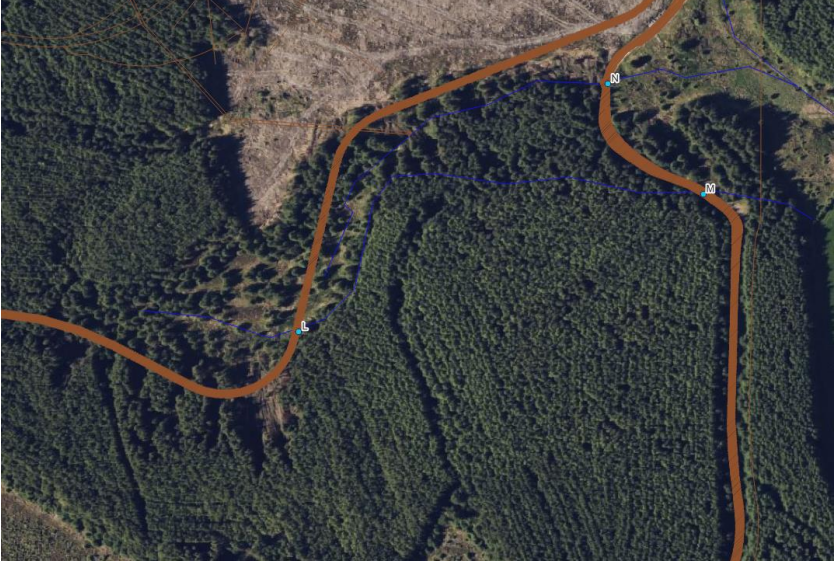
NGR Ref: 380199 786132	
Photo – Upper Burn of Baulks (from Bing aerial imagery)

ID – N (Existing track crossing and 15 m watercourse buffer breach of temporary construction track)	Burn of Baulks
<p><u>Watercourse Description:</u> Crossing N is an existing track crossing of the upper burn of Baulks, which flows to the east. There was no access to crossing N at the time of writing. If this existing access route is to be used to access the Proposed Development, there will be an existing culvert and its suitability will be assessed at detailed design stage.</p> <p>The temporary construction access track maintains a buffer of 10 m from the line of the upper Burn of Baulks, which is the recommended buffer size based on the watercourse size at this location. However, it is noted that the track can be locally micro-sited to achieve a 15 m buffer at next phase of design, if required. The principal design consideration was to achieve a 1:8 gradient, and the temporary construction route is indicative only at this stage.</p>

Width of watercourse/ drain (m)	Estimated ~ 0.5 m
Bed Sediment	Unknown
Bank Erosion	-
Natural Channel	Yes
Crossing Type	Existing culvert (dimensions unknown)
Additional Mitigation	Additional SuDS and pollution control measures (e.g. silt fences) at this location during construction phase.
Catchment (km ²)	0.5 km ²
Minor Watercourse	Yes
CAR Authorisation Required	No

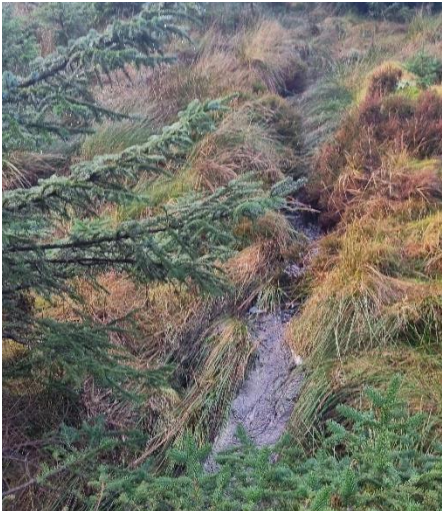
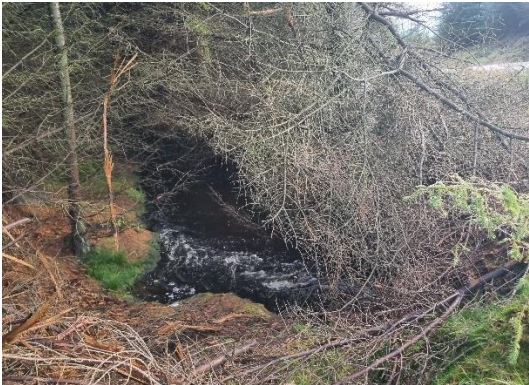
ID – 0 (Existing track crossing)	Burn of Day
<p><u>Watercourse Description:</u> Burn of Day flows beneath existing track crossing to the east, culvert dimensions unknown.</p>	
NGR Ref: 379998 786787	
Photo – Burn of Day looking upstream	Photo – Burn of Day looking downstream

Width of watercourse/ drain (m)	0.6 m
Bed Sediment	Pebble
Bank Erosion	No
Natural Channel	Yes
Crossing Type	Existing culvert (dimensions unknown) – no upgrade proposed.
Additional Mitigation	Additional SuDS and pollution control measures (e.g. silt fences) at this location during construction phase.
Catchment (km ²)	0.8 km ²
Minor Watercourse	No
CAR Authorisation Required	No
