**Hurlie 400kV Substation
Environmental Impact Assessment -
Appendix 12.3**

**Hurlie Substation Phase 1 Peat Survey
Report**

November 2024

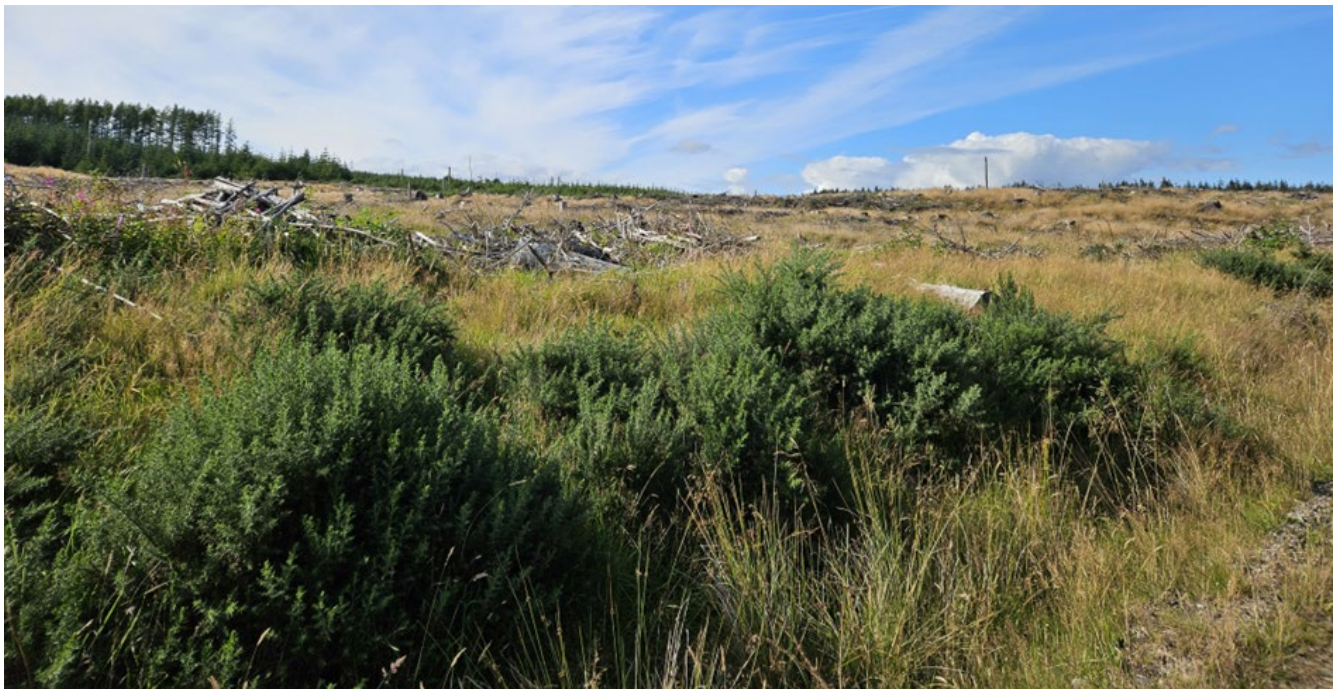
Photo 1: Site Overview 1

1.2.5 **Photos 1** and **2** present an overview of the existing site conditions.

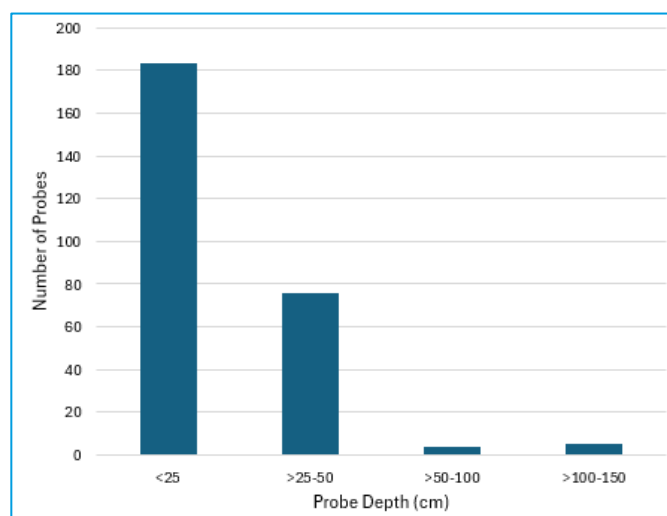
A summary of the probe depth data is presented in **Table 1** and the histogram below it. The probe depth data is presented spatially in **Figure 12.5**.

- 68.4% of probes were recorded as having a depth of less than or equal to 25cm. These probes are not classified as peat.
- 28.2% of probes were recorded as having a peat depth of between >25-50cm. These probes are classified as organo-mineral soils and not formally considered to be peat.
- 1.5% of probes were recorded as having a peat depth of between >50-100cm.
- 1.9% of the probes were recorded as having a peat depth of >100cm.

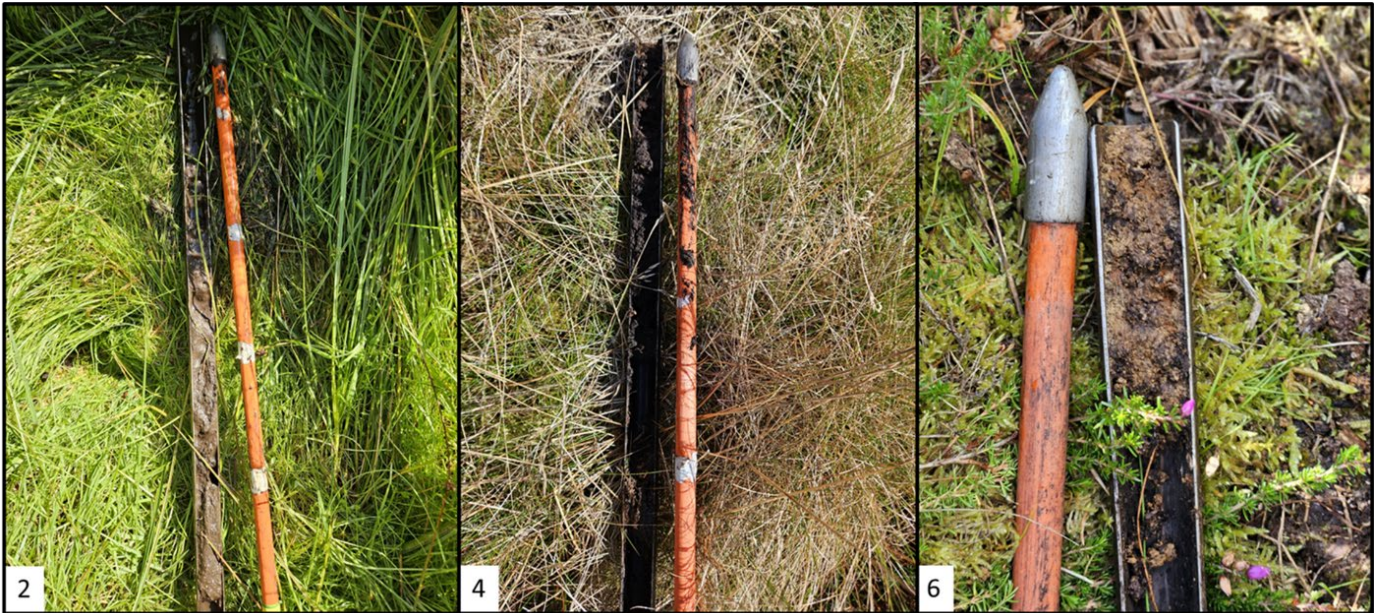
Photo 3: Examples of cores taken during the survey

3.2.2 A consistent approach was taken to core sampling, with a core taken in the deepest part of suspected peat or peaty soil. Areas containing peat identified in the survey had been heavily modified by forestry plantation, and as a result the acrotelm and catotelm layers in the cores were often poorly defined. Generally, the cores indicated that there is very little peat across the Site. In the two cores (cores 2 and 3) where peat was suspected, the core indicated that the peat was heavily modified and of extremely poor quality, incohesive and oxidised.

3.2.3 The areas cored were all found to be underlain with stony clay or gravels with some area of bedrock.

3.2.4 Representative examples of the cores taken are shown in **Photo 3**.

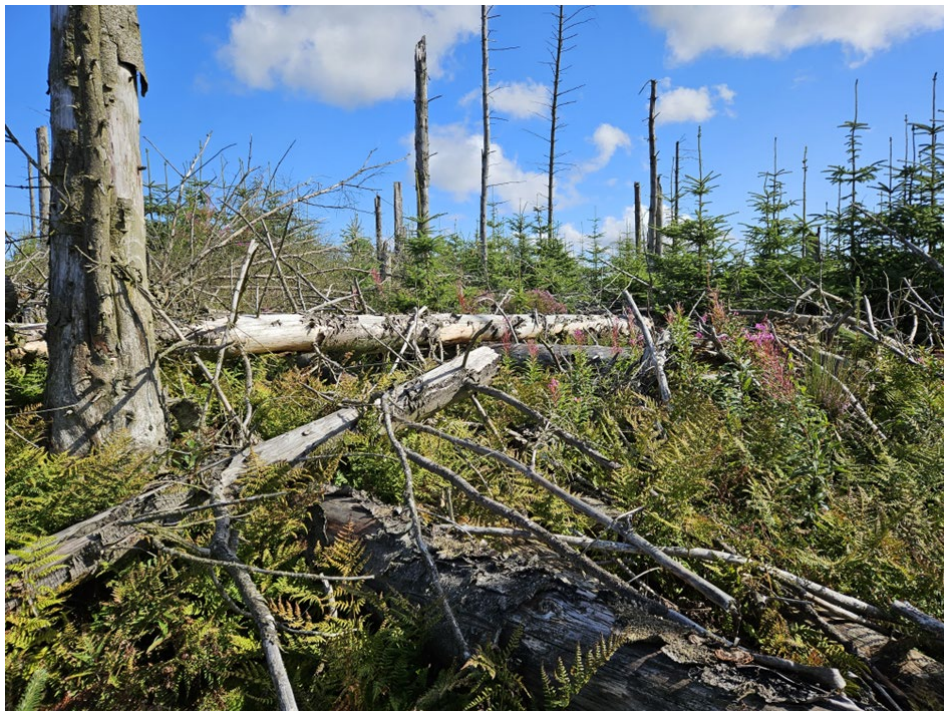
Photo 4: Forestry within the Site

3.3.1 The Site is composed mainly of plantation forestry, of varying stages of maturity. The forestry has had a significant impact on the soil, due to several factors such as transpiration of the trees, artificial drainage and the physical disturbance of the soil. Therefore, the peatland condition within the Site has been designated a mixture of 'Forestry/Previously Forested' and 'Modified' due to human influences degrading any peat which may have once dominated the Site. **Photo 4** demonstrates the current land use and is representative of the condition of much of the Proposed Development.
