New Deer 2 400kV Substation

Geotechnical Inteperative Report

Scottish & Southern Electricity Networks (SSEN)

Document no: S123039-TG-XX-XX-RP-GI-0001

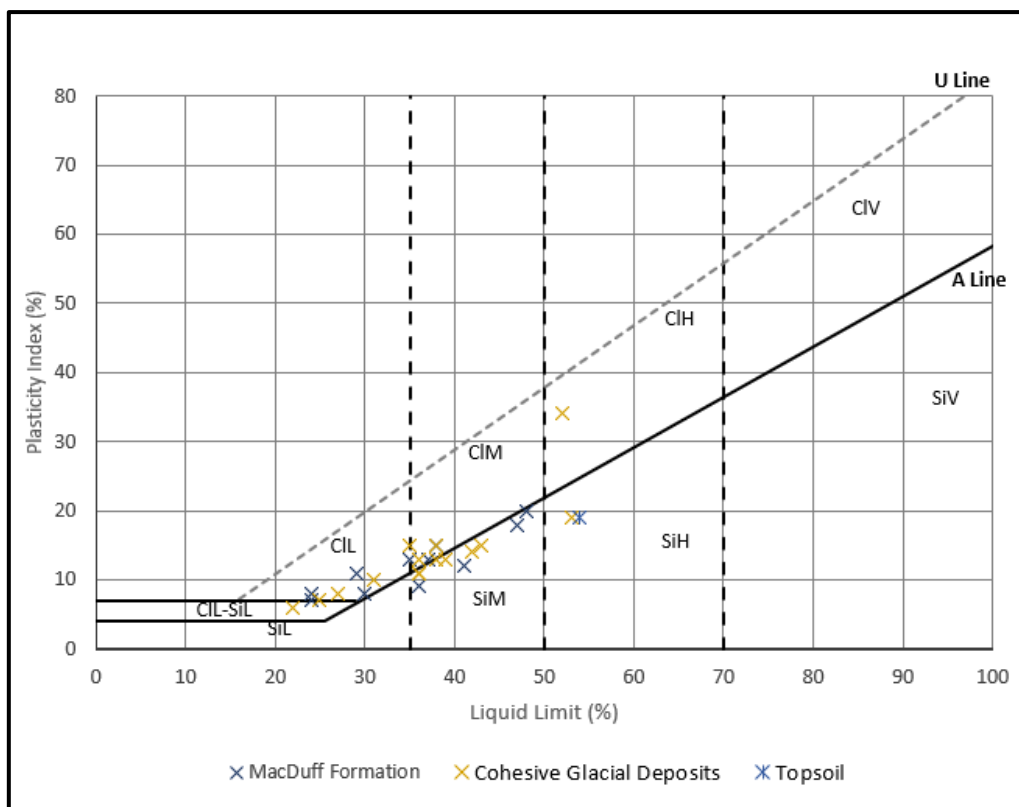
Figure 4. Atterberg Limit Test Results

- 2 No. sample from the MacDuff Formation were classified as being non-plastic.
- 1 No. sample from the Cohesive Glacial Deposits was classified as being non-plastic.

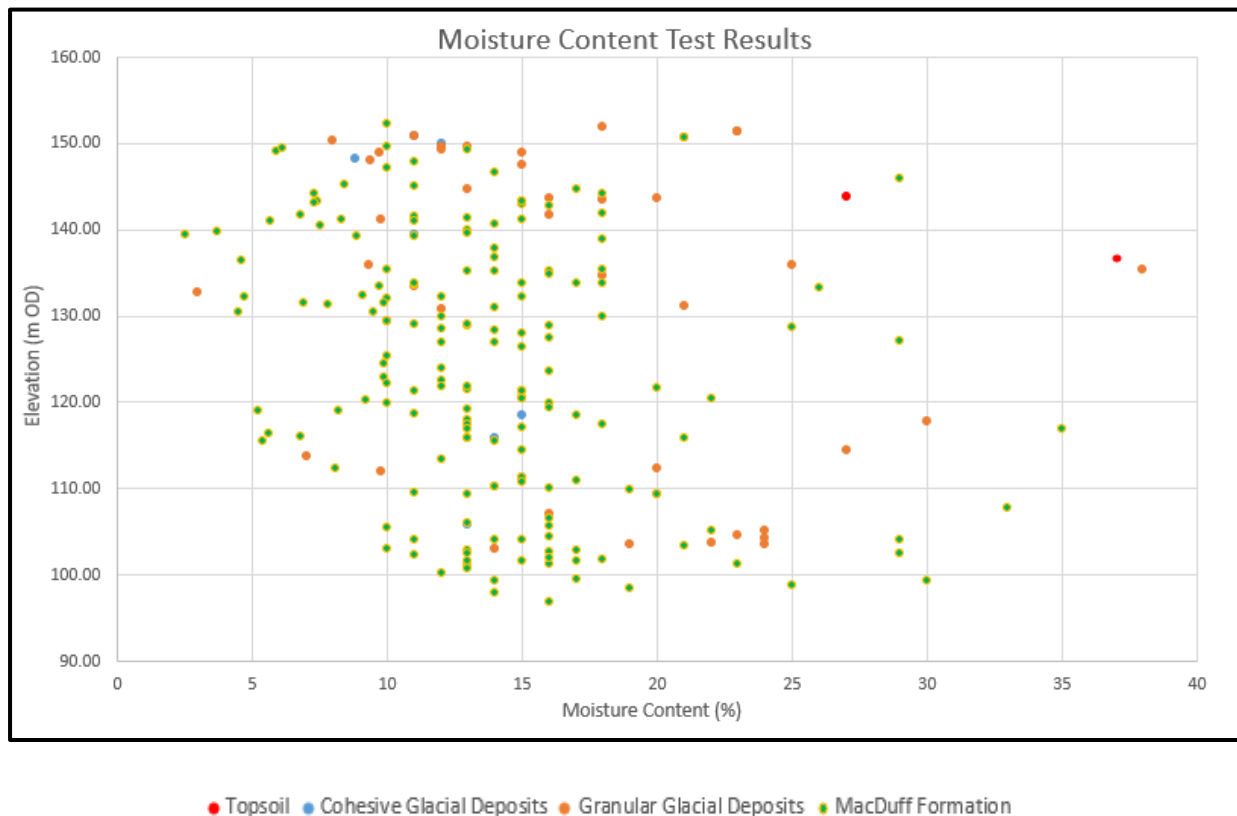
Figure 5. Plot of MC Test Results

Figure 5 below presents the moisture content percentage against the elevation for each strata.

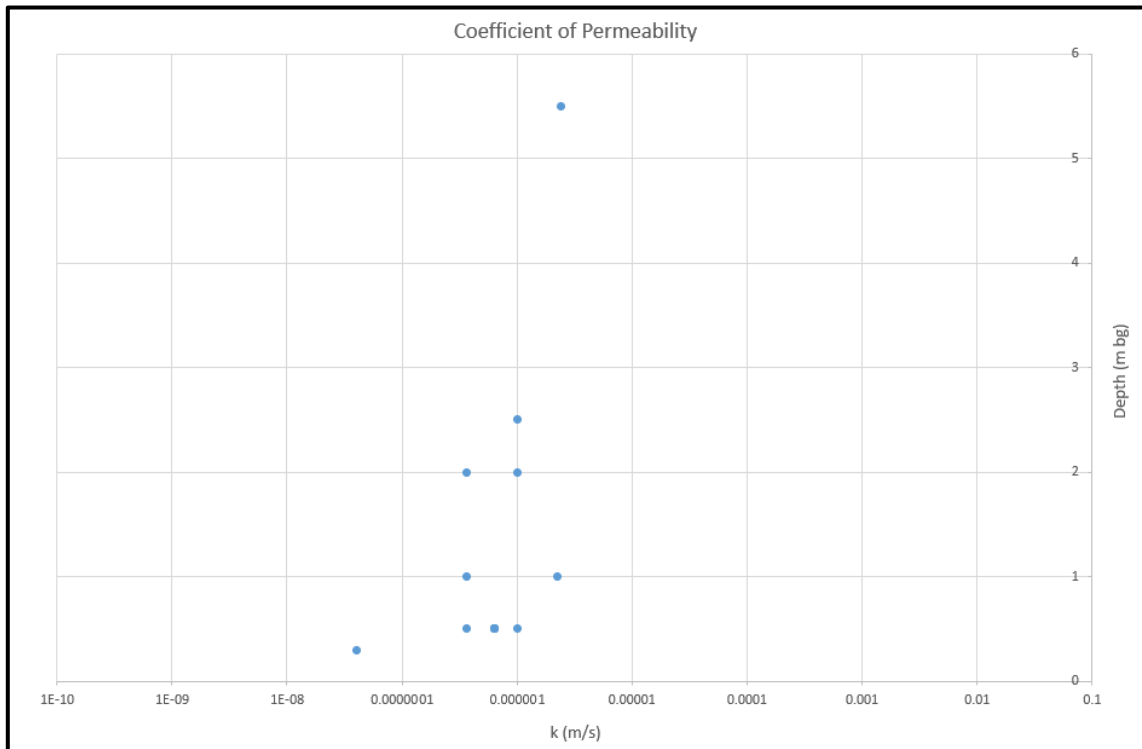
Figure 18. Plot of k values for Cohesive Glacial Deposits

The coefficient of permeability of the soil, k , can also be correlated from the laboratory test data, using the results of PSD testing. The correlation developed by Kozeny-Carman Hazen (1927) allows the use of grain size data D_{10} (corresponding to the sieve size at which 10% of material passes) to estimate the permeability of the soil. The plot of permeability values for the Cohesive Glacial Deposits is presented in Figure 18.

Figure 18 shows a range of soil permeability values of approximately 1×10^{-8} to $1 \times 10^{-6} \text{ ms}^{-1}$. This would indicate the Cohesive Glacial Deposits to be of a low to very low permeability, meaning natural drainage properties of these soils may be poor.

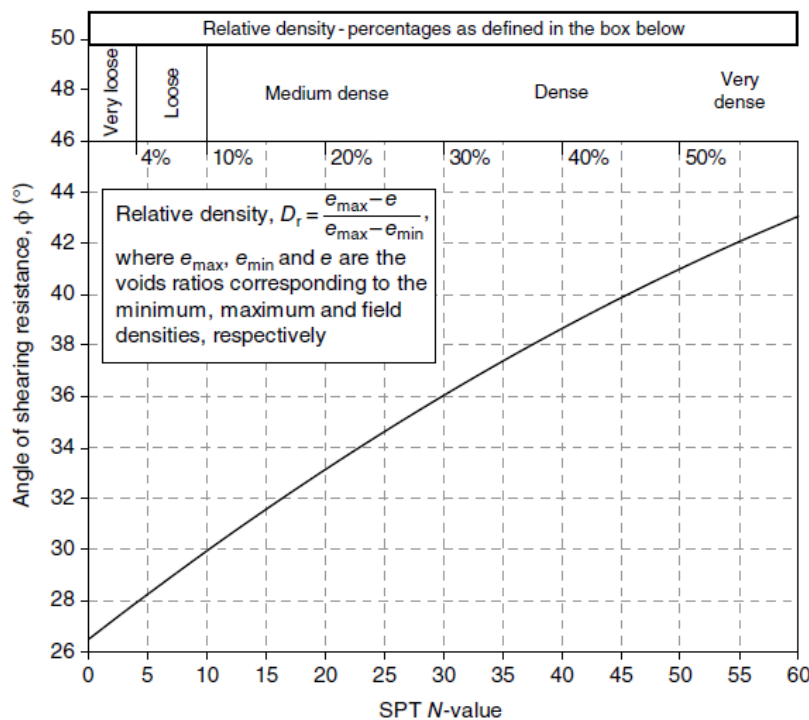
Figure 20. Estimation of the Friction Angle of Granular Soils from SPT results. Adapted from Peck et al. (1974)

For the Granular Glacial Deposits at the Site, an estimation of the internal angle of friction has been developed through correlation developed by Peck et al, using the chart presented in Figure 20. Observing the scatter of SPT N₆₀ values for the Granular Glacial Deposits, a characteristic SPT value of between N₆₀ = 35 - 45 would be considered appropriate for design purposes, and therefore the anticipated non-peak angle of shearing resistance for the soil is estimated to be in the region of φ = 37 - 40°.

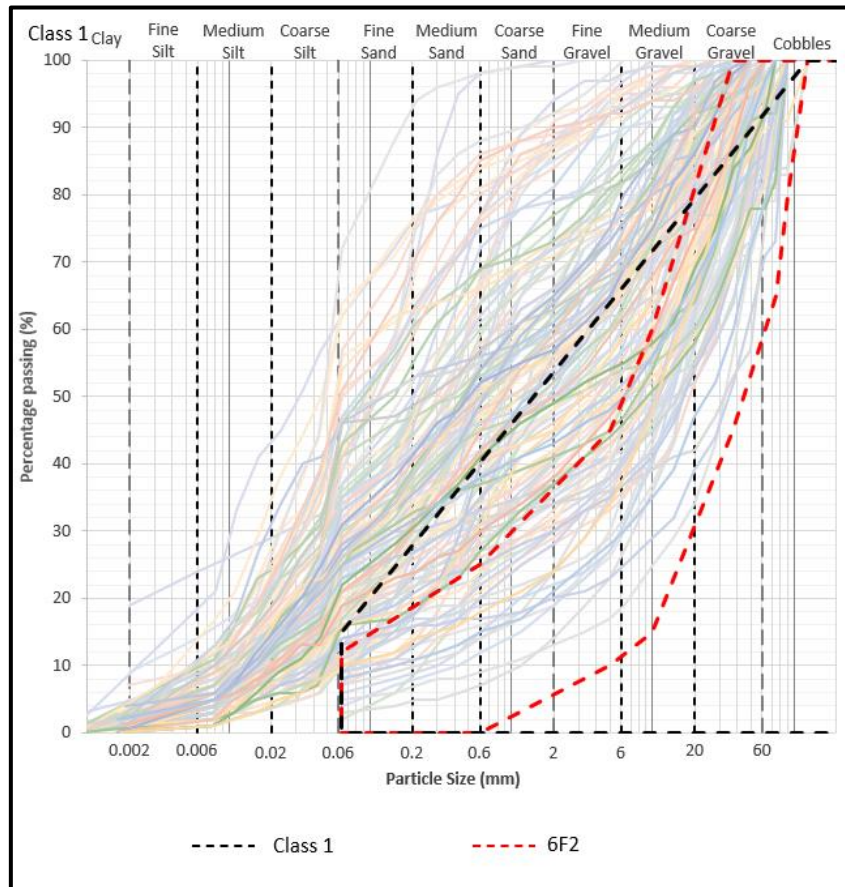
Figure 27. Plot of PSD Results compared to typical Granular Engineering Fills

The results of the PSDs from the Granular Glacial Deposits and Weathered and Non-Intact Rock from the MacDuff Formation are plotted against the grading envelopes for Class 6F2 and Class 1 Fills outlined within Table 6/2 of the SHW – 'Grading Requirements for Acceptable Earthworks Materials' are presented in Figure 27.

The data from Figure 27 indicates that the majority of the PSD curves for the granular superficial material lie out with the envelope for the in-situ material to be immediately classified as either Class 1 or Class 6F2 engineering fill, due to high fines content. As such, earthworks processing would be required in order to develop most of the on-site soils into an engineering fill for use during construction, which would require the introduction of larger particles. On Site sourcing of these larger particles may be possible through excavation and reprocessing of the Site bedrock, which could be sourced from areas of deep cut within the west of the site.

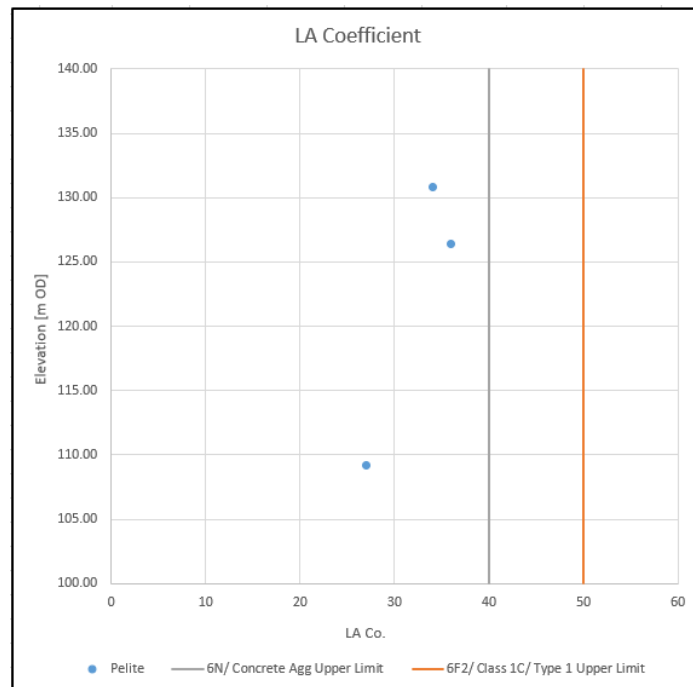
Figure 29. LA Coefficient Test Results

The data indicates that the durability characteristics of the rock at the Site fall within the acceptable limits for reusing this material as a Class 6F2, Class 1C and a Concrete Aggregates. However, only Pelite was tested and no LA Coefficient testing was conducted on Semi-Pelite or Psammite samples. Magnesium Sulphate Soundness tests were conducted on all three rock types encountered throughout the Site, and the test results show many of the Magnesium Sulphate Soundness test results fall above the upper bound limit for consideration of this material to be reused as a Type 1 fill.

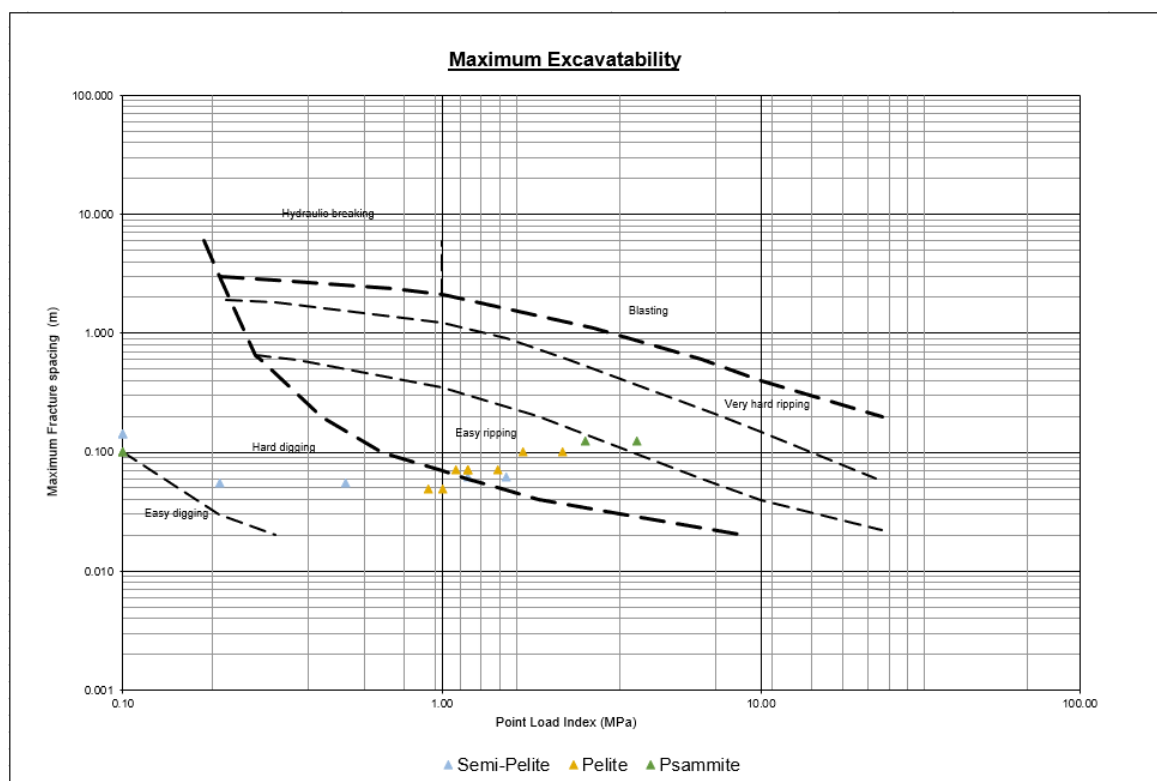
Figure 31. Excavatability Chart

Figure 31 below presents analysis of the rock strength data against the rock fracture index to provide an indication of the likely required methods of excavation required, based on a maximum excavatability chart developed by Pettifer and Fookes¹⁰.

Most of the plotted data can be observed to fall within the areas of the chart that would indicate a requirement for Hard digging and easy ripping in order to excavate the bedrock at the Site. Blasting is not anticipated to be required for the bedrock at the Site.
