New Spittal Substation, Spittal, Caithness

Archaeological Watching Brief and Walkover Survey Data Structure Report

AOC Project 70767

September 2023

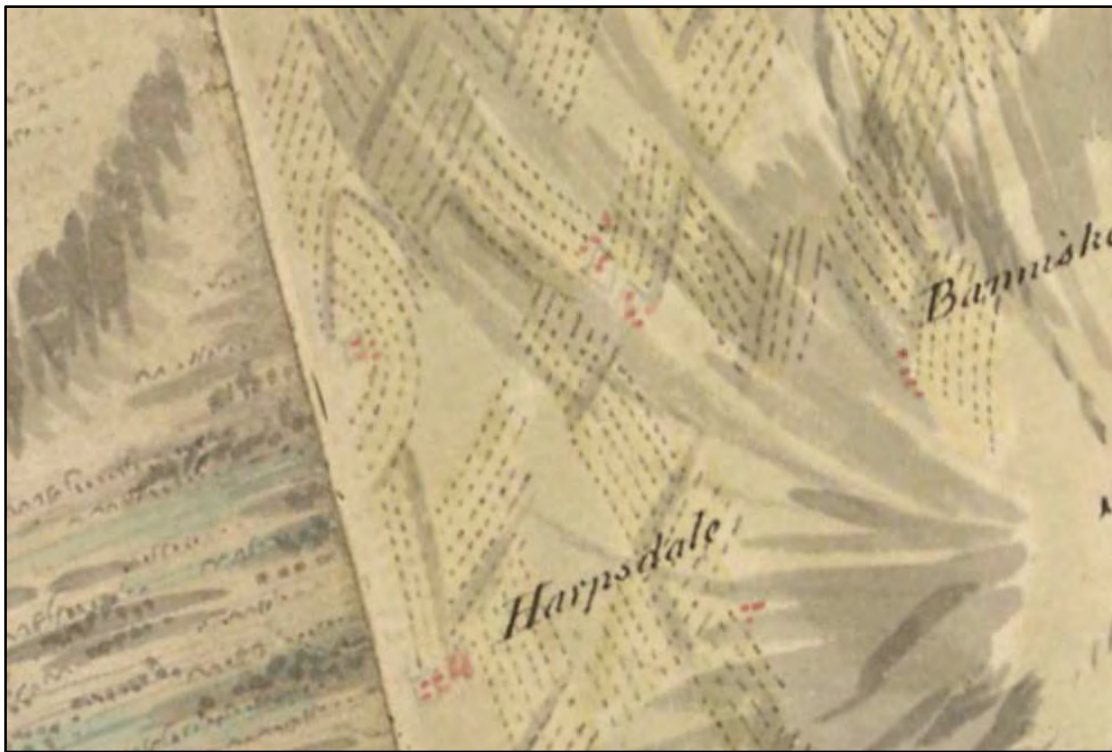
Figure 5: Extract from Roy's *Military Survey of Scotland*, 1747-52, showing structures possibly representing longhouse farms or their predecessors at Achalone

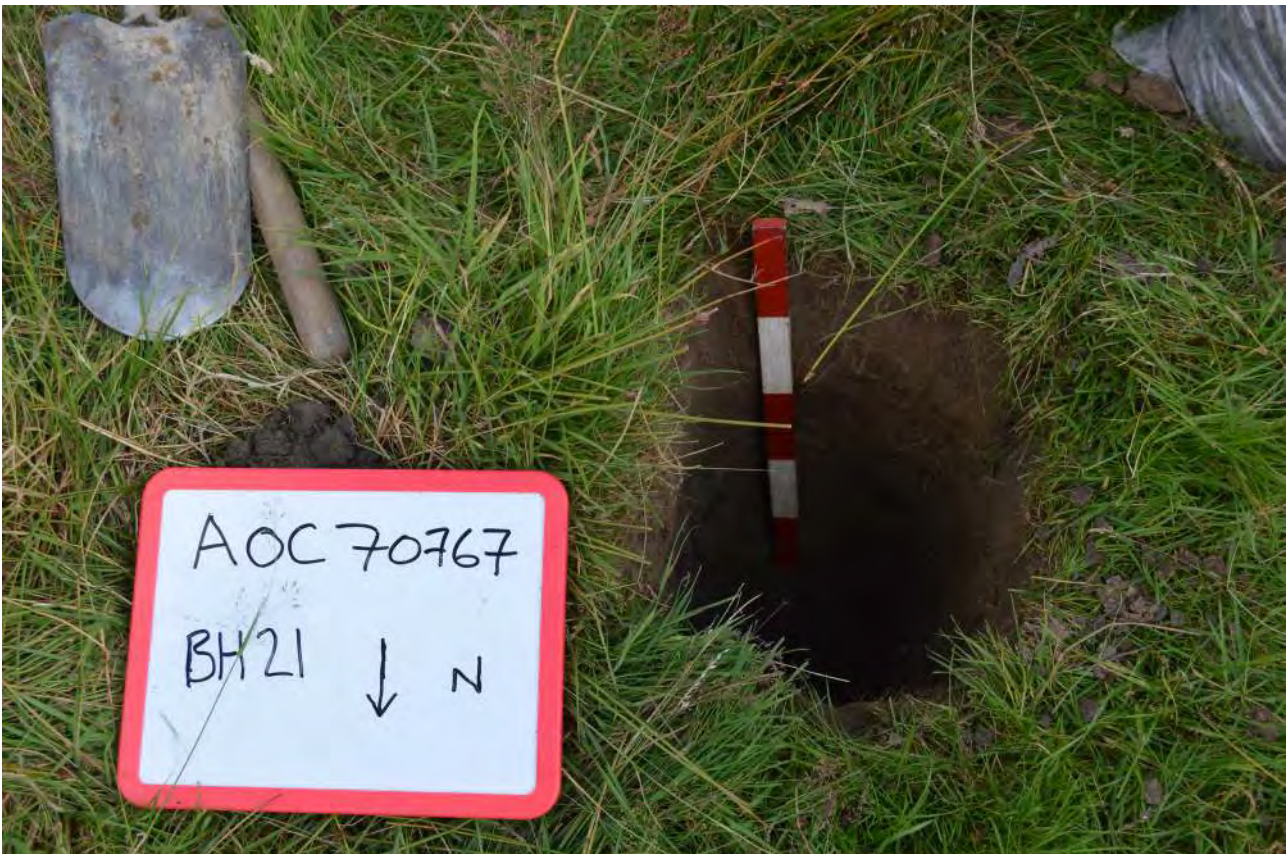
Plate 22: General view of BH21 down to stoney natural, looking south

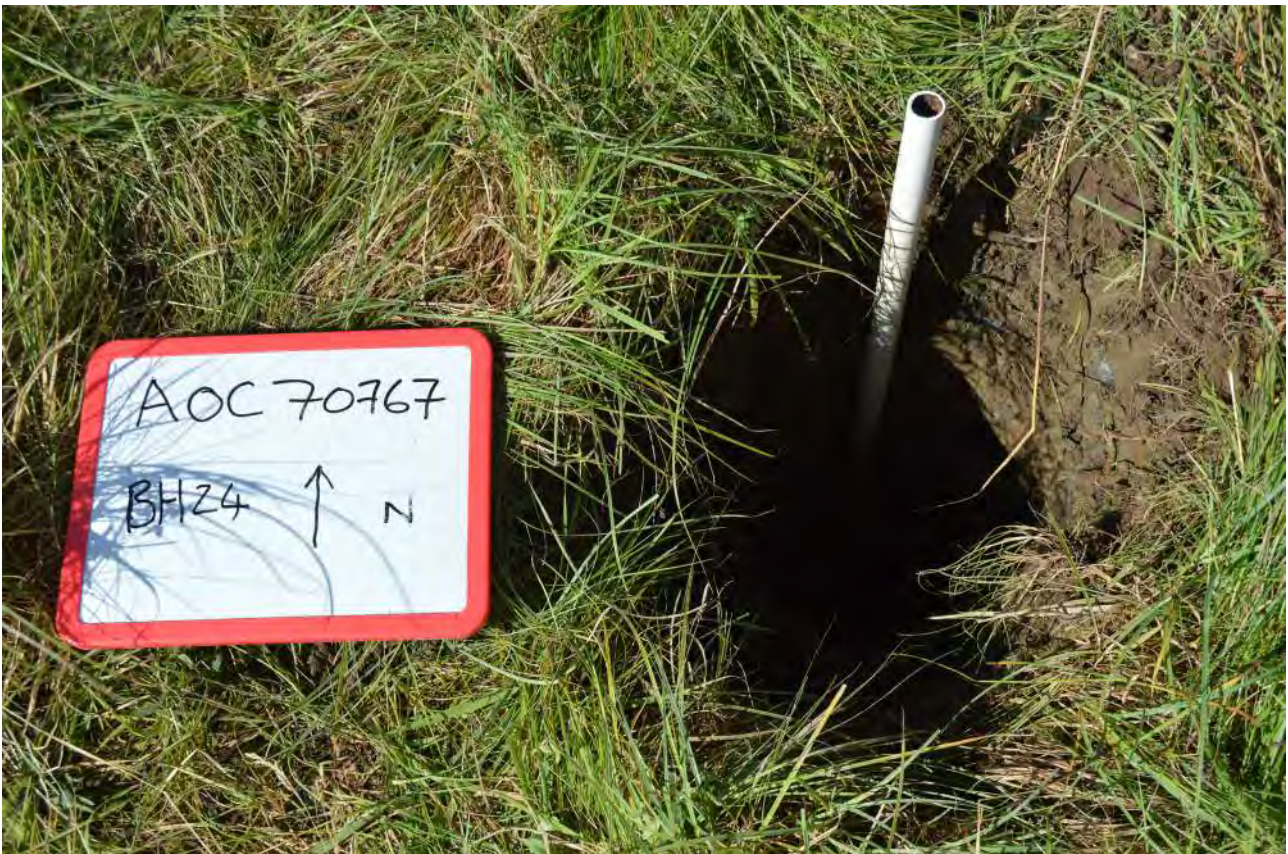
Plate 26: General view of BH24 post-excitation. Excavated down to 1.1m, unable to reach natural subsoil, looking north

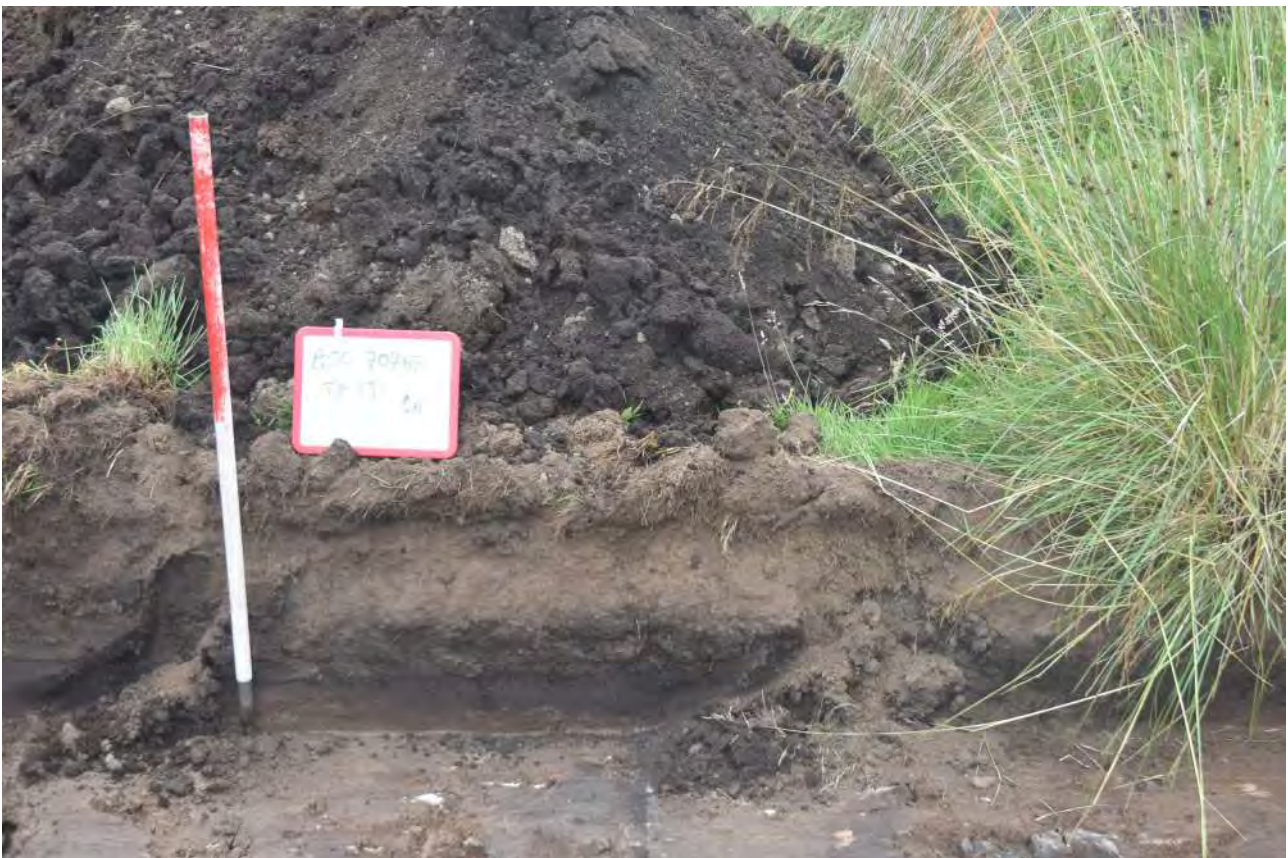
Plate 40: General view of TP13 south facing section , looking south
