Foyers Tree Felling

Resilience Survey and Woodland Condition Report

Landowner Scottish and Southern Electricity Network

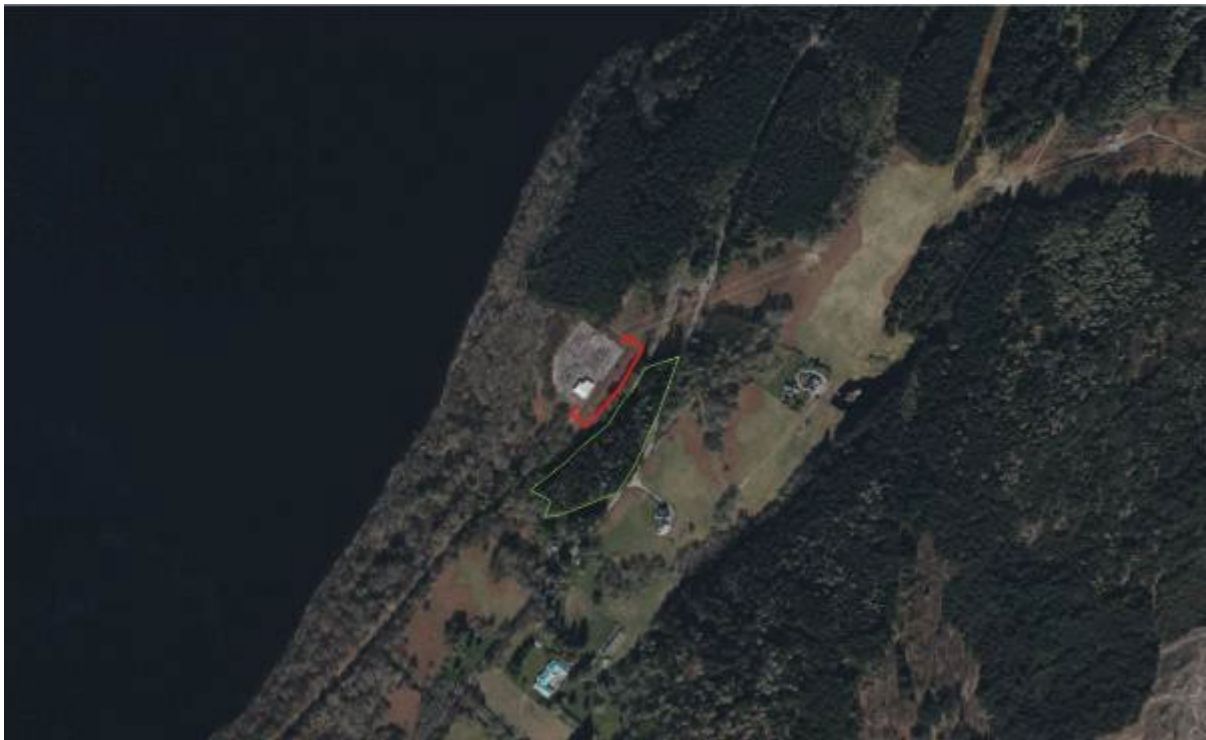
*Figure 1: Study Area*

The red line illustrates the initial proposed substation extension, civil works are likely to go beyond this, but the footprint is yet to be fully determined. The area highlighted in green illustrates the woodland Scottish Woodlands were contracted to survey.

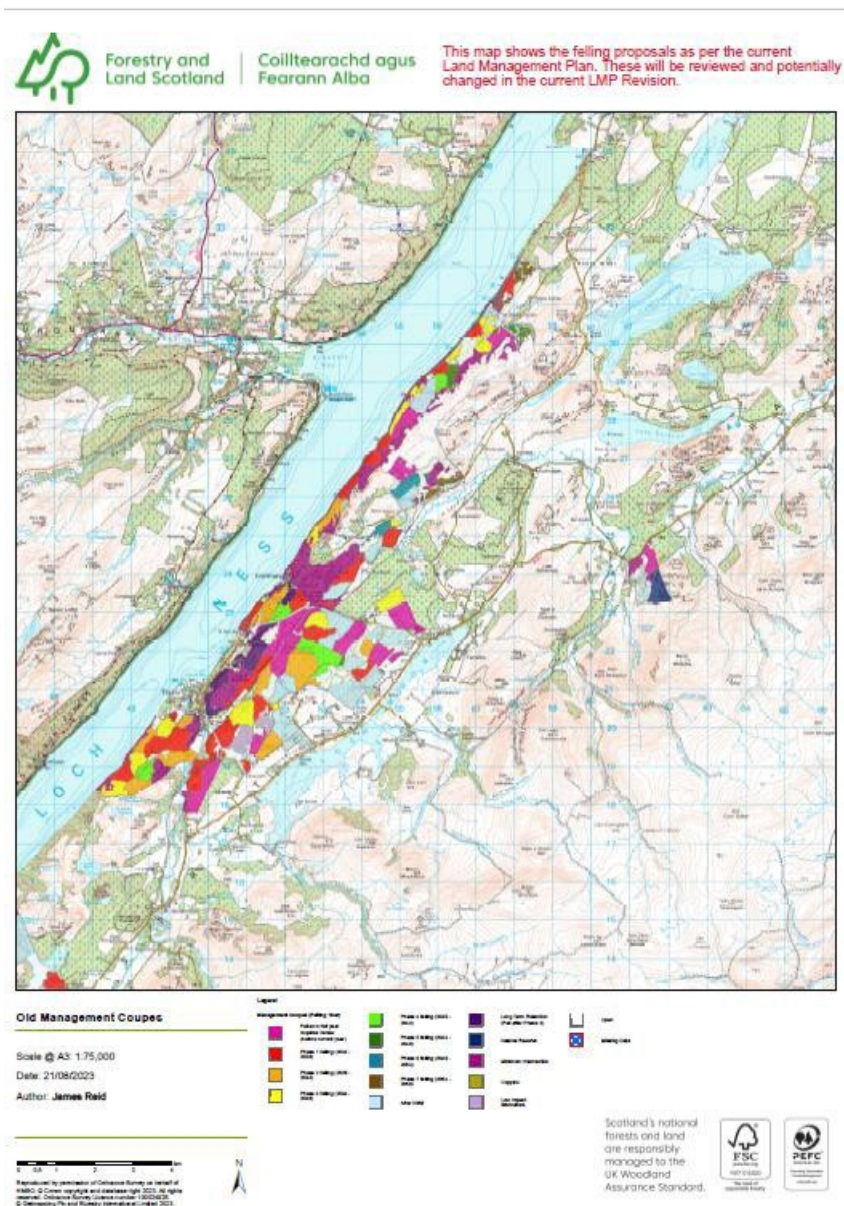
Figure 3: FLS Management Coupes

As mentioned above in section 4 the risk of windthrow from the north and northwest is moderate to high due to exposure from non-prevailing winds after the phase 1 felling has concluded based off the FLS phase 1 felling plans as illustrated below in Figure 3.

The coniferous trees within the study area are nearing a stage where they are beyond conventional harvesting size. Scottish Woodlands recommend felling the area within the next 12 months. Due to the conditions on site and the size of the area it would be recommended that the area is deer fenced and restocked with native species. It would be beneficial to plant the area with a diverse mix of broadleaves to help ensure a continuous screen from residential receptors is maintained long term and to also help promote greater resilience within the woodland. Stratified edges are encouraged along the road and substation to reduce the risks to established infrastructure. Tree shelters could also be utilised outside of the main compartments to leave access available along the foot path.
